SERVICE BULLETIN

APPLICABILITY: 2020-22MY Legacy & Outback

NUMBER: 06-83-22

SUBJECT: VDC Reprogramming File Availability

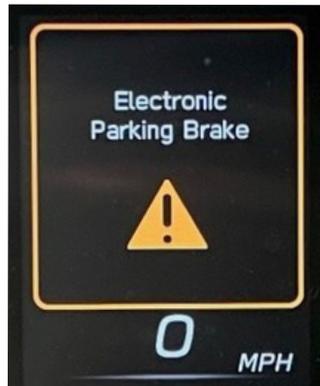
This bulletin announces availability of reprogramming files to optimize the Vehicle Dynamic Control control module (VDCCM). The new files will address VERY rare cases of the Electronic Parking Brake (EPB) not disengaging along with an associated EPB warning message. This new logic optimizes the VDC parameters for the EPB mode of operation. If this concern is duplicated, reprogram the VDC control module following the normal FlashWrite procedure.

Reprogram the VDC following the normal FlashWrite procedure.
