SERVICE BULLETIN

SUBJECT: Front Coil Spring- Design Change to Address

Cracking Sound from Front Suspension

NUMBER: 05-75-20R

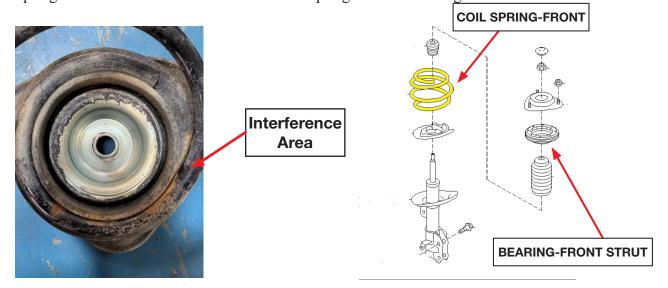
This bulletin announces a design change of the front coil spring to address a cracking-type sound coming from the suspension when turning left or right. The sound is a result of interference between the front coil spring and the strut bearing. The design change increases the amount of turns in the coil spring which minimizes the area between the spring and strut bearing and eliminates the sound.

NOTE: Impreza has a turn increase from 4.2 turns to 4.4. Crosstrek Hybrid has a turn increase from 4.83 turns to 4.87. These changes have been incorporated into the 2022MY vehicle production.
