TECHNICAL SERVICE BULLETIN

Hard Top Headliner Loose And/Or Sagging

22-2073
01 March 2022

Ford 2021-2022 Bronco

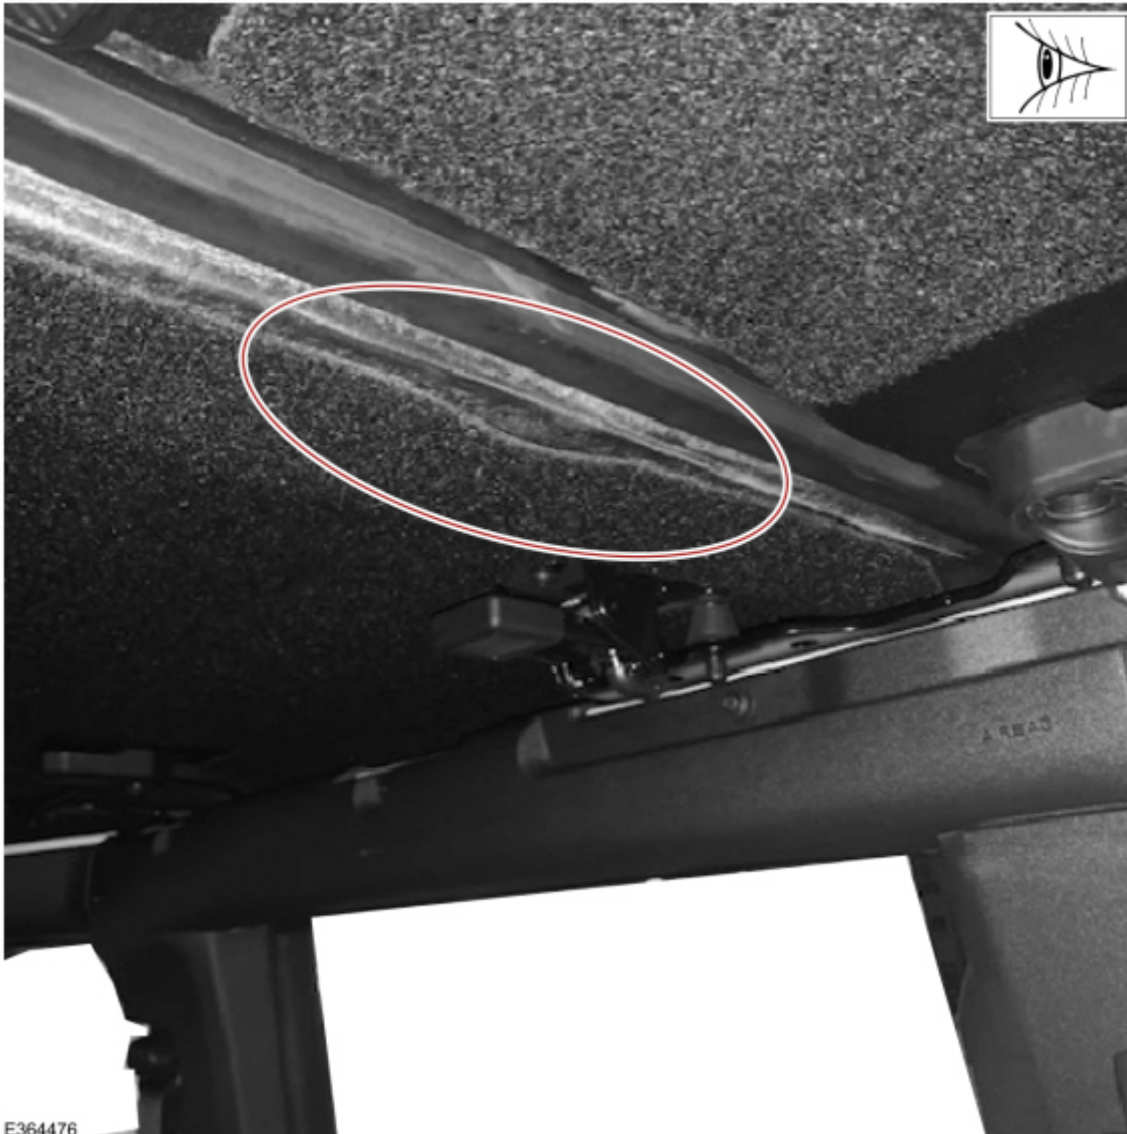
Figure 1

1. Inspect the interior headliner. Is the headliner loose and/or sagging? (Figure 1)
