TECHNICAL SERVICE BULLETIN

Water Leak From A-Pillars And/Or Windshield Header

22-2074
01 March 2022

Ford 2021-2022 Bronco

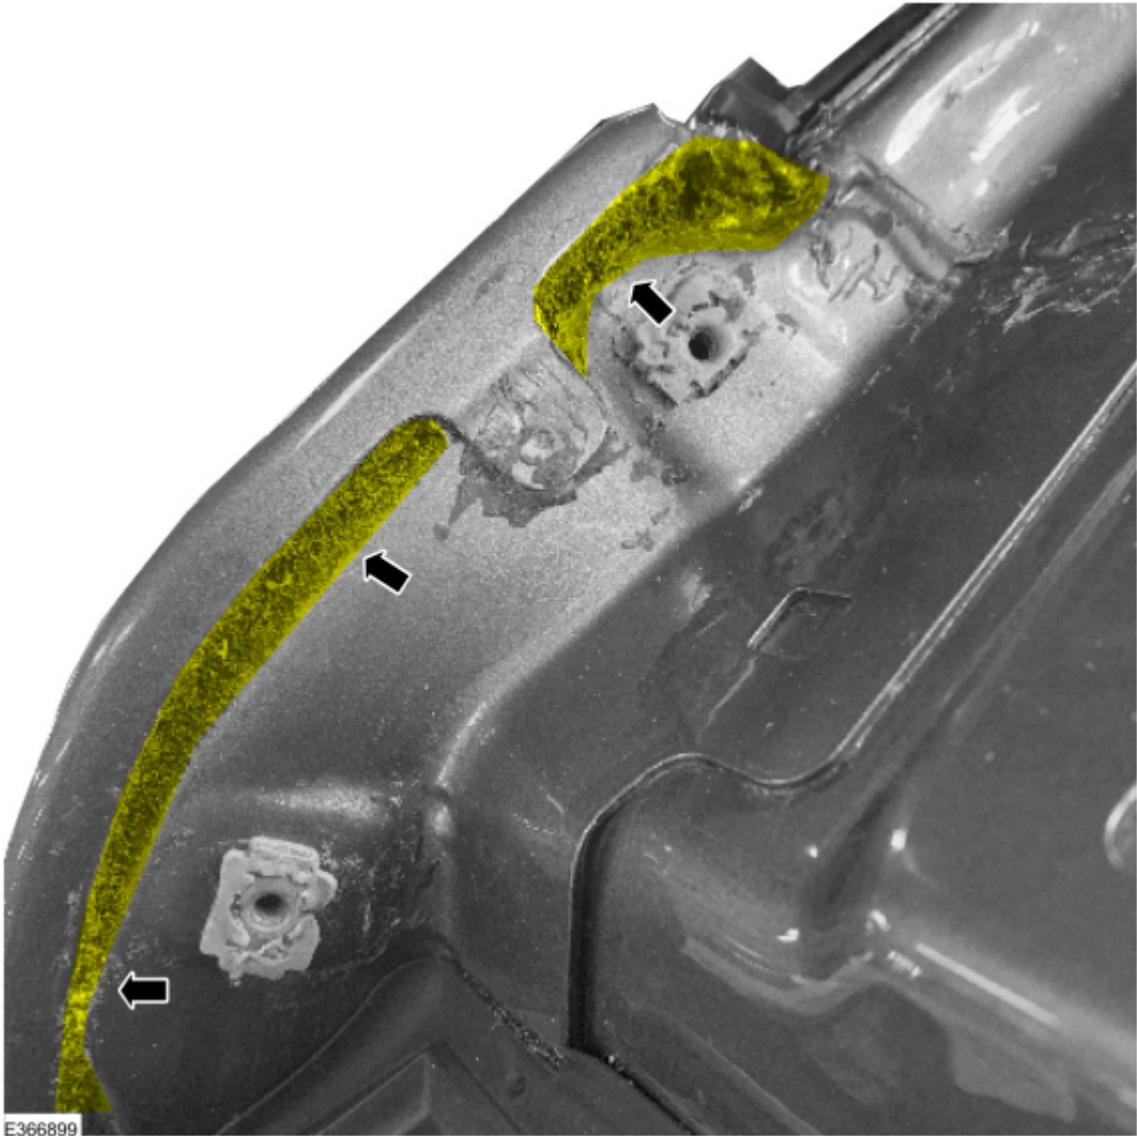
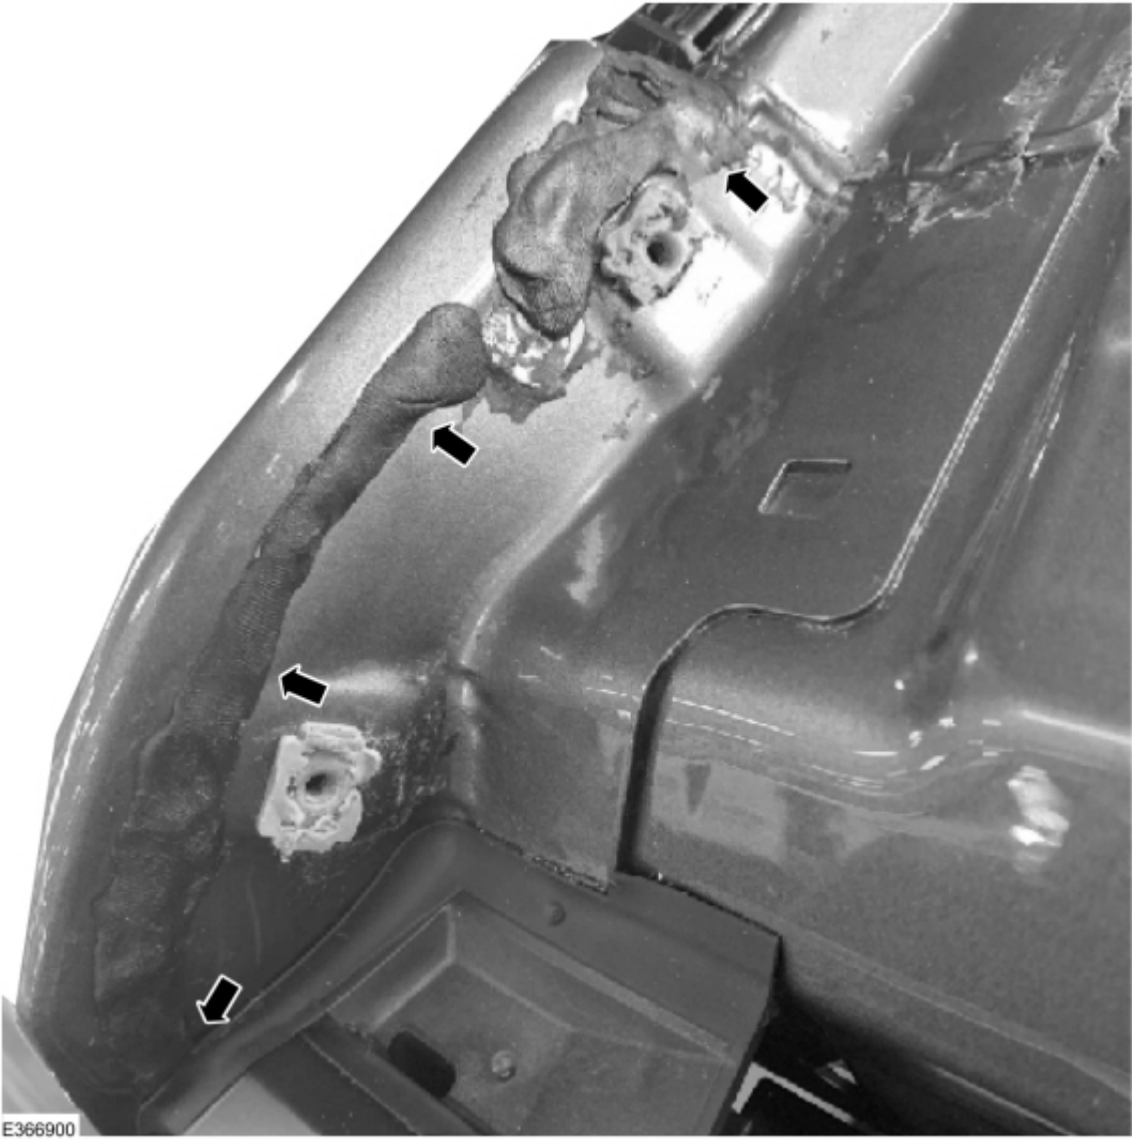
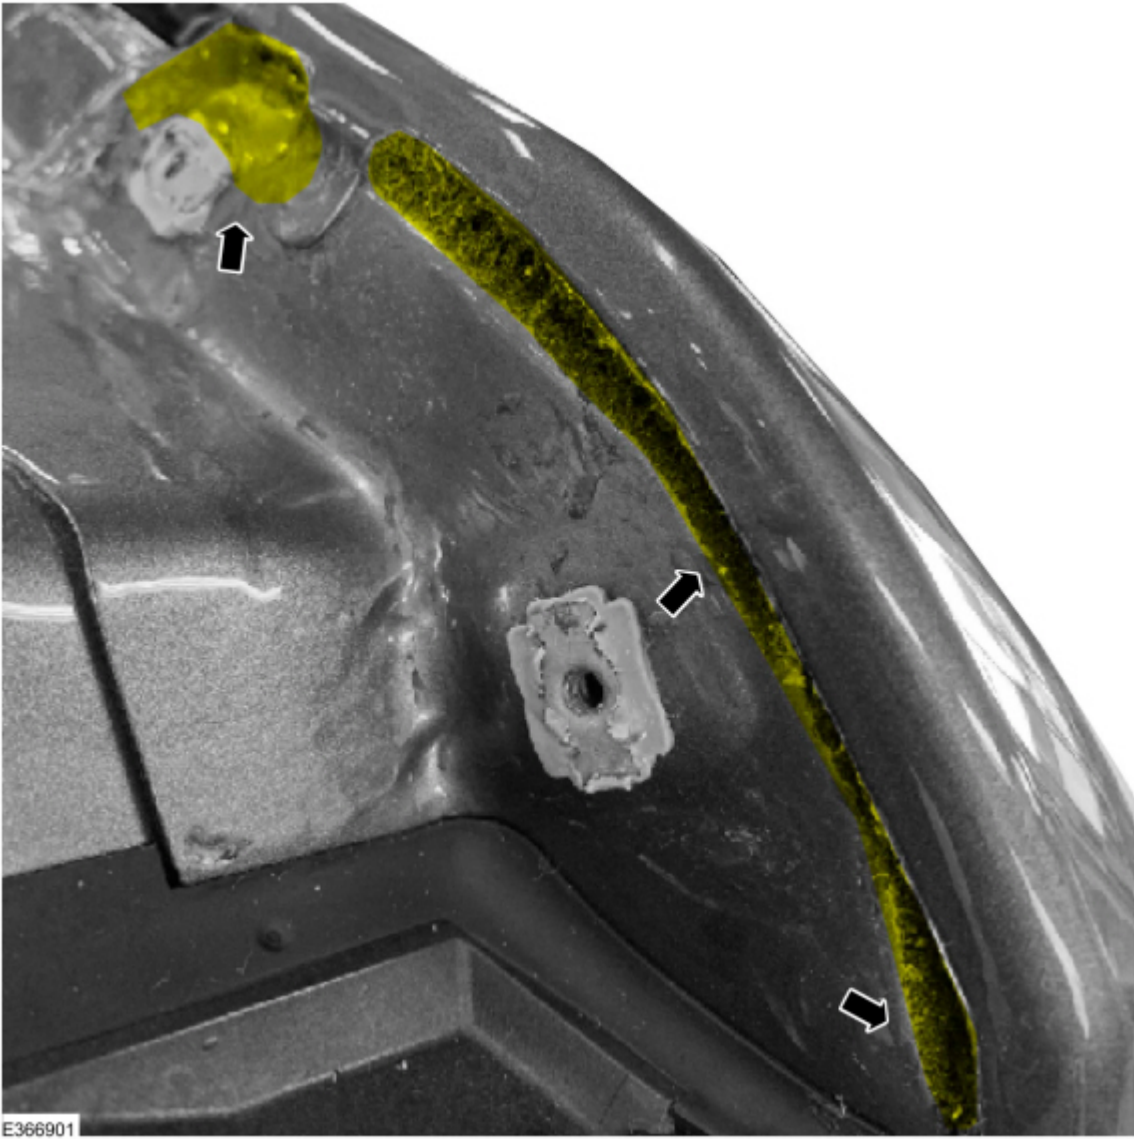
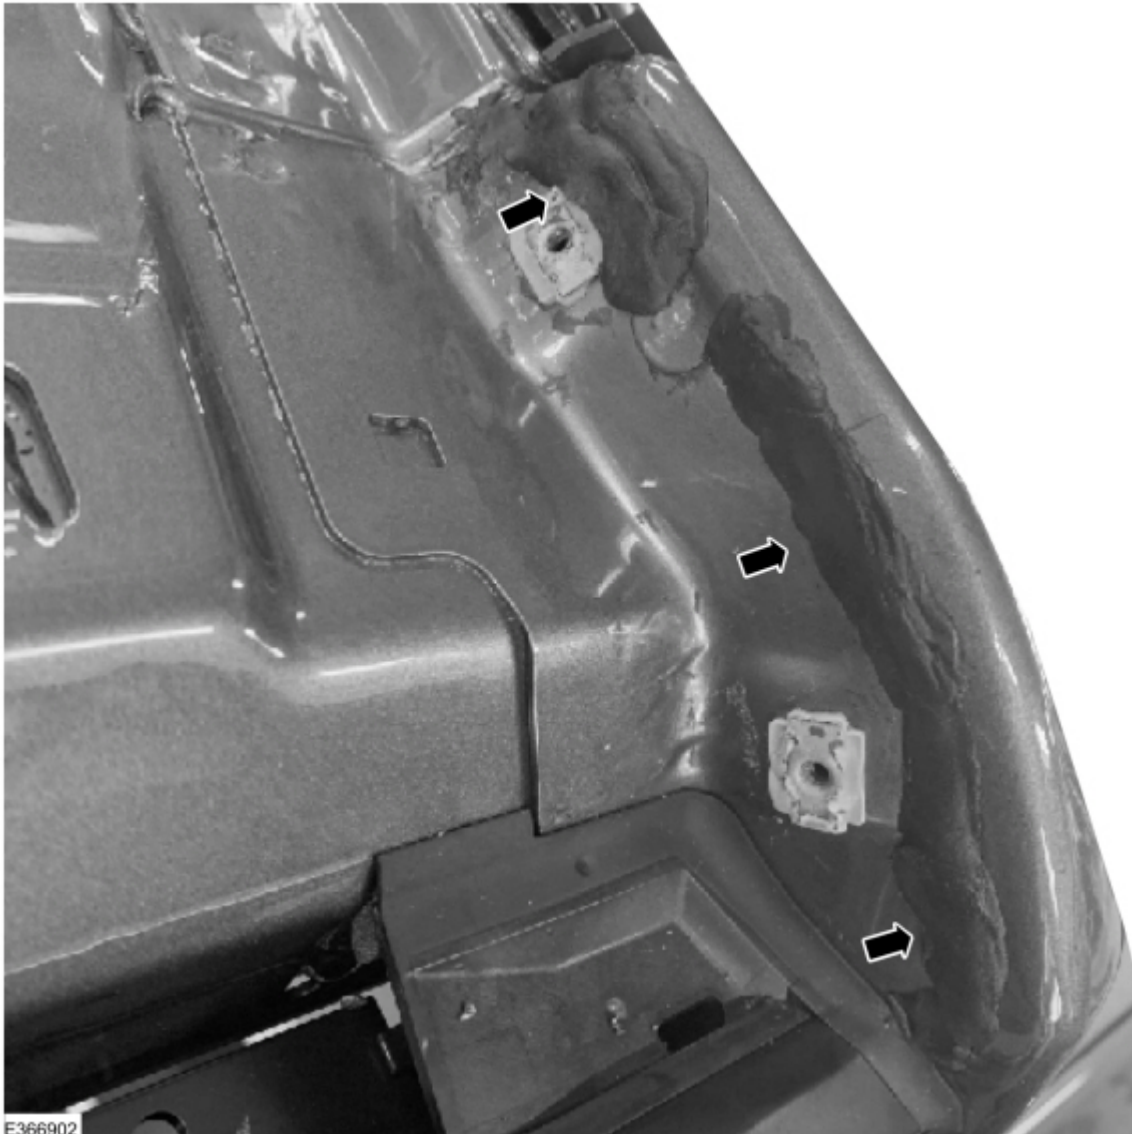
Issue: Some 2021-2022 Bronco vehicles may experience a water leak that originates from the left and/or right A-pillars and/or the windshield header. This may be due to excessive gaps in the body seams from the factory. To correct the condition, follow the Service Procedure to reseal the affected body gaps and replace the front header seal.

5. Clean the header seal mating surface on the body by removing all residual sealer left over from the old header seal. Use a plastic scraper and isopropyl alcohol wipes to clean the surface without harming the painted surface. If any painted surfaces are scratched during the cleaning process, touch up these areas with paint (covering any exposed metal) prior to proceeding.
6. Follow the instructions on the container to apply 3M™ Strip-Calk to the exposed body seams starting at the roof rack trim cover area and ending at the corner seal where the body seam ends. Do not leave a gap between the edge of the caulk and the corner seal. (Figures 5-8)
