TECHNICAL SERVICE BULLETIN

Vibration/Pulsation From Brakes - Brake Pad Material Stuck To Rotor - Built On Or Before 06-Jan-2022

22-2023

Ford 2021-2022 Mustang Mach-E	Built on or before 06-Jan-2022
----------------------------------	--------------------------------

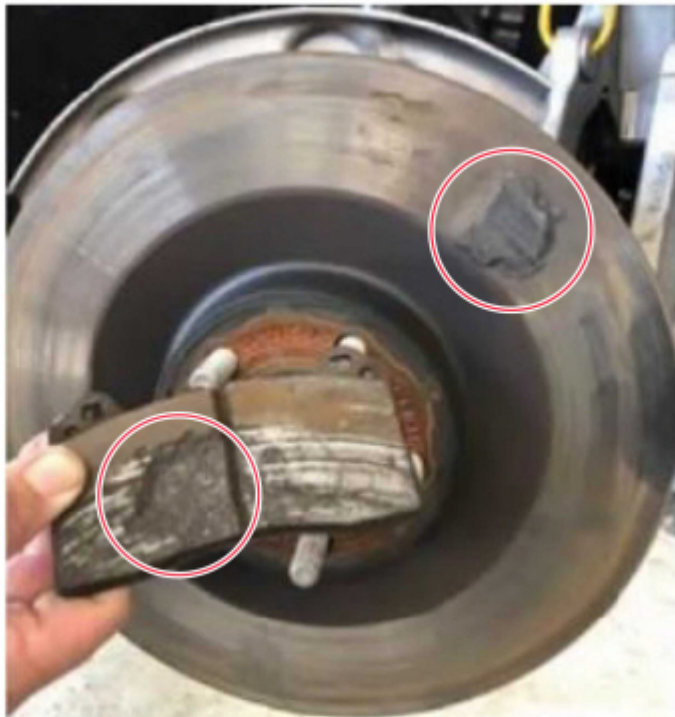
Figure 1

Issue: Some 2021-2022 Mustang Mach-E vehicles built on or before 06-Jan-2022 may exhibit a vibration or pulsation from the brakes. This may be due to brake pad material bonded to the rotor. To correct the condition, follow the Service Procedure to replace the brake pads and resurface the rotors.

1. Is there brake pad material bonded onto the front brake rotor(s)? (Figure 1)

3. Resurface the affected front brake rotor(s) to remove brake pad material. Refer to WSM, Section 206-00.
4. Is there brake pad material bonded onto the rear brake rotor(s)?
 - (1). Yes - proceed to Step 5.
 - (2). No - repair is complete.
5. Replace the rear brake pads with the revised brake pads. Refer to WSM, Section 206-03. (Figures 2-3)
6. Resurface the affected brake rotor(s) to remove brake pad material. Refer to WSM, Section 206-00.
