TECHNICAL SERVICE BULLETIN

Non-Hybrid - Radio Static And/Or Poor Radio Sound Quality When Moving

22-2040

14 March
2022

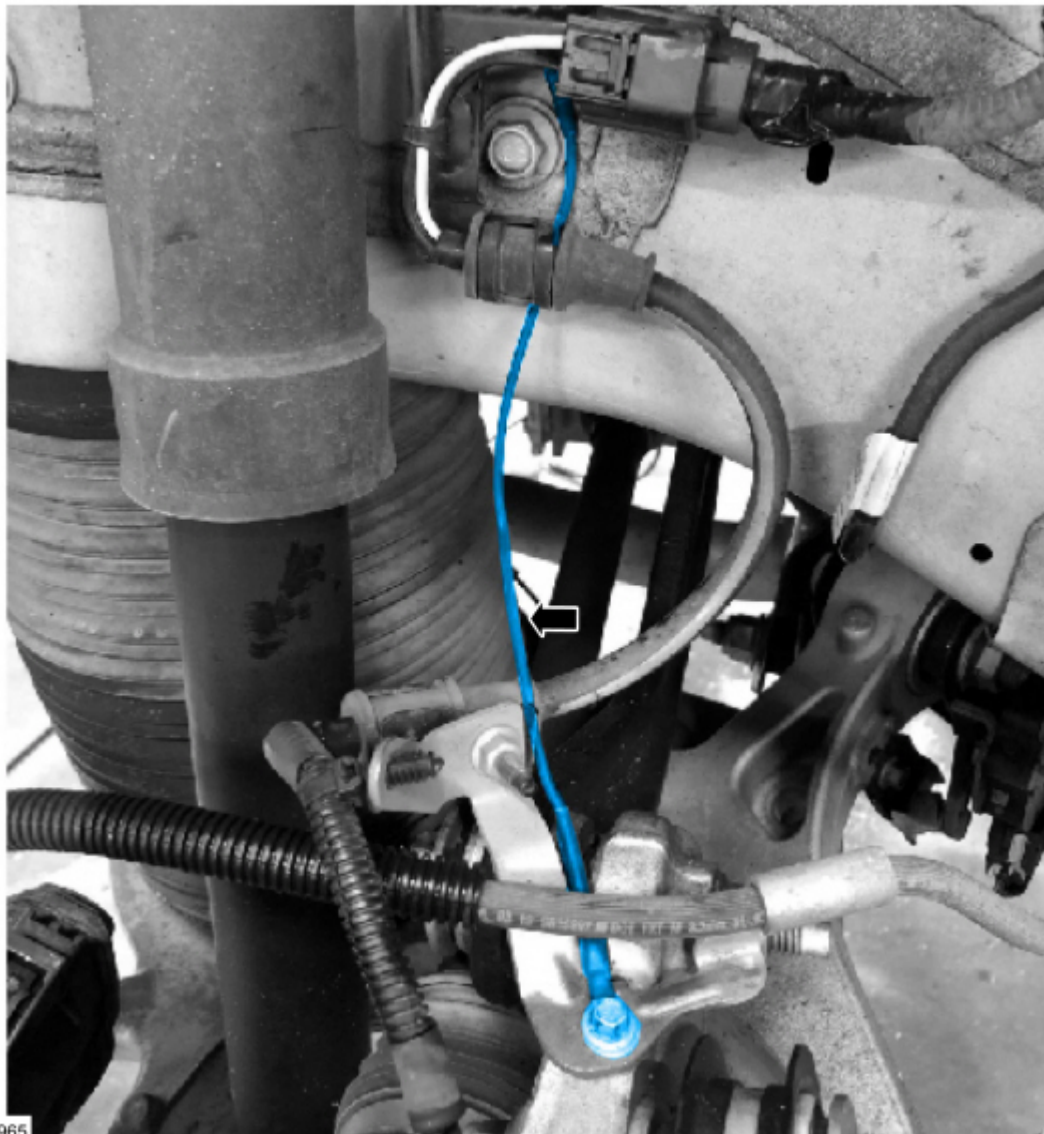
Figure 1

Issue: Some 2020-2022 Explorer/Aviator non-hybrid vehicles may exhibit radio static and/or poor radio sound quality when moving. This may be more noticeable on AM radio stations. This may be caused by an electromagnetic interference concern. To correct the condition, follow the Service Procedure to install new grounds on the rear knuckle.

1. Install new ground straps on each side of the vehicle on top of the brake hose bracket bolt on the rear knuckle. Tighten to 133 lb-in (15 Nm). Refer to Workshop Manual (WSM), Section 204-02. (Figures 1-2)

2. Install the other side of the ground straps underneath the rear wheel speed sensor harness bracket mounting stud. Tighten to 62 lb-in (7 Nm). Refer to WSM, Section 206-09. (Figures 1-2)
