TECHNICAL SERVICE BULLETIN

5 Door - Hard Top Roof - Squeak And/Or Chirp From Rear Of Vehicle

22-2097

Ford	5 door
2021-2022 Bronco	Hard top roof

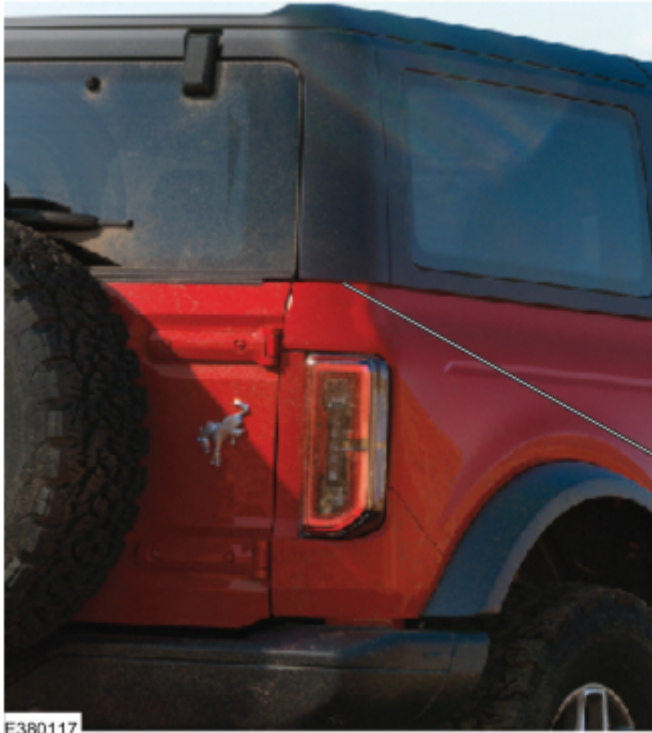
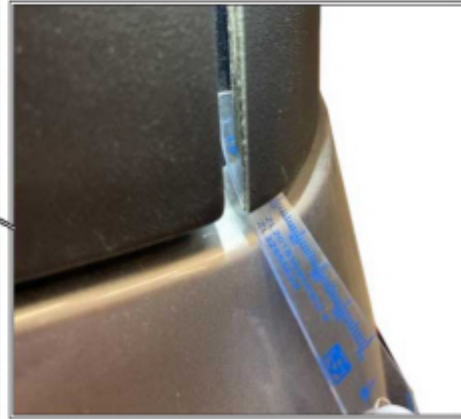
Figure 1

Issue: Some 2021-2022 Bronco vehicles equipped with 5 doors and a hard top roof may experience a squeak and/or chirp noise from the rear of the vehicle while driving over bumps with the roof installed. This may be due to an insufficient gap between the hard top and the body rear quarter panel. To correct the condition, follow the Service Procedure to adjust this gap to the correct specifications.

1. Insert a 3/64 in. (1 mm) plastic feeler gauge in the gap between the bottom/rear corner of the hard top and the rear quarter panel until the gauge is 2 in. (50 mm) deep. (Figure 1)

10. Use a plastic feeler gauge to measure the gap between the bottom/rear corner of the hard top and the rear quarter panel. (Figure 1)
11. Does the gap measure between 3/32 - 7/32 in (2.5 - 5.5 mm)?

14. Use a plastic feeler gauge to measure the gap between the bottom/rear corner of the hard top and the rear quarter panel. (Figure 1)
15. Does the gap measure between 3/32 - 7/32 in (2.5 - 5.5 mm)?
