TECHNICAL SERVICE BULLETIN

Long Wheelbase - Second Row Seat(s) Stuck Or Difficult To Fold/Unfold - Built On Or After 1-Jan-2013

22-2114

Ford 2013-2022 Transit Connect	Built on or after 1-Jan-2013 Long wheelbase
--	--

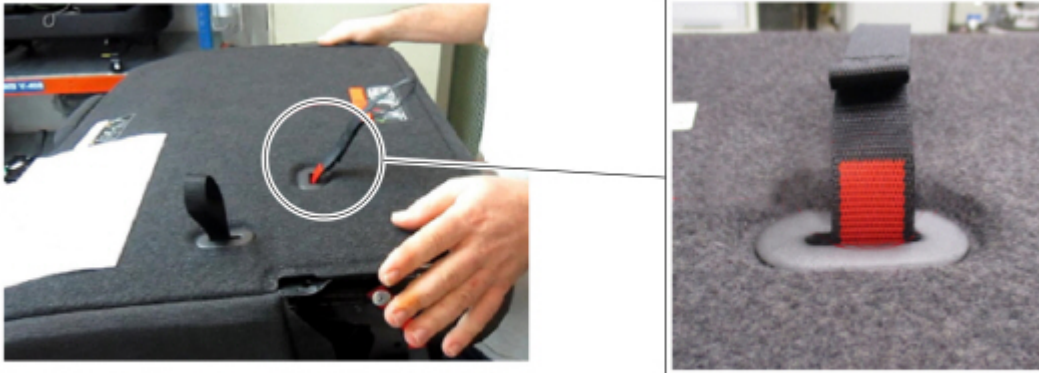
Figure 1

1. Is either section of the second row seat bottom stuck in the folded position and/or is the strap stuck and displaying the red indicator on the strap on the seat back? (Figure 1)

NOTE: The seat back will not fold when the seat bottom is stuck in the stowed position.

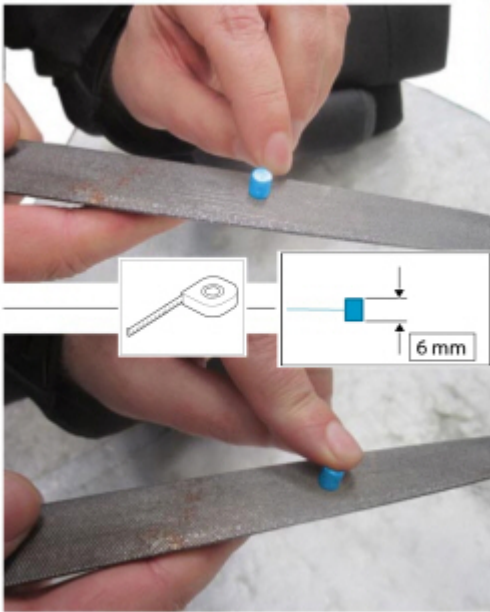
Figure 7

6. Using a Vernier caliper, measure the length of the head. The head should be a minimum of 6 mm (0.2362 in) long. (Figure 6)

(1). Using a file, reduce the end fitting on both sides to reduce the length of the head to achieve a minimum of 6 mm (0.2362 in) long. (Figure 7)

(2). Clean the cable end and seat area to remove shavings.
