TECHNICAL SERVICE BULLETIN

Parking Brake Fault Service Now Message In IPC - DTCs C2008, C2007, C1034, U0293 And/Or U0100 - Built On Or Before 15-Mar-2022

22-2143

| Ford 2021-2022 Mustang Mach-E | Built on or before 15-Mar-2022 |

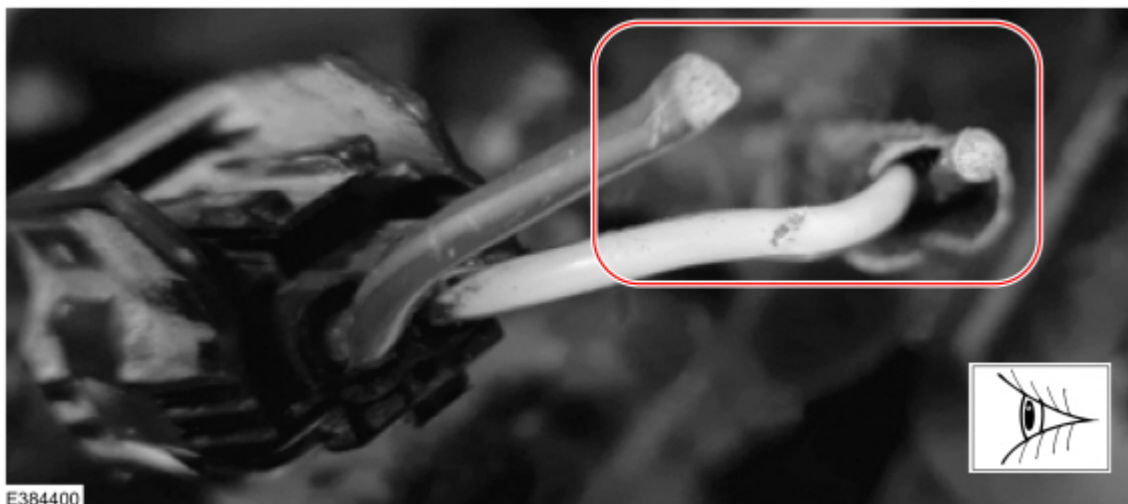
Figure 1

1. Remove both rear tires. Refer to Workshop Manual (WSM), Section 204-04A.
2. Remove the tape and the conduit on the wiring harness to both the left/right rear brake calipers.
3. Inspect the wiring for damage or open circuit. Is there a damaged or open circuit? (Figure 1)
 - (1). Yes - proceed to Step 4.
 - (2). No - proceed to Step 9.
