## TECHNICAL SERVICE BULLETIN

### 4WD - Grinding/Rubbing Noise Under Acceleration From Floor Pan/Underbody Area

**22-2161**

<b>Ford</b>
2021-2022 Bronco Sport
2020-2022 Escape
2022 Maverick
<b>Lincoln</b>
2020-2022 Corsair

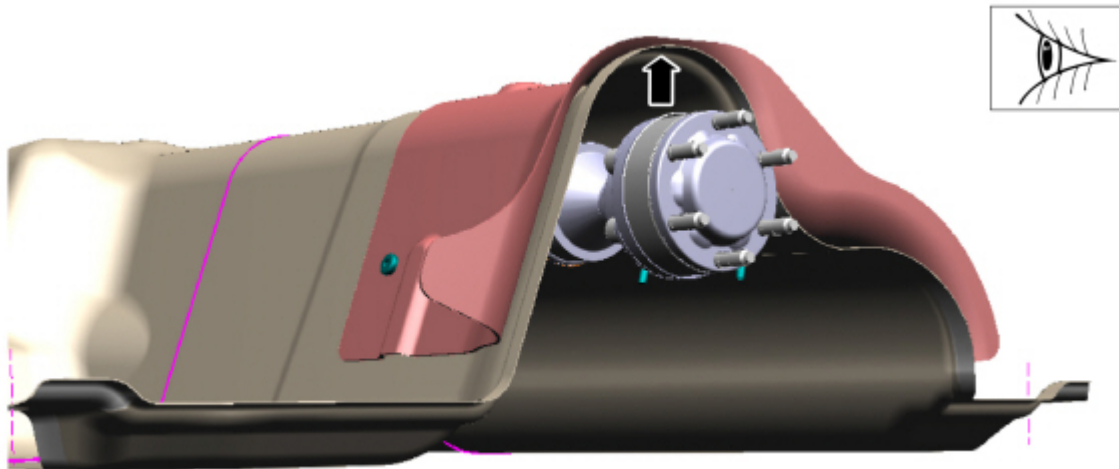
Figure 1

1. Visually inspect the fuel tank heat shield to see if there are witness marks from where the driveshaft has made contact with the fuel tank heat shield.
2. Are there signs of witness marks from the driveshaft contacting the fuel tank heat shield? (Figure 1)
  - (1). Yes - proceed to Step 3.
  - (2). No - this article does not apply. Refer to Workshop Manual (WSM), Section 100-04 for normal diagnostics.
