**SERVICE BULLETIN**

**APPLICABILITY:** 2019-21MY Forester

**NUMBER:** 12-237-22

**SUBJECT:** Loose Fitting Side Windshield Cowl Panels

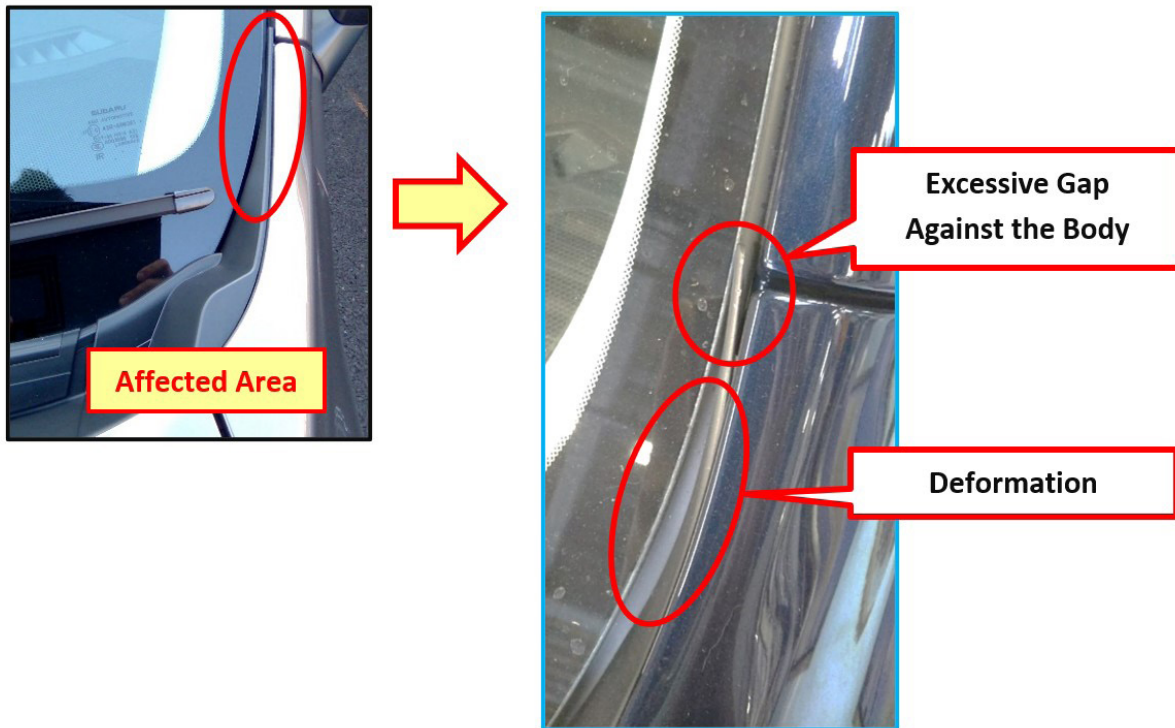
This bulletin announces the design change made to the side cowl panels. A fortified building material has been introduced into production to avoid any possible panel deformation. This was initiated to address the small number of cases of the side cowl panels having an excessive gap against the body or exhibiting a “loose fitting” appearance. If any panel deformation is confirmed, replace the affected panel(s) with the new part.

The new parts have been incorporated into production of the Forester as of the starting VIN **MH576492**.
