SERVICE BULLETIN

APPLICABILITY: 2017-18MY Impreza
 2018MY Crosstrek
 2018MY Legacy and Outback
 2018MY BRZ*

NUMBER: 15-211-17R
DATE: 06/13/17
REVISED: 04/26/22

SUBJECT: Reprogramming File Availability for Additional Optimization of Harman Gen 3 Audio and Navigation Head Units

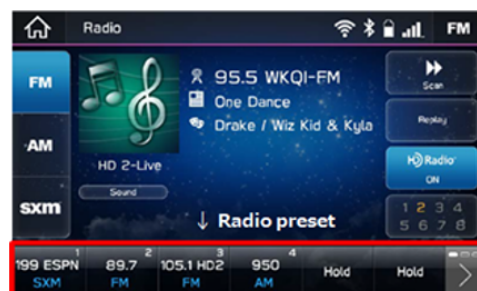
- Update to address some or all AM/FM station presets becoming lost and replaced by “Hold”

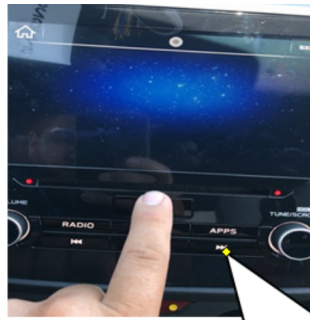
- On 2018MY Legacy / Outback models with Navigation (High) head units, the update corrects a condition where the head unit remains powered even after the ignition is OFF and the driver door is opened.
- Update for a condition where the SXM presets become lost and only “Initializing” appears as shown below.
- Update for condition where only the star field background is displayed (without icons) after the HOME button is pressed.

Background shown, but no icons

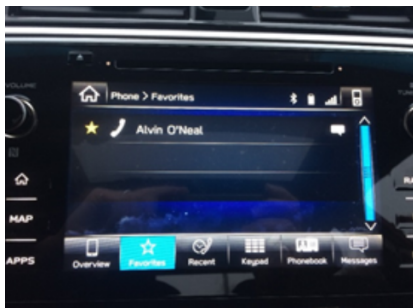
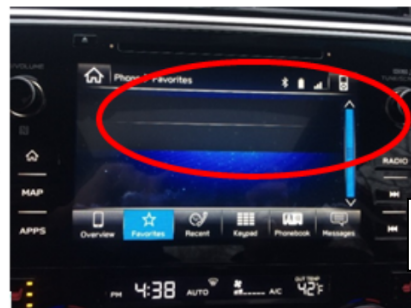
- Update for a “Pop” or “Crackling“ sound concern when listening to AM radio.
- Update for a concern of the head unit continually resetting itself.
- Update for a concern of after selecting a contact to be a “Favorite” and the “Favorite” list display is blank.

List is blank

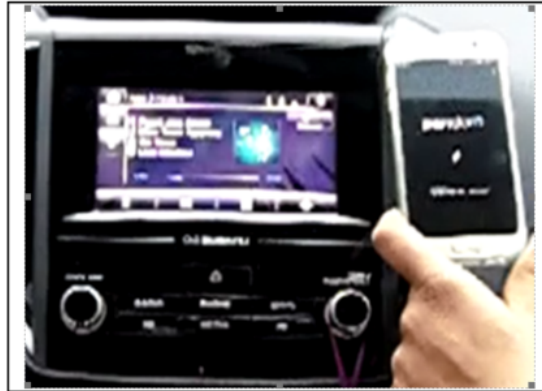
- 1- No streaming audio; when using the Pandora® app, there is no audio output.

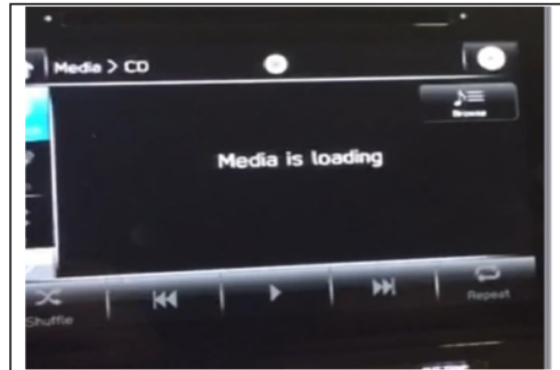
- 2- “Media is loading” is displayed on the screen but, the media never completes loading.

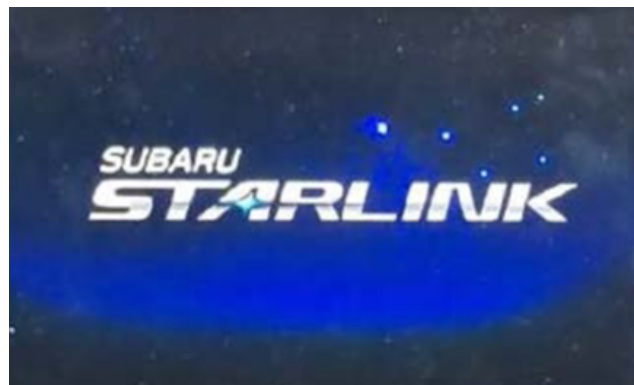
- 3- The screen freezes when the STARLINK screen is displayed.

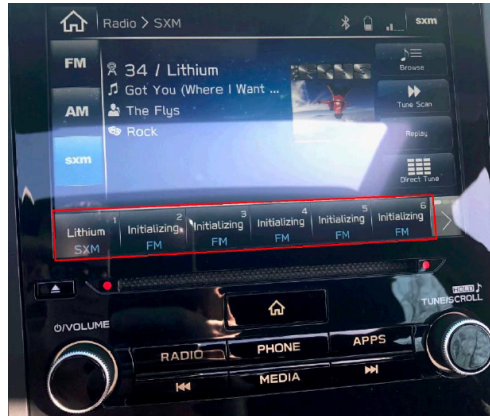
- 1- Radio station presets disappear (touch screen buttons return to “Initializing”).

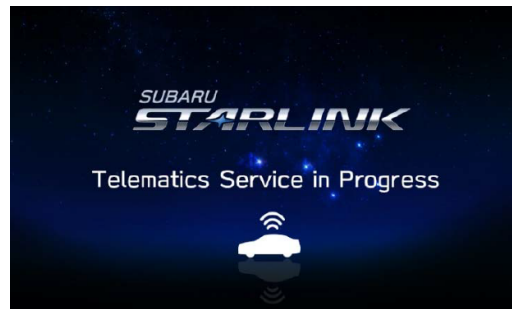
- 2- STARLINK “Telematics Service in Progress” screen freezes.

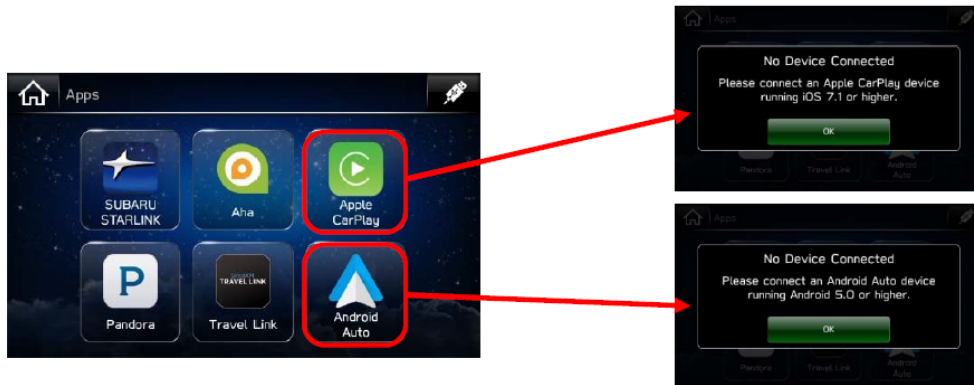
- 3- Apple Car Play / Android Auto function does not operate (“No Device Connected”).

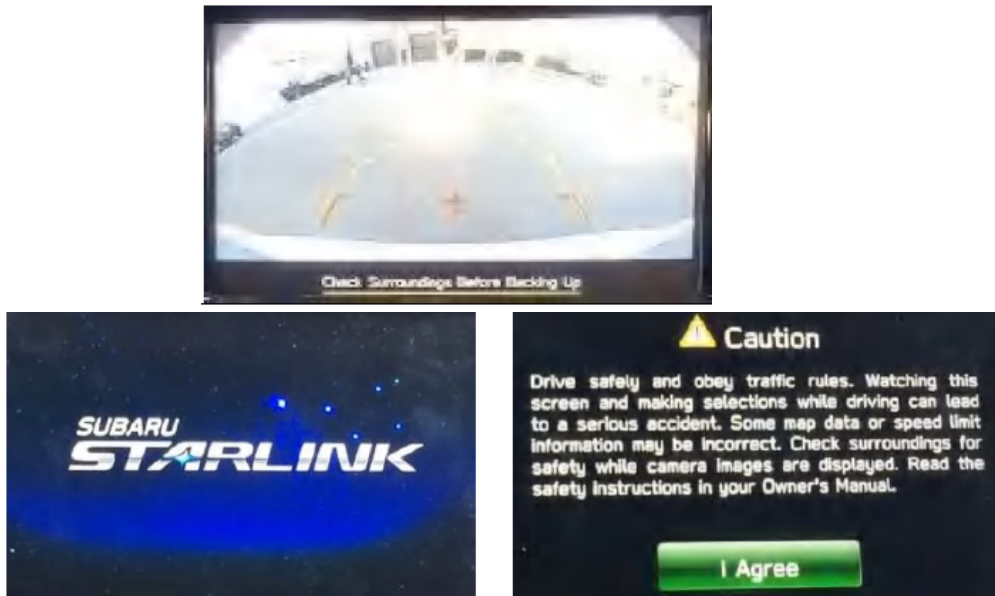
For reference, the previously released WTN-74R symptoms are also provided below. The main purpose of WTN-74R was to address display screen freeze-up during Back-Up Camera display (when the shifter is in “R”). In addition, the screen may also freeze when either the Subaru STARLINK or Disclaimer Caution / I Agree screen is displayed.

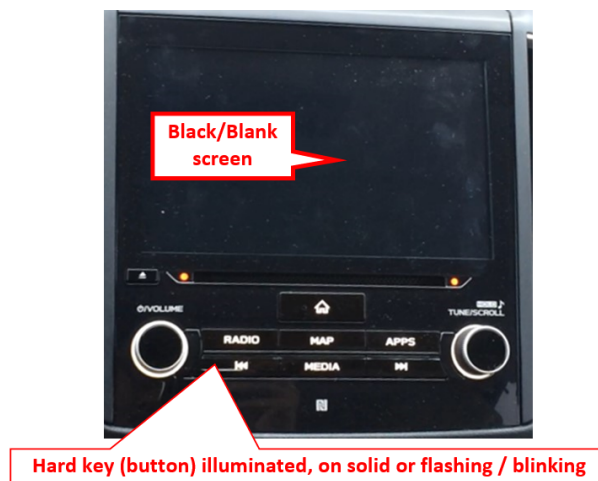
- 1) After switching the vehicle (ACC or IGN) on, the display screen goes black with no audio output and the hard key buttons are illuminated (on solid, or flashing / blinking).

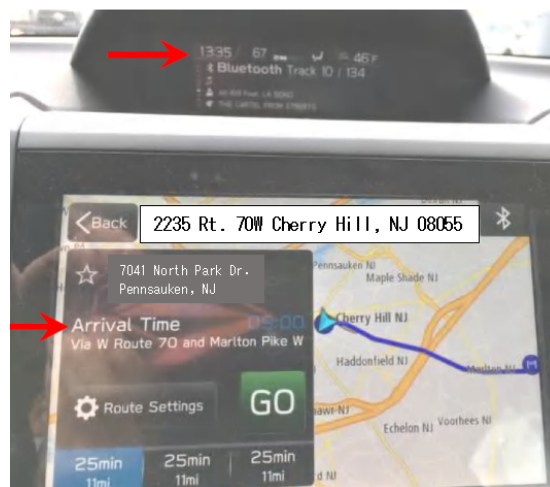
- 2) Time of day displayed in the MFD is incorrect and the arrival time displayed in Navigation unit is also incorrect.

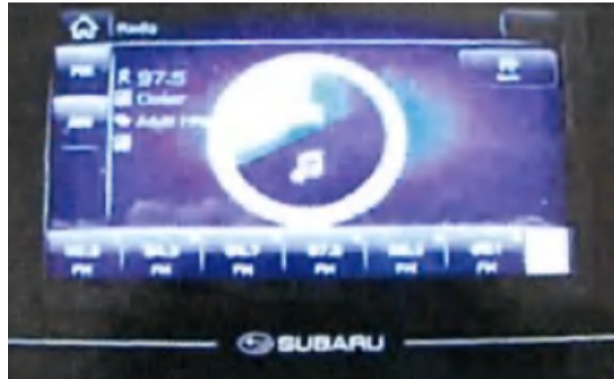
- 3) The time in the MFD automatically reverts to a “default” setting, even after setting the time using “Manual” mode.
- 4) Audio volume goes to maximum automatically after one click of the volume up button on the steering wheel. In some cases, this condition may also occur without input from the operator. Maximum volume is also displayed on the screen.
