# TECHNICAL SERVICE BULLETIN

## 3.0L, 6.7L - Illuminated MIL With Various Reductant System Related DTCs

**22-2191**  
16 May 2022

<b>Ford</b> 2018-2021 F-150	Engine: 3.0L
2017-2022 F-Super Duty	Engine: 6.7L Built on or before 08-Mar-2022
2016-2022 F-650/F-750	Engine: 6.7L

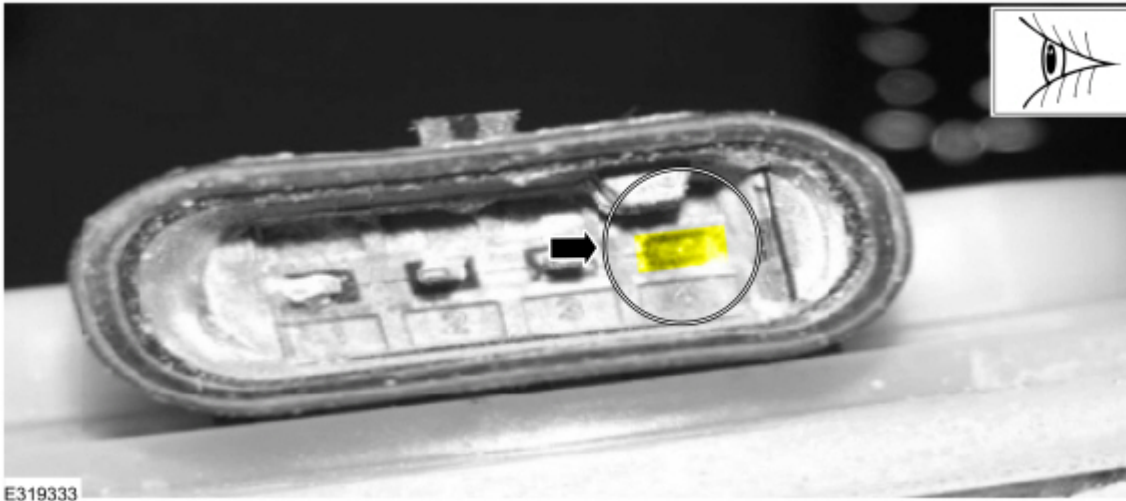
Figure 3

- Visible green corrosion on the reductant level sensor/quality module side of connector C4851/C3610. (Figure 3)

- If there are signs of corrosion or discoloration on the reductant level sensor/quality module, replace both the reductant tank harness and the reductant tank (reductant level sensor/quality module built in).

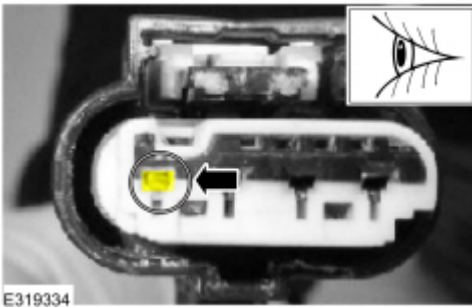
Figure 4

- Visible green corrosion on the harness side of connector C4851/C3610. (Figure 4)

- If there is corrosion or discoloration on the reductant tank harness connector only and not the reductant level sensor/quality module, only replace the reductant tank harness.
