TECHNICAL SERVICE BULLETIN

4WD - 6R100 - Metallic Grinding Noise Under Light Acceleration Between 23-33 MPH (37-53 Km/H) - Built On 01-Feb-2021 And Through 16-May-2022

22-2199

17 May 2022

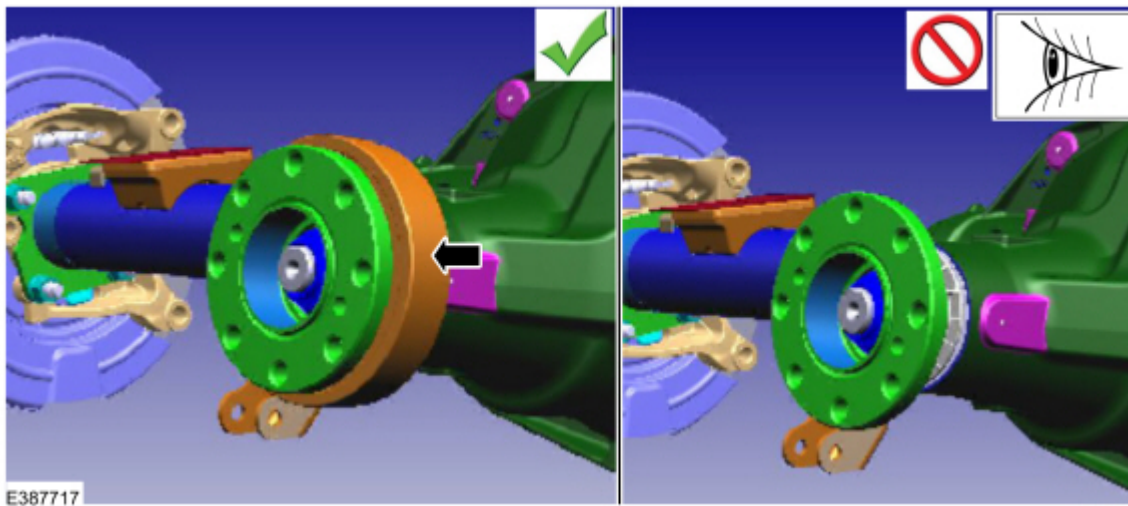
Figure 1

1. Inspect the rear axle pinion flange for the presence of a sound damper. Is a damper present? (Figure 1)

(1). Yes - proceed to Step 2.

(2). No - replace the rear axle pinion flange and rear pinion seal. Refer to Workshop Manual (WSM), Section 205-02.
