# TECHNICAL SERVICE BULLETIN

## 5 Door - Hard Top - Poor Sirius XM® Satellite Radio Reception And/Or Signal Loss - Built On Or Before 17-May-2022

**22-2096**

<b>Ford</b> 2021-2022 Bronco
---------------------------------

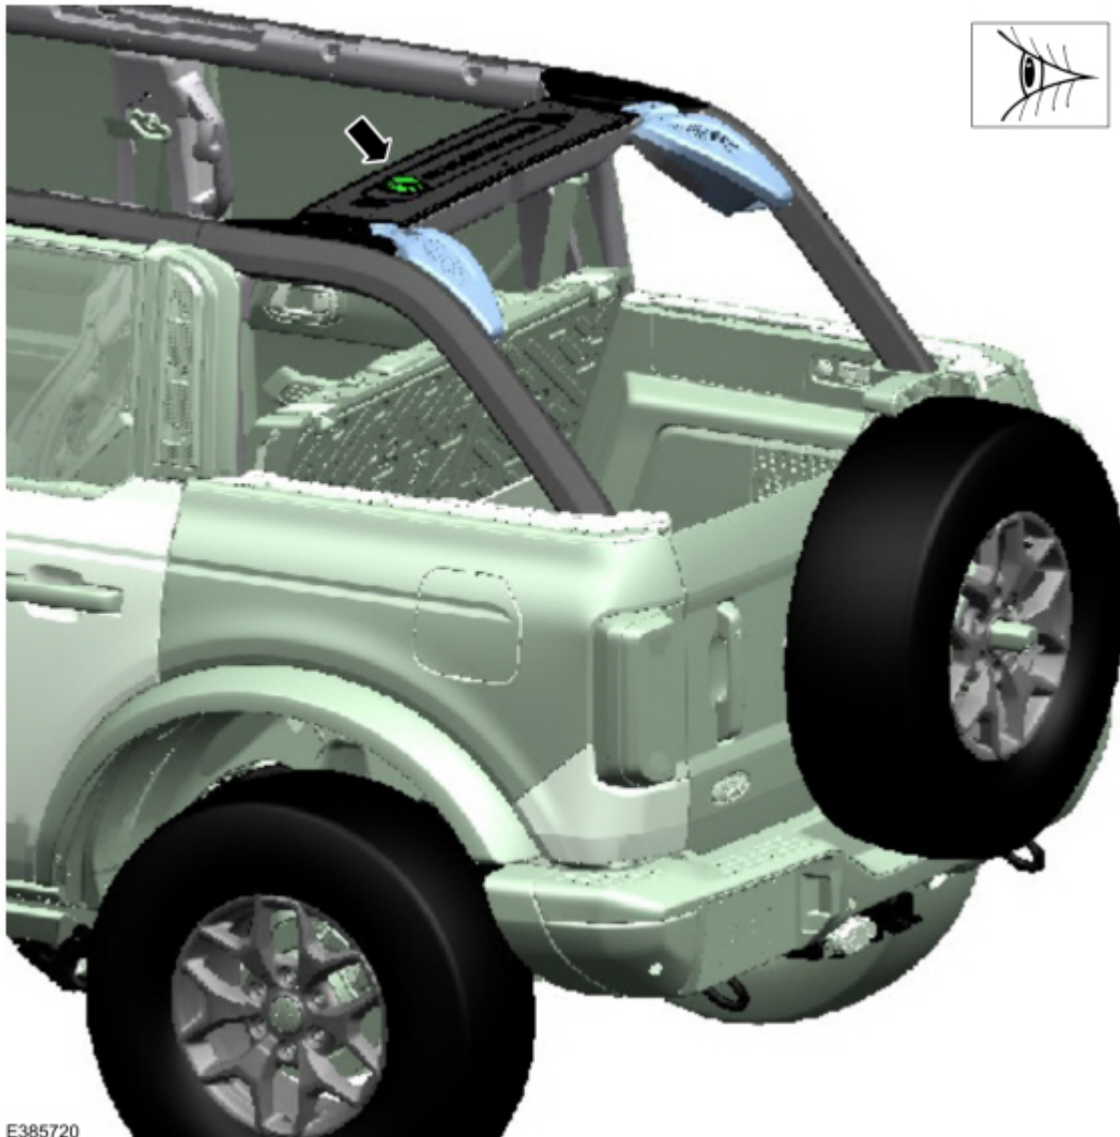
Figure 1

2. Locate the satellite radio/global positioning system (GPS) antenna on the rear overhead cross tube of the sport tube. It is mounted on the top of the sport tube between it and the hard top. (Figure 1)

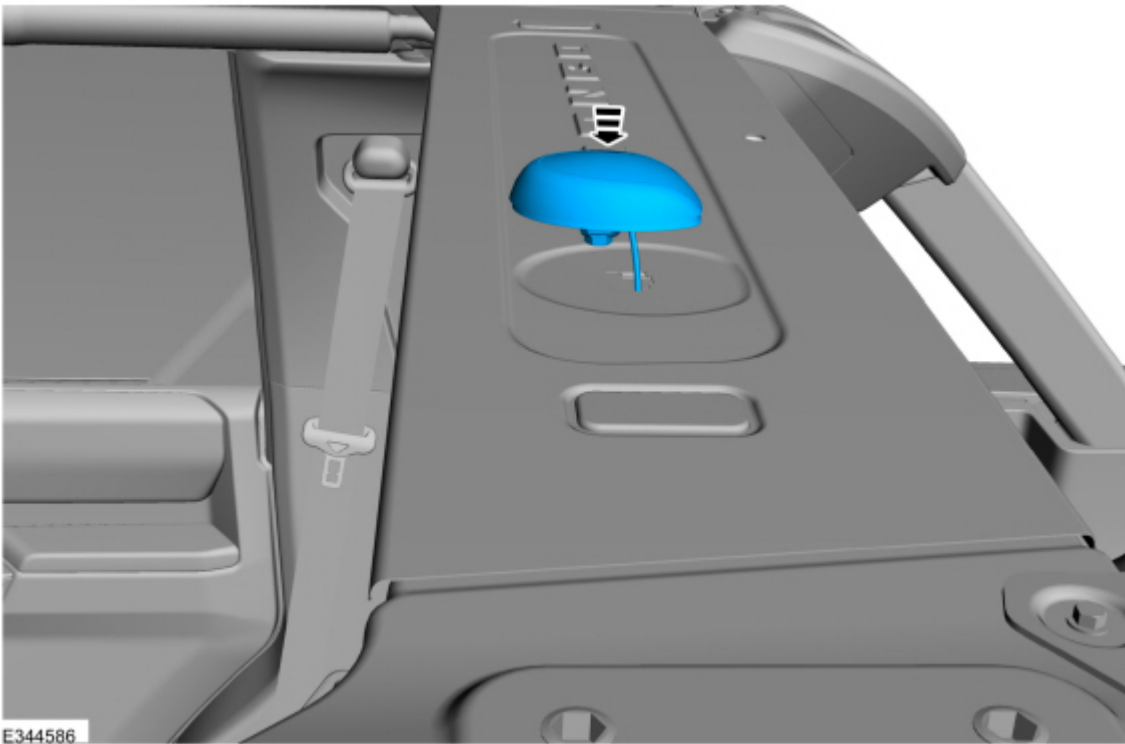
Figure 2

3. Inspect the position of the satellite radio/GPS antenna. Does the base of the antenna match the depression/outline in the sheet metal? (Figure 2)
