**SERVICE BULLETIN**

**APPLICABILITY:** 2020-22MY Legacy and Outback Models      **NUMBER:** 15-261-20R  
**SUBJECT:** Reprogramming File Availability for Optimization of Gen 4 Denso CP1 Infotainment Systems      **DATE:** 03/10/20  
**REVISED:** 05/02/22

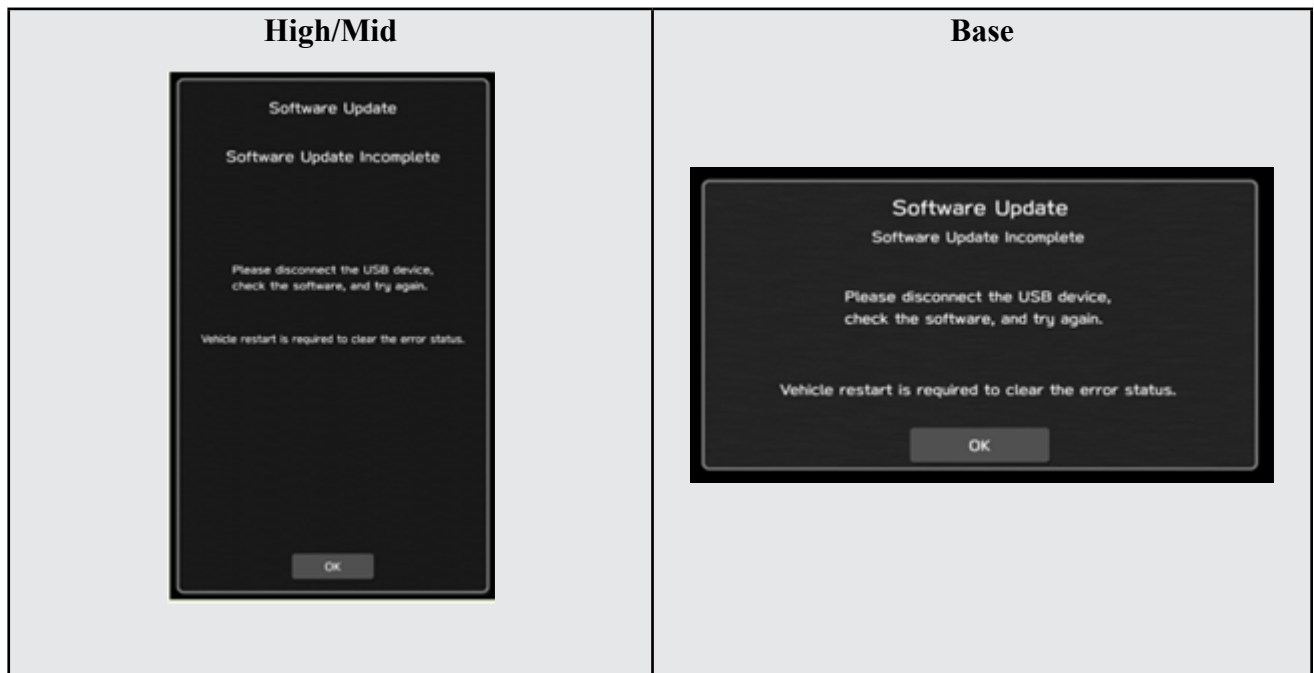
If you get the message Software Update Incomplete as shown below, please don't replace the hardware but retry updating the software according to the instructions in "Appendix B" on pg. 21.

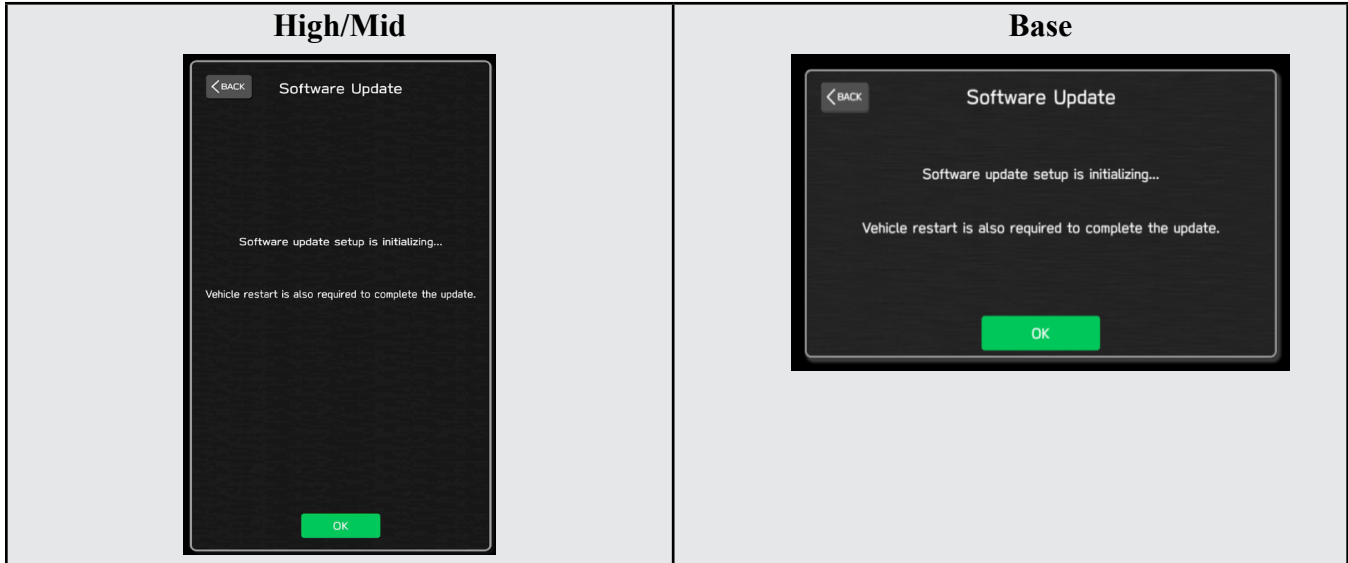
- If the screen shown below appears, **WAIT** for approximately 30 minutes or as long as necessary (waiting for longer than 60 minutes might indicate system malfunction). In that case please perform recovery according to the instructions in “Appendix B ” to allow the Software update setup initialization process to complete.

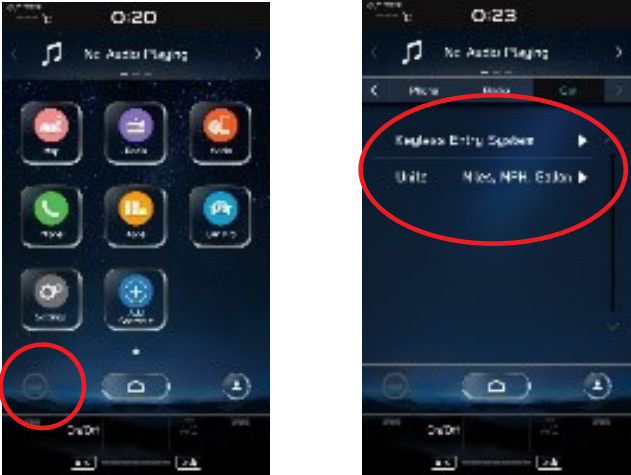
Number	Symptoms to be Improved:
4	<p>Vehicle Setting Icon in &lt;Home&gt; menu is grayed out. Menu list in the “Car” tab in the Setting Menu is not displayed.</p>

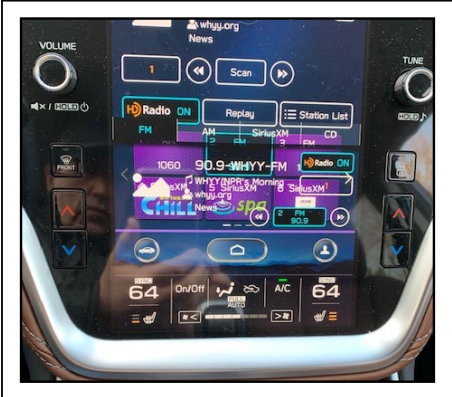
5	CarPlay stopped working after hanging up a hands-free phone call.
6	<p>CID shows multiple images simultaneously.</p>

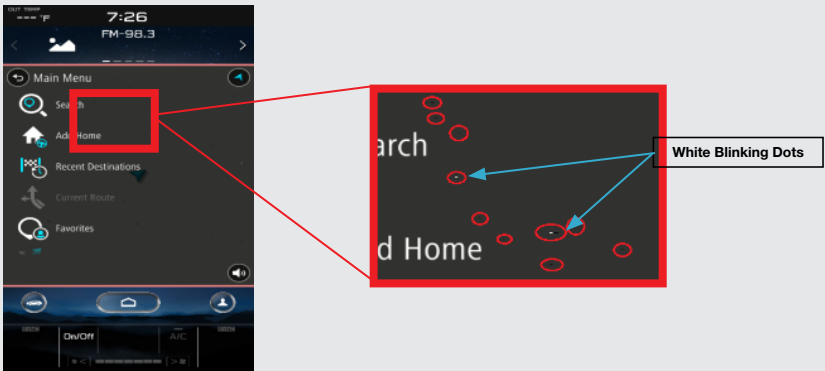
Symptom #	Description of Symptom:
1	Several minutes after Engine start, the Center Information Display (CID) reboots.
2	<p>After an extended period of usage, some white blinking dots appear on the display.</p>

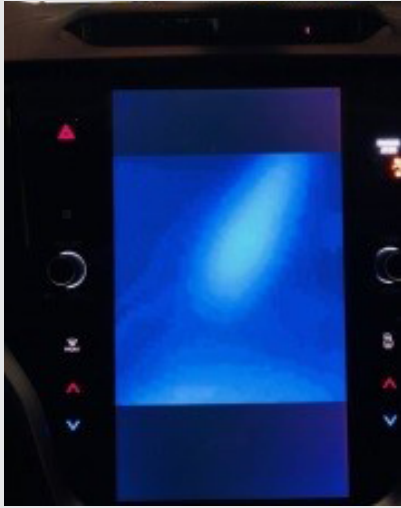
Symptom #	Description of Symptom:
14	<p>The HOME screen goes blank. When the screen is switched from Camera mode to HOME, no icons are displayed as shown below.</p>

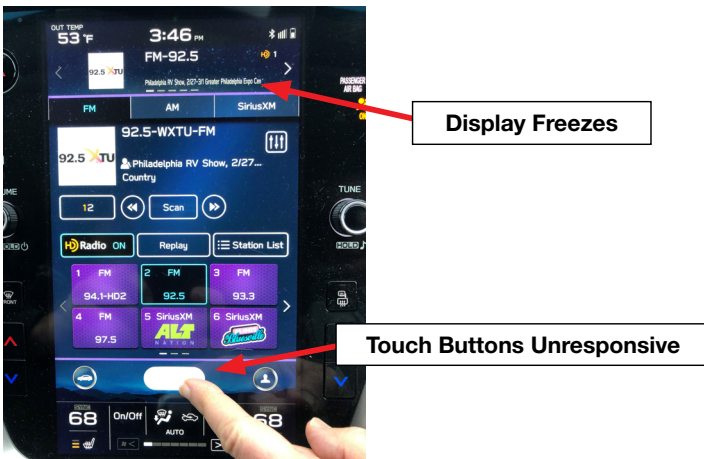
Symptom #	Description of Symptom:
1	<p>The CP1 display and/or center Combination Meter display freezes. No response from touch screen or voice guidance. After switching the ignition off and opening the driver’s door, the system does not recover**.</p>

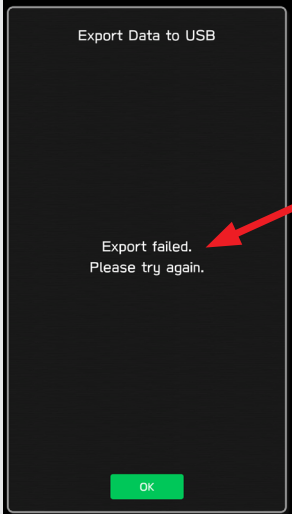
4	<p>Diagnostics Recorder Data cannot be exported to the USB memory device. When the diagnostic log data is being downloaded (by selecting: Dealership Menu &gt; Diagnostics Recorder &gt; Export Data to USB), it fails after the progress bar reaches almost 90% with an error message of Export failed. Please try again.</p>
