**SERVICE BULLETIN**

**APPLICABILITY:** 2013-22MY BRZ

**NUMBER:** 04-28-22

**SUBJECT:** Squeaking Sound Occurs When Turning Steering Wheel

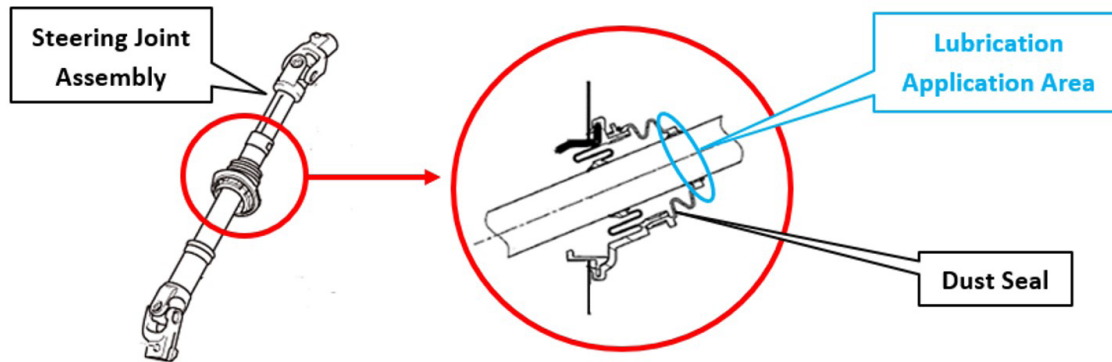
This bulletin announces the repair procedure to address rare cases of a squeaking-type sound occurring when turning the steering wheel. This sound may be caused by a lack of lubrication where the dust seal contacts the steering joint assembly. If this situation is duplicated, follow the lubrication procedure outlined below.
