SERVICE INFORMATION BULLETIN

APPLICABILITY: 2020MY-**2021**MY Legacy & Outback

SUBJECT: Denso CP1 BASE (Dual 7" Display Screen)
Erratic Operation

NUMBER: 15-273-20

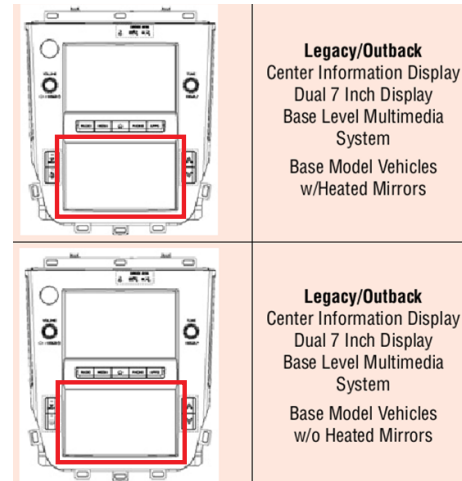
This Service Information Bulletin addresses isolated customer concerns regarding the pictured CP1 BASE Model Center Information Display (CID) LOWER 7-inch display screen flashing, not responding to touch inputs and / or shutting off intermittently.

Legacy/Outback
Center Information Display
Dual 7 Inch Display
Base Level Multimedia System
Base Model Vehicles
w/Heated Mirrors

Legacy/Outback
Center Information Display
Dual 7 Inch Display
Base Level Multimedia System
Base Model Vehicles
w/o Heated Mirrors

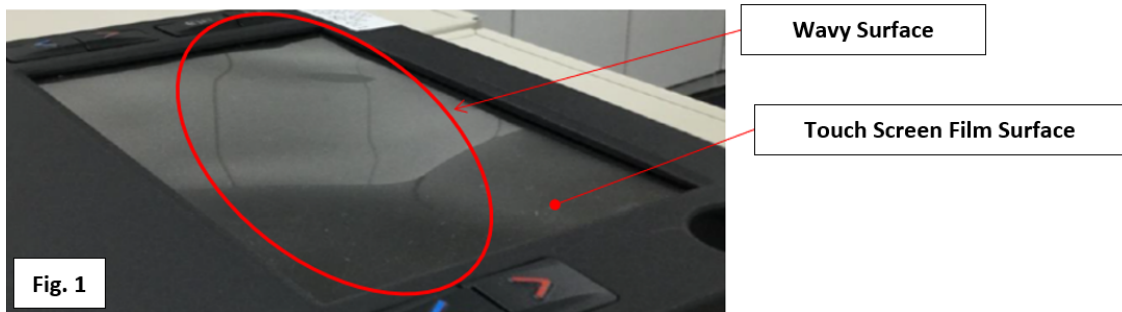
Check for any deformation or waviness of the touch screen surface. Inspect the surface condition diagonally with light reflecting on it at various angles. Is any waviness visible as shown in **Fig. 1** below?

- **If YES:** Replace the CID display component because the surface of the touch screen is deformed.
- **If NO:** Proceed to **Step 2**.

NOTE: In the event the CID requires replacement, the new unit **INCLUDES** a new surrounding trim panel and new control buttons as a ready to install assembly.

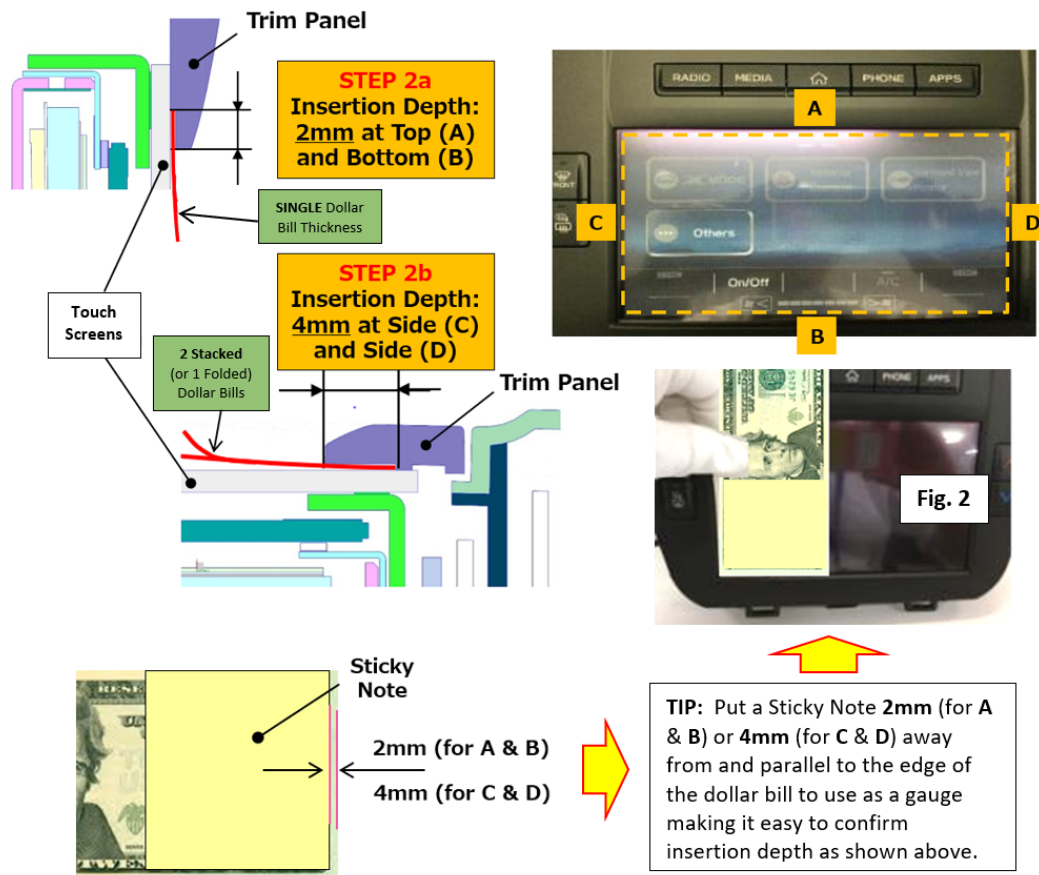
Steps 2a & 2b: Inspect for deformation of the lower touch screen, the surrounding trim panel and for any foreign material trapped in between them. Use the illustrations below as a guide.

- **2a:** Insert a (preferably a crisp, new) dollar bill into the gaps between the touch screen and the surrounding trim panel along the top (**A**) and bottom (**B**) as shown in the **Fig. 2** example below. The dollar bill should be able to be inserted **2mm** into the full width of both the top and bottom gaps.
- **2b:** Insert a dollar bill folded in half (to provide 2 thicknesses) into the gaps between the touch screen and the surrounding trim panel along the sides (**C**) & (**D**). The folded dollar bill should be able to be inserted **4mm** into the side gaps from top to bottom.

- If the dollar bill can be inserted into the gap **2mm** on the **Top** and **Bottom** and **4mm** on **BOTH** sides, there is no deformation of the touch screen or surrounding trim panel. Proceed to **Step 4**.
- If the dollar bill cannot be inserted, replace the CID because the surrounding trim panel and / or touch screen are likely deformed.

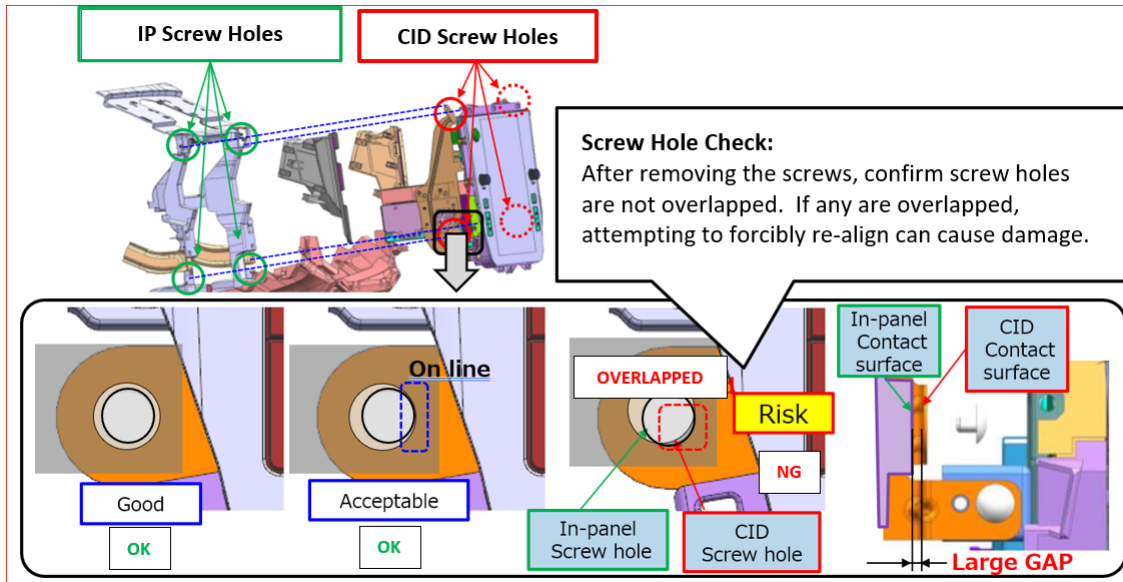
Step 4: Check condition of the retaining screw holes and contact surfaces between the instrument panel (IP) and CID after removing the screws.

- Inspect the screw holes of the IP and the bracket following the illustrations below. If the screw hole(s) are overlapped, **CAREFULLY** re-align to Acceptable or “**OK**” as shown below.
- Inspect the gap between contact surfaces of the IP and the bracket following the illustration below. If a gap exists between the two contact surfaces, **CAREFULLY** adjust the seating / alignment by changing the tightening order of the retaining screws.

TIP: If there is too much mis-alignment, **CAREFULLY** loosen the other three screws, let things settle, then try tightening them again in a different order to see if the alignment improves before installing the final screw or, loosen them all, let things settle then tighten again but in stages so any one hole is not too far offset (beyond **OK**).

- **If YES:** The condition persists, replace the CID.
- **If NO:** The condition no longer persists. Operate the unit for an extended period to confirm a successful repair.
