SERVICE BULLETIN

APPLICABILITY: 2019-22MY Impreza
 2019-22MY Crosstrek (Including Hybrid Model)
 2019-22MY Forester
 2019MY Legacy/ Outback
 2019-22MY WRX
 2019-21MY WRX STI
 2019-21MY BRZ- Navigation -equipped ONLY
 2019-22MY Ascent

NUMBER: 15-236-18R

SUBJECT: Reprogramming File Availability for Optimization of Harman Gen 3.1 and Gen 3.1α Audio and Navigation Head Units

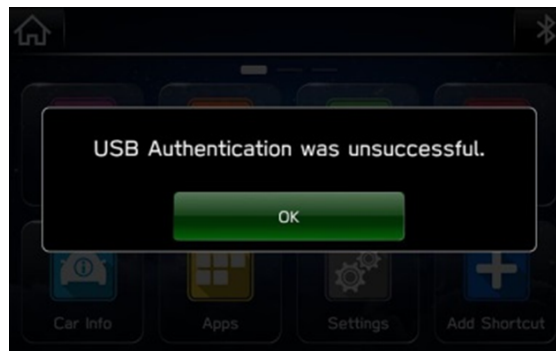
NOTE: If an attempt is made to install the wrong “grade” file into the wrong grade head unit (EXAMPLE: “Base” update file into a “Base Plus or Mid” or “High” head unit), the USB Authentication error screen below will be displayed:

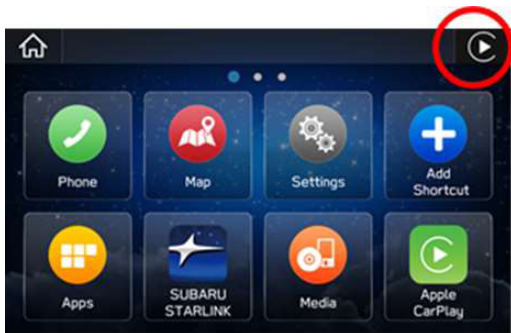
On Ver. 6.0 and before:

Music playing via iPhone in CarPlay.

After disconnecting, the music source changes to Radio automatically.

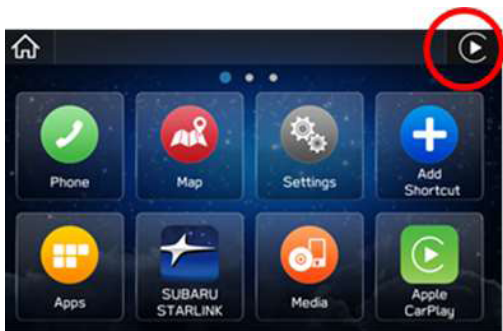
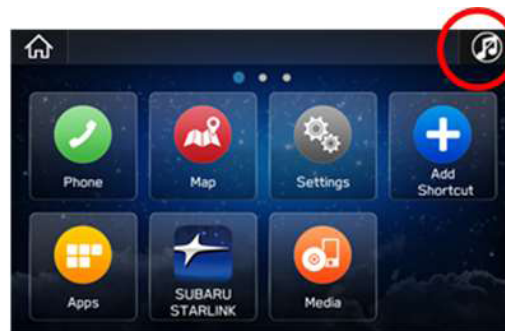
Music playing via iPhone in CarPlay.

After disconnecting, no music source is selected automatically.

If a source of music other than CarPlay has been playing when the iPhone is disconnected, the music source remains same (it is not turned off.)

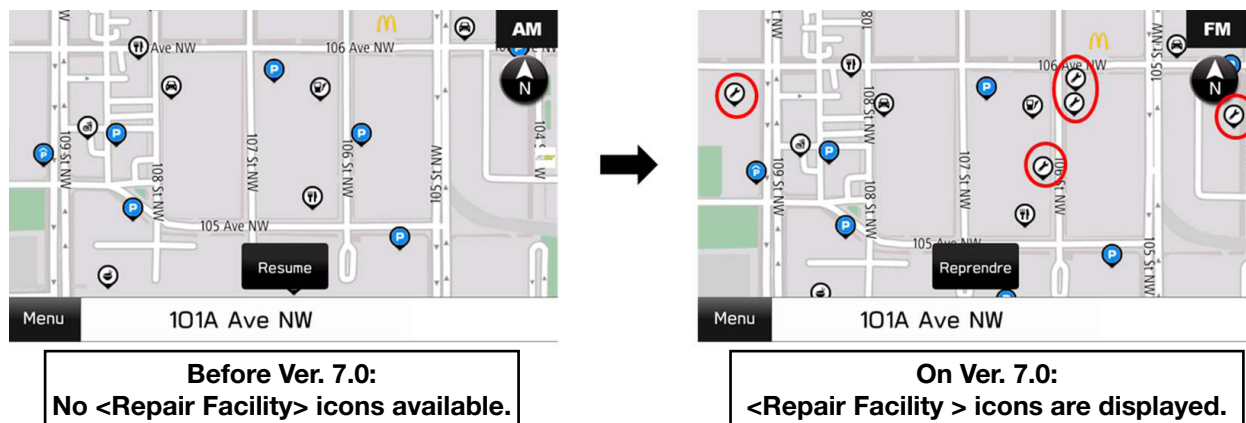
NOTE 4: Displaying Repair Facility POI icons:

<Repair Facility> Icons can be displayed in the NAVI Map.

<Repair Facility> Icons can be turned On or OFF by going to: Settings > Navigation > POI Icons.
