TECHNICAL SERVICE BULLETIN

6.7L - Chassis Cab/Dual Rear Wheel (DRW) Pickup Only - Oil Consumption Under Extended Idle Conditions

22-2223

07 June 2022

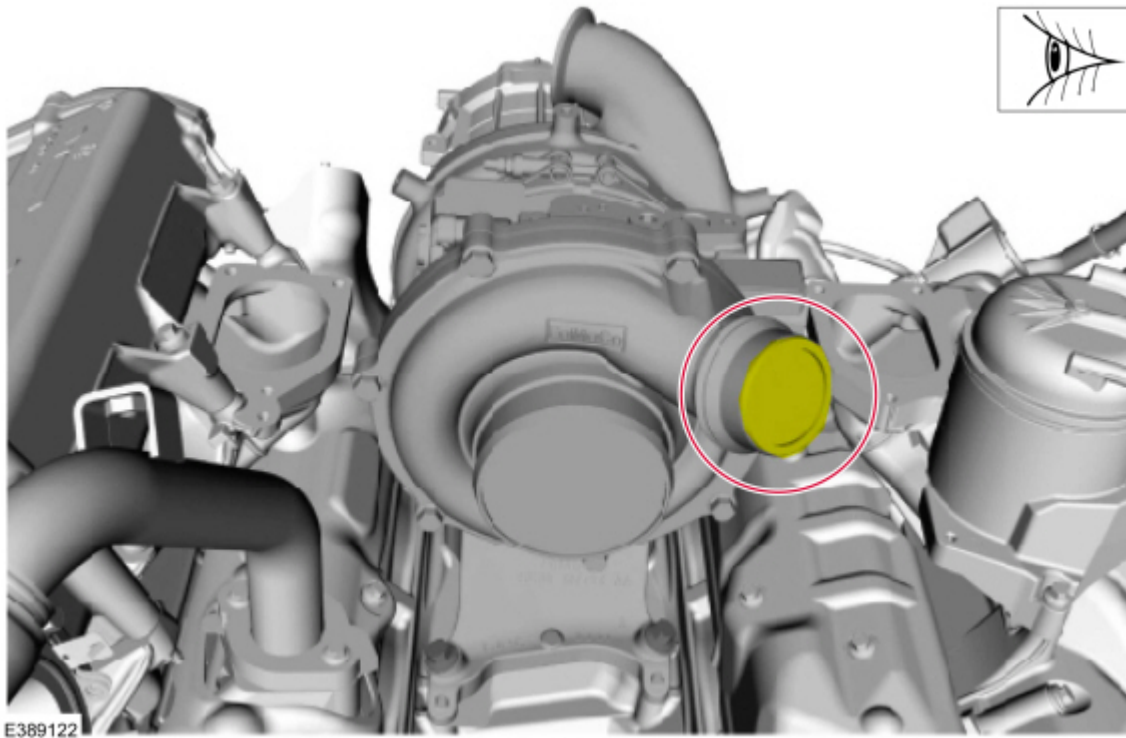
Figure 1

3. Remove the charge air pipe that connects the turbocharger compressor outlet to the charge air cooler. Refer to WSM, Section 303-12.
4. Inspect the turbocharger compressor outlet. Is there oil on the compressor outlet of the turbocharger? (Figure 1)

- (1). Yes - proceed to Step 5.
- (2). No - repair is complete.

5. Clean any oil from the compressor outlet and charge air cooler.

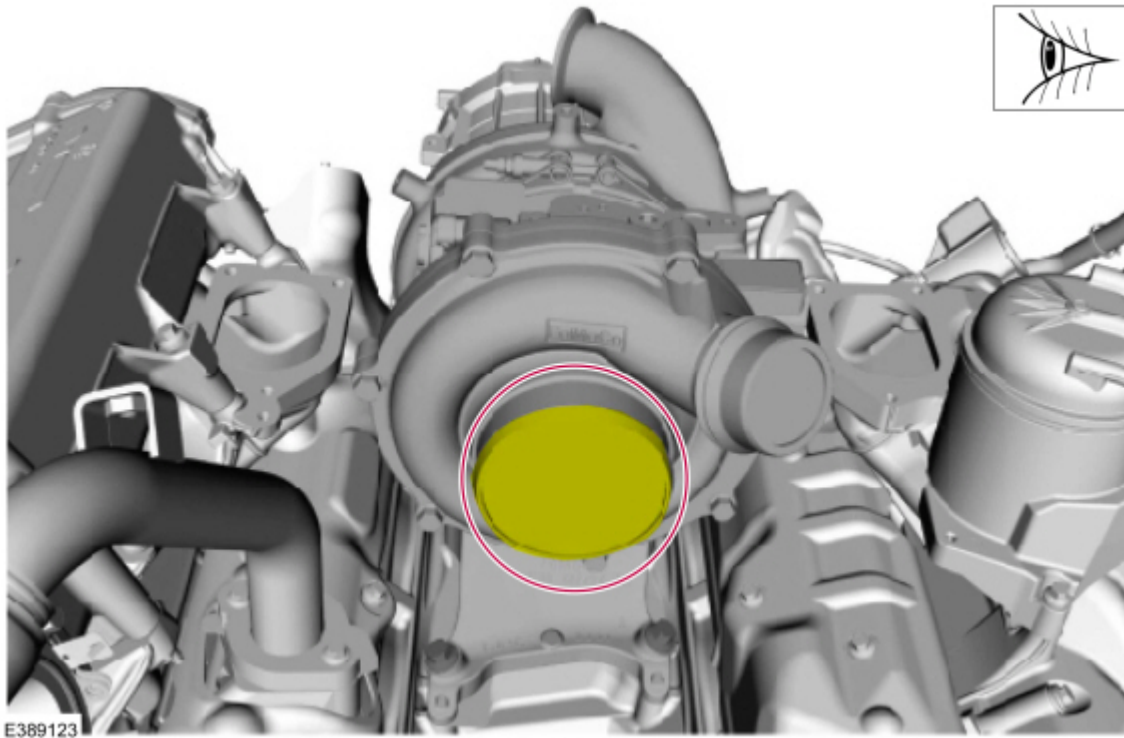
Figure 2

7. Look through the lower intake manifold tube and inspect the turbocharger compressor wheel for damage. (Figure 2)

NOTE: Do not attempt to wiggle, or push up and down on the compressor wheel. Evidence of oil in the compressor outlet, outlet hose or charge air cooler (CAC) is not a reason for turbocharger replacement. Correcting the crankcase pressure will prevent oil from being pushed past the turbocharger rings (seals) and into the turbo housing, outlet hose, exhaust system, and CAC.

8. Is the turbocharger compressor wheel damaged?

- (1). Yes - replace the turbocharger. Refer to WSM, Section 303-04. Repair is complete.
- (2). No - proceed to Step 9.
