# TECHNICAL SERVICE BULLETIN

## 4WD - Grinding/Clicking/Ratcheting Noise From Front Wheel Area

**22-2219**

20 June 2022

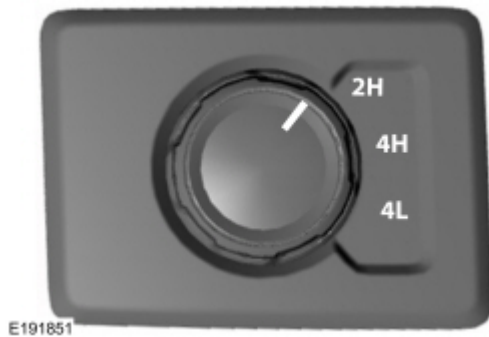
Figure 1 - Example of MSS without 4A selection

1. Does the vehicle have a MSS that only includes 2H, 4H and 4L positions (does not include 4A)? (Figure 1)

(1). Yes - proceed to Step 2.

(2). No - proceed to Step 4.

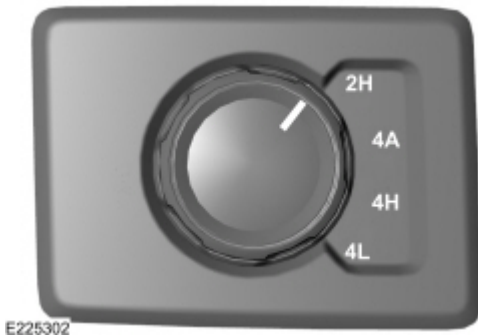
Figure 2 - Example of MSS with 4A selection

**4. Does the vehicle have a MSS that includes a 4-wheel auto (4A) option? (Figure 2)**

(1). Yes - proceed to Step 5

(2). No - this article does not apply. Refer to the Workshop Manual (WSM) for normal diagnostics.

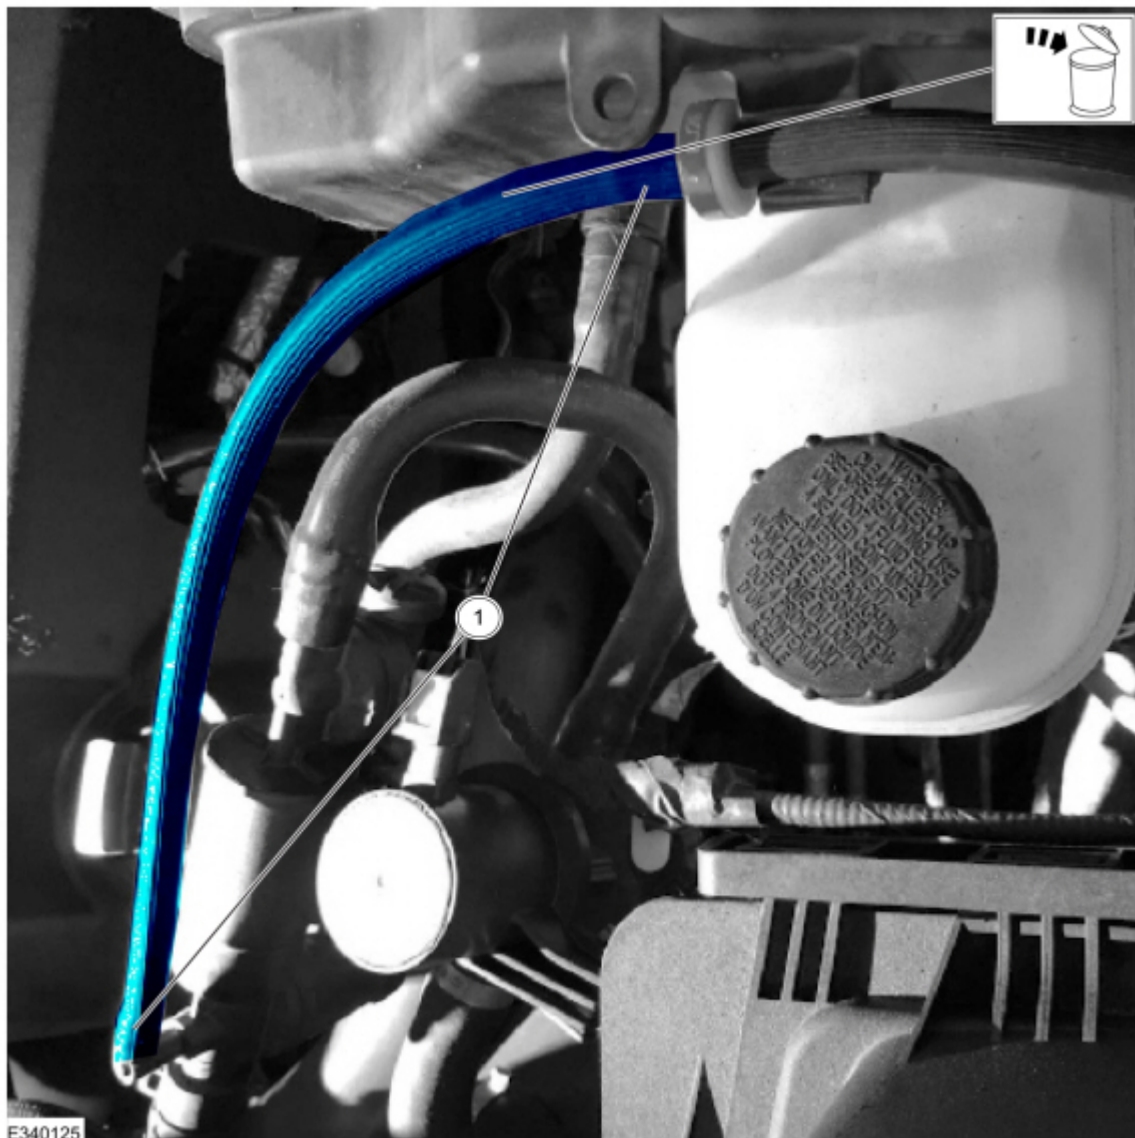
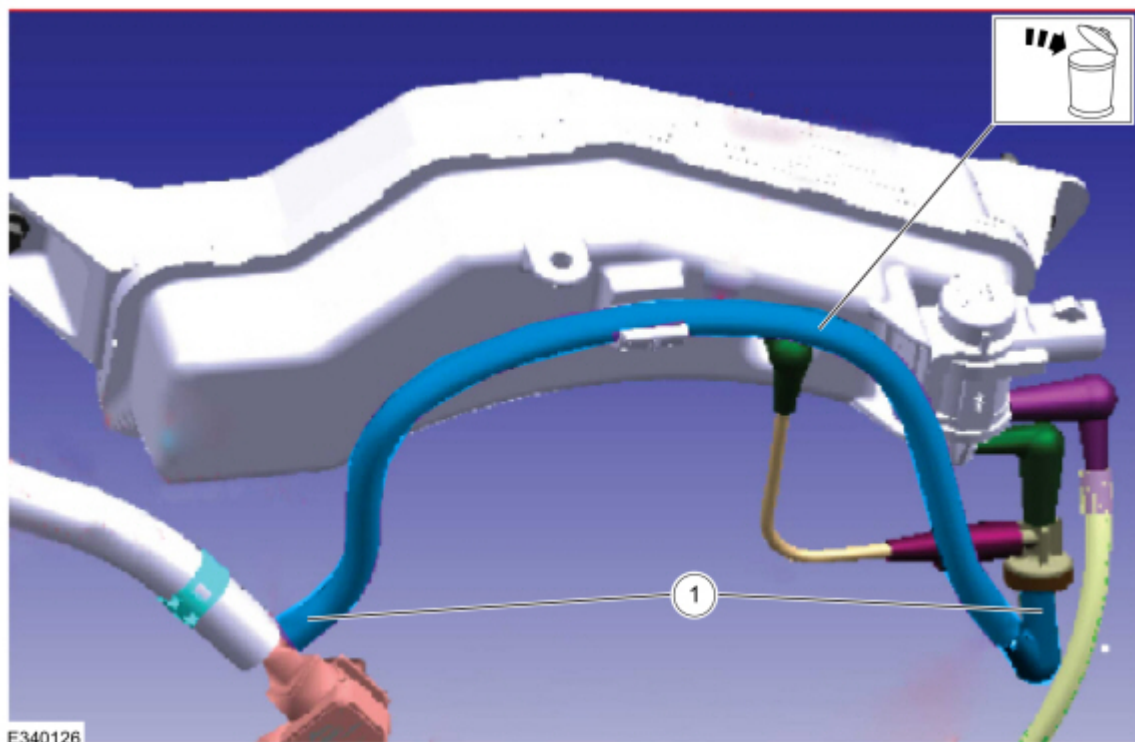
**5. Locate the vacuum supply line between the source vacuum and the IWE check valve. Refer to WSM, Section 308-07A. (Figures 3-4)**

**6. Remove the vacuum supply line.**

**7. Install the vacuum caps at the IWE check valve and the vacuum source.**
