# TECHNICAL SERVICE BULLETIN

## Water Leak Onto Front Carpet From A-Pillar

**22-2242**

<b>Ford</b> 2015-2022 Mustang
----------------------------------

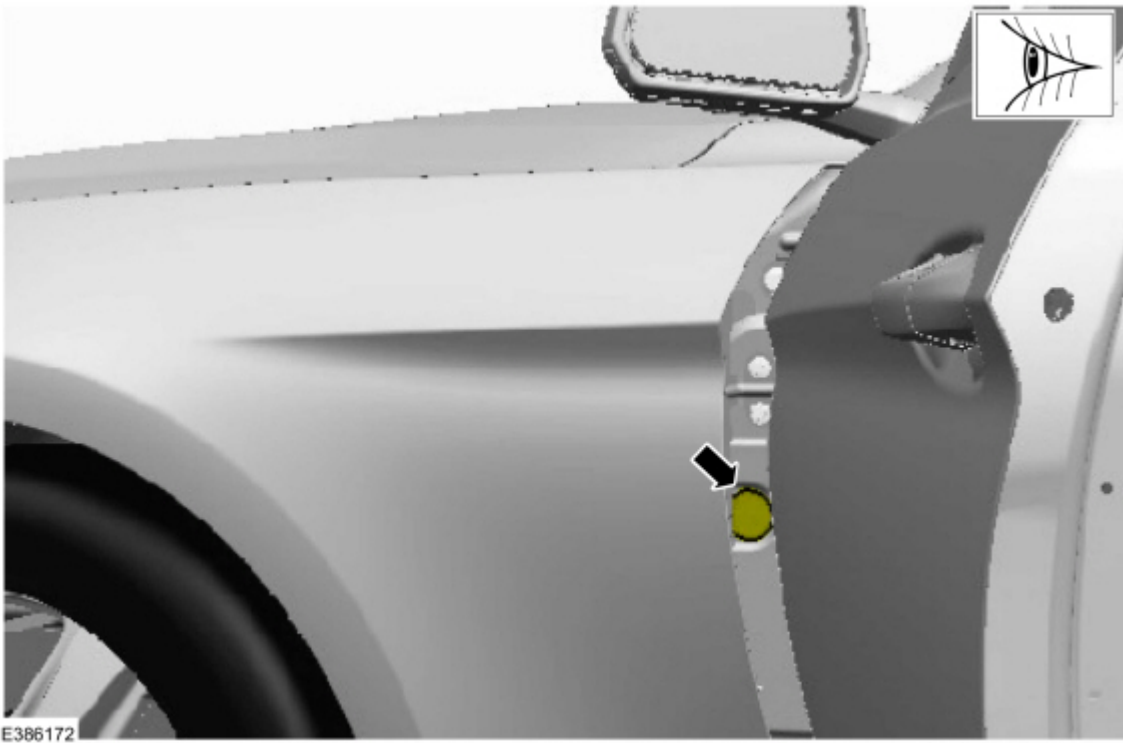
1. Fully open both doors.
2. Inspect the body seals on both A-pillars for complete 360-degree adhesion to the sheet metal. (Figure 1)

**NOTE: The A-pillar body seals are an adhesive patch that seals a 19 mm (0.75 in.) diameter hole in the sheet metal. These seals must have complete adhesion around all edges. If any portion of the sealing surface is compromised, water entry into the cabin may result.**

Figure 1 - Left A-pillar shown, right A-pillar similar

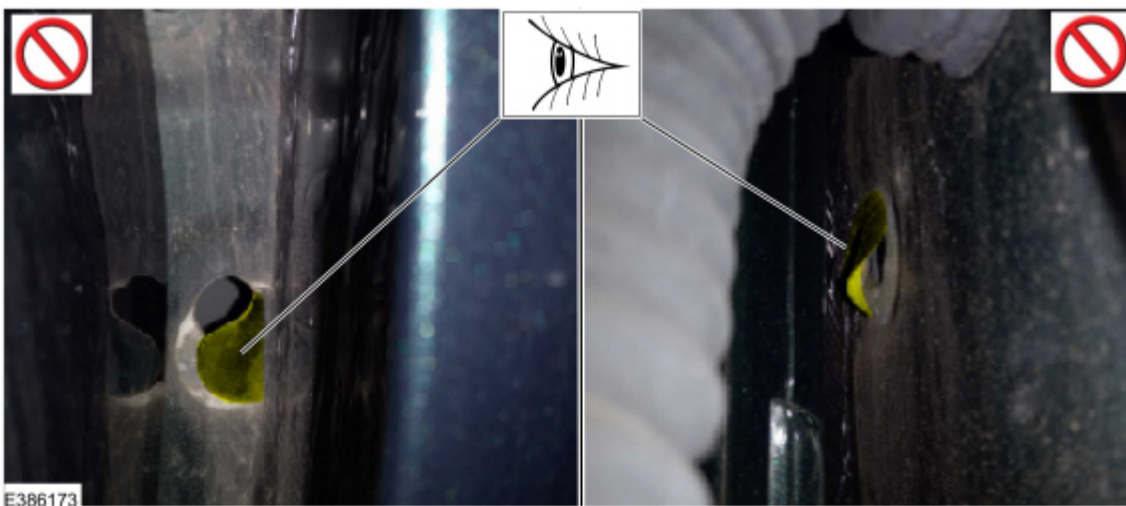
**Issue:** Some 2015-2022 Mustang vehicles may exhibit a water leak onto the front carpet that originates from the either the left or right A-pillar. This may be due to a detached A-pillar body seal. Follow the service procedure to repair the vehicle.

3. Are the body seals on both A-pillars completely sealed to the body? (Figure 2)

Figure 2 - Example of failed A-pillar sticker seals

- (1). Yes - this article does not apply.
- (2). No - proceed to Step 4.
4. Inspect the fender insulator to be sure it does not restrict access to the A-pillar body seal. If the fender insulator covers any portion of the A-pillar body seal, the foam fender insulator can be slightly indented to allow for unobstructed access to the seal.
5. Apply paint-safe, protective tape to the door and fender edges.
6. Use fingers and/or pliers to completely remove and discard the A-pillar body seal.

7. Use alcohol wipes to remove all remaining adhesive left by the discarded body seal.
8. Apply Motorcraft® Anti-Corrosion Coating to all exposed metal around the A-pillar body hole. Allow the Motorcraft® Anti-Corrosion Coating to dry following the instructions on the container.
9. Use a small paint brush to apply touch-up paint to the exterior surfaces that were previously coated with Motorcraft® Anti-Corrosion Coating. Allow paint time to dry following the instructions on the touch-up paint container.
10. Install and fully seat the new rubber body plug into the A-pillar body hole.
11. If the other A-pillar body seal requires repair, repeat Steps 4-10.
