TECHNICAL SERVICE BULLETIN

Exterior Door Does Not Open From The Outside Handle

22-2246

27 June 2022

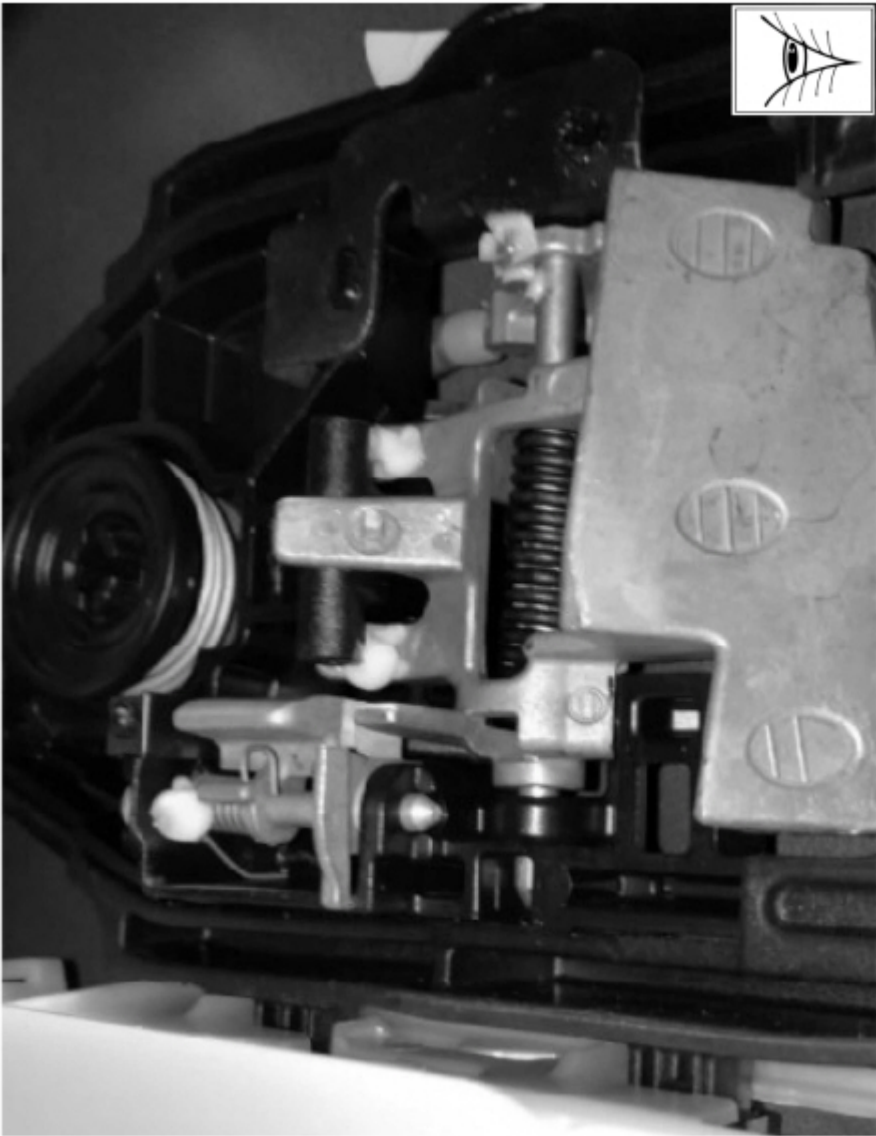
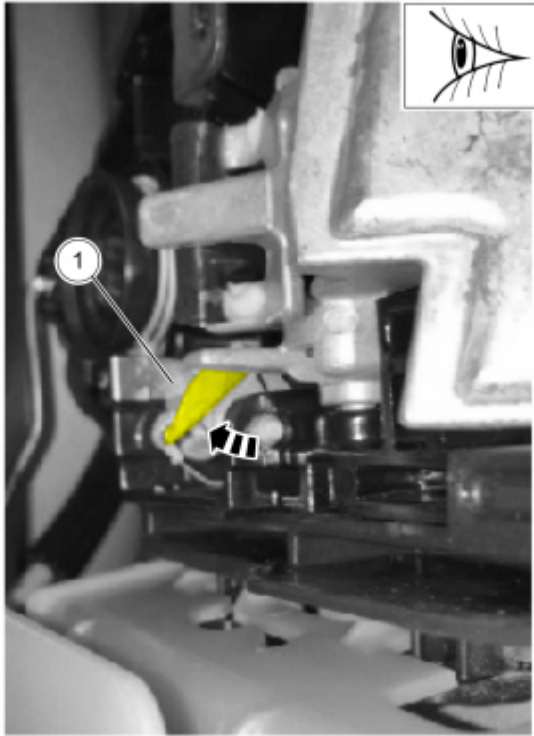
3. Inspect the exterior door handle reinforcement for permanent engagement inertia lock clip engaged and the inertia lock rotated outboard (Figures 1-2). Is the inertia lock rotated outboard and the permanent engagement inertia lock clip engaged?

- (1). Yes - proceed to Step 4.
 - (2). No - this article does not apply. Refer to WSM, Section 501-14 > Handles, Locks, Latches and Entry Systems > Diagnosis and Testing > Pinpoint Test B.
4. Use a small flat head screwdriver to depress the permanent engagement inertia lock clip and allow the inertia lock to rotate inboard to the rest position. (Figures 3-4).
