TECHNICAL SERVICE BULLETIN

Lack Of Audio And/Or Water Leak In Rear Of Vehicle And/Or Spare Tire Area

22-2262

Ford 2020-2022 Explorer
Lincoln 2020-2022 Aviator

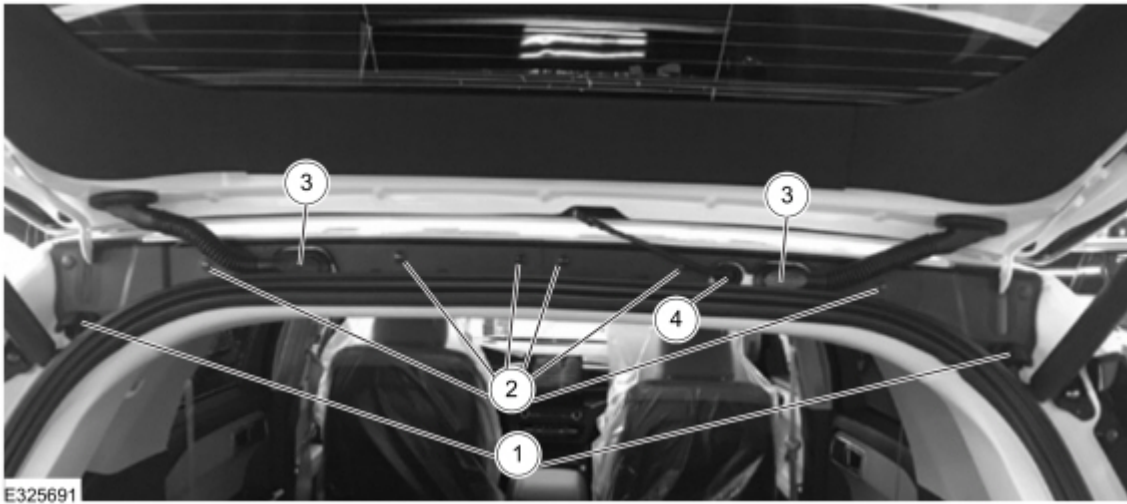
Figure 1

1. Open the rear liftgate.
2. Inspect and make sure the following components are correctly seated by pushing:
 - (1). Power liftgate grommet (if equipped). If not properly seated, replace the affected power liftgate strut. (Figure 1 Callout 1, Figure 2)

(2). Margin seal and margin seal pushpins. (Figure 1 Callout 2, Figure 3 Callout 2)

(3). Electrical wiring grommet. (Figure 1 Callout 3, Figure 3 Callout 3)

(4). Rear washer hose. (Figure 1 Callout 4, Figure 3 Callout 4)

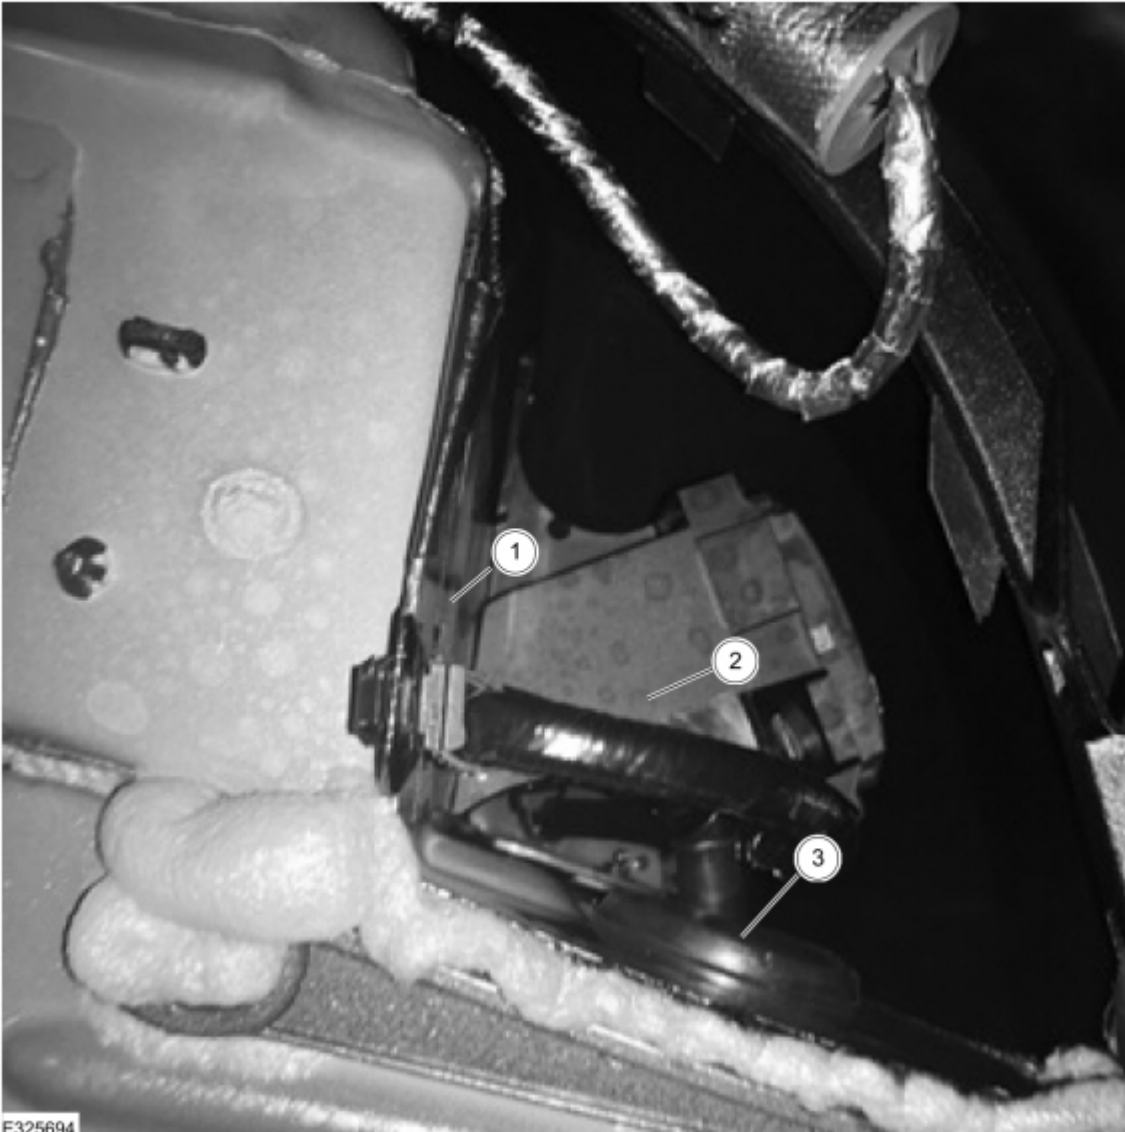
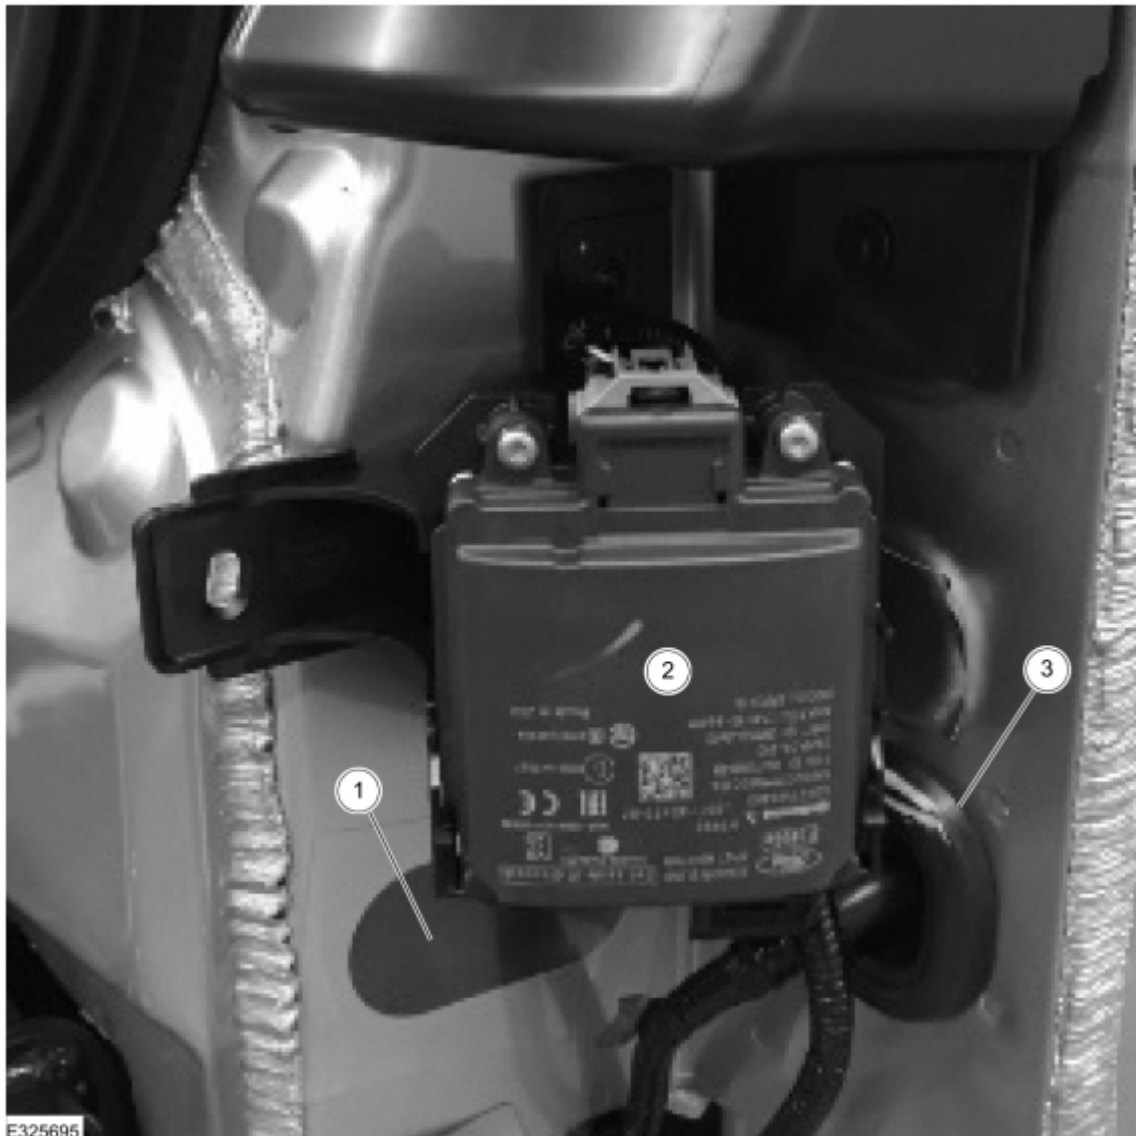
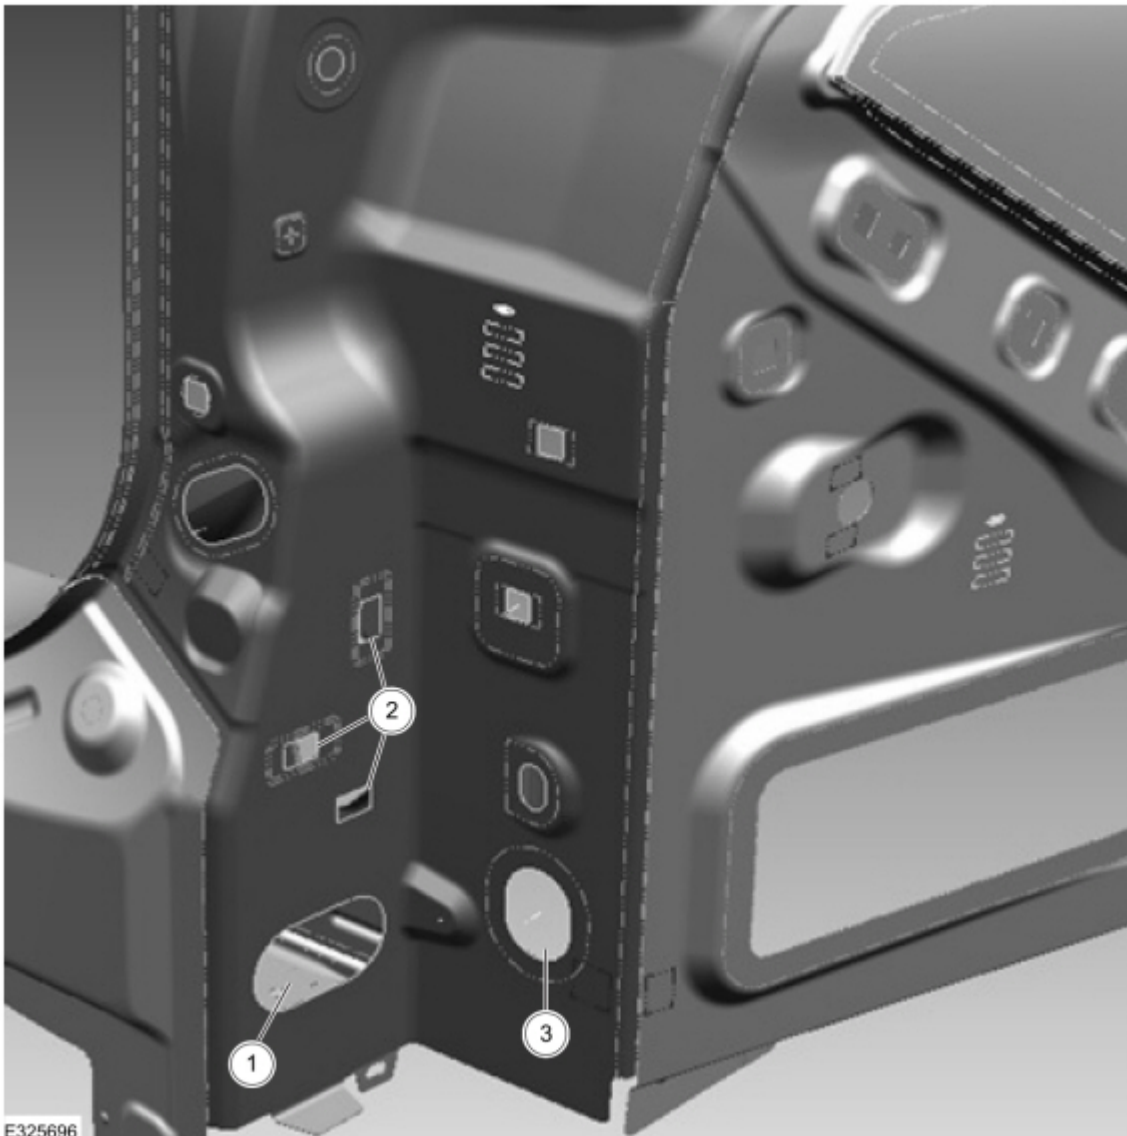
3. If a water leak is present on the right side of the vehicle, replace the audio control module (ACM).
4. Raise the vehicle on a hoist.
5. Inspect the right side rear corner area under the rear bumper cover for the following loose, disconnected, or missing items:
 - (1). Visually inspect for delete tape completely covering the body hole. (Figures 4-6 Callout 1)
 - (2). Press down on the blind spot information system (BLIS) module to make sure the BLIS module is fully seated into the body. (Figures 4-6 Callout 2)
 - (3). Visually inspect the BLIS module harness wire grommet is seated. (Figures 4-6 Callout 3)

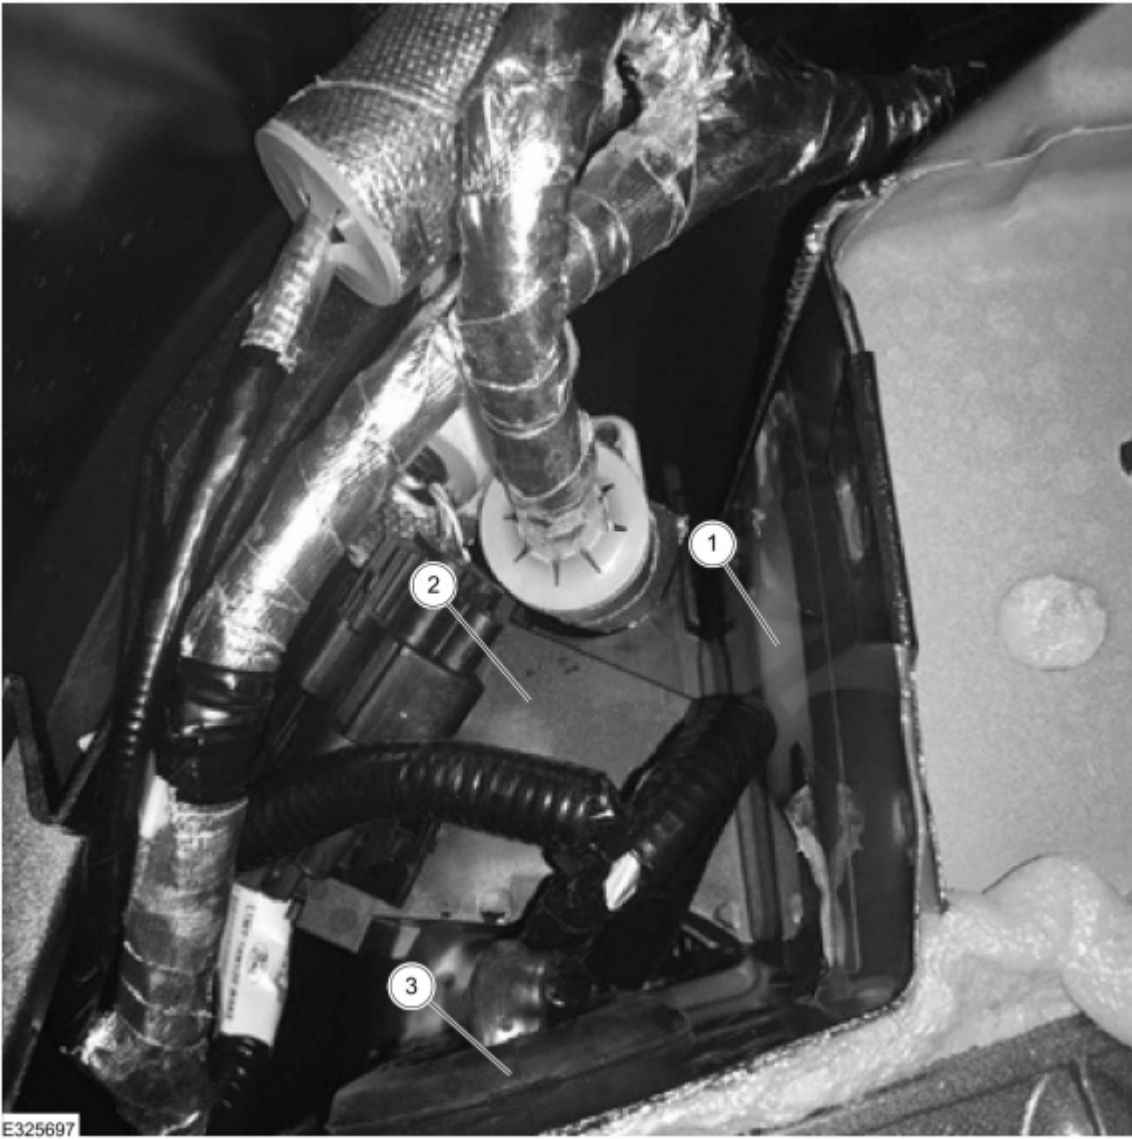
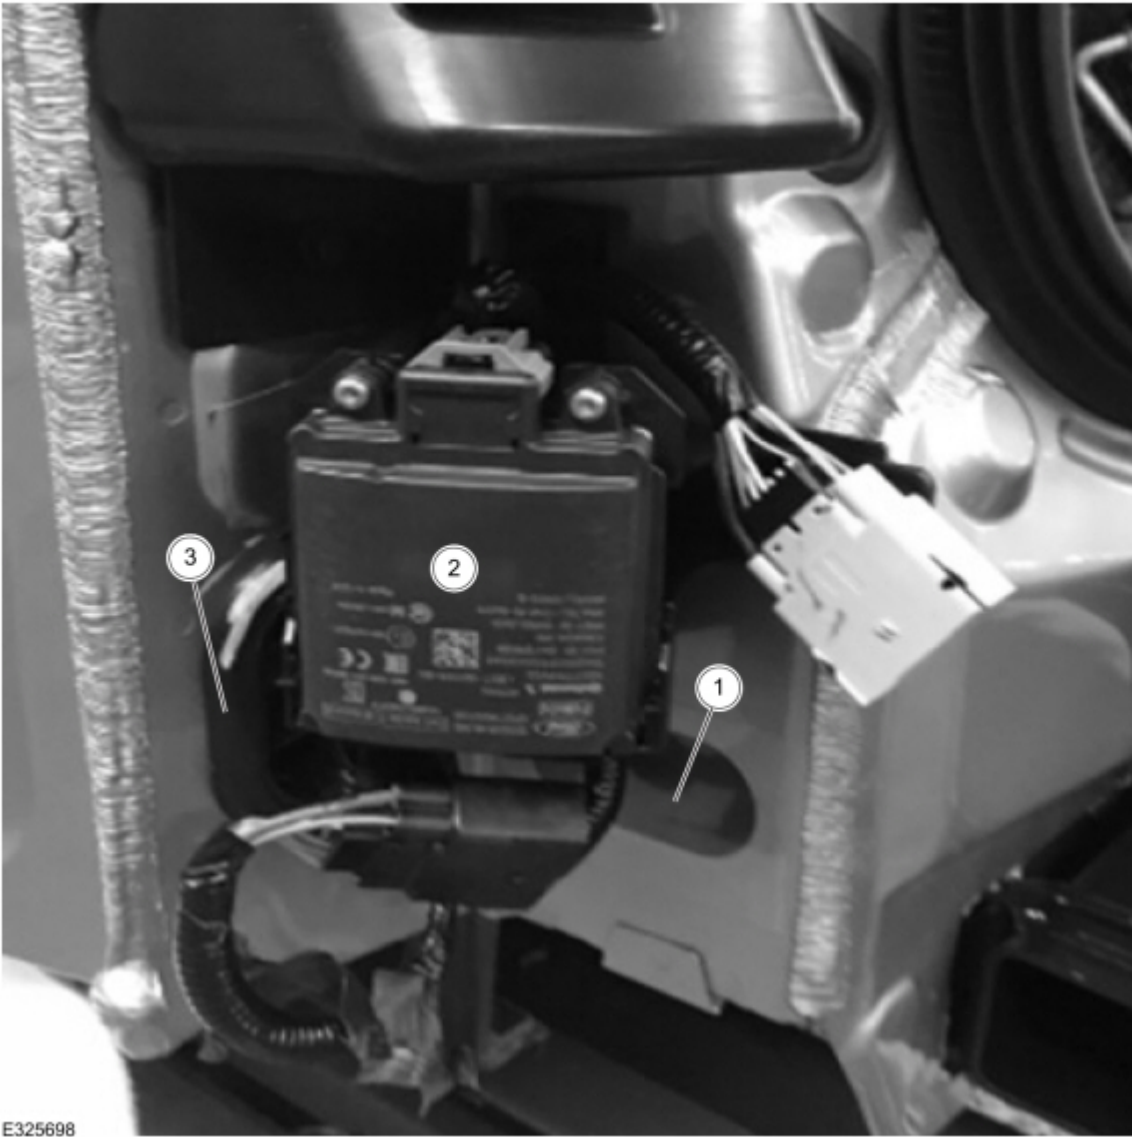
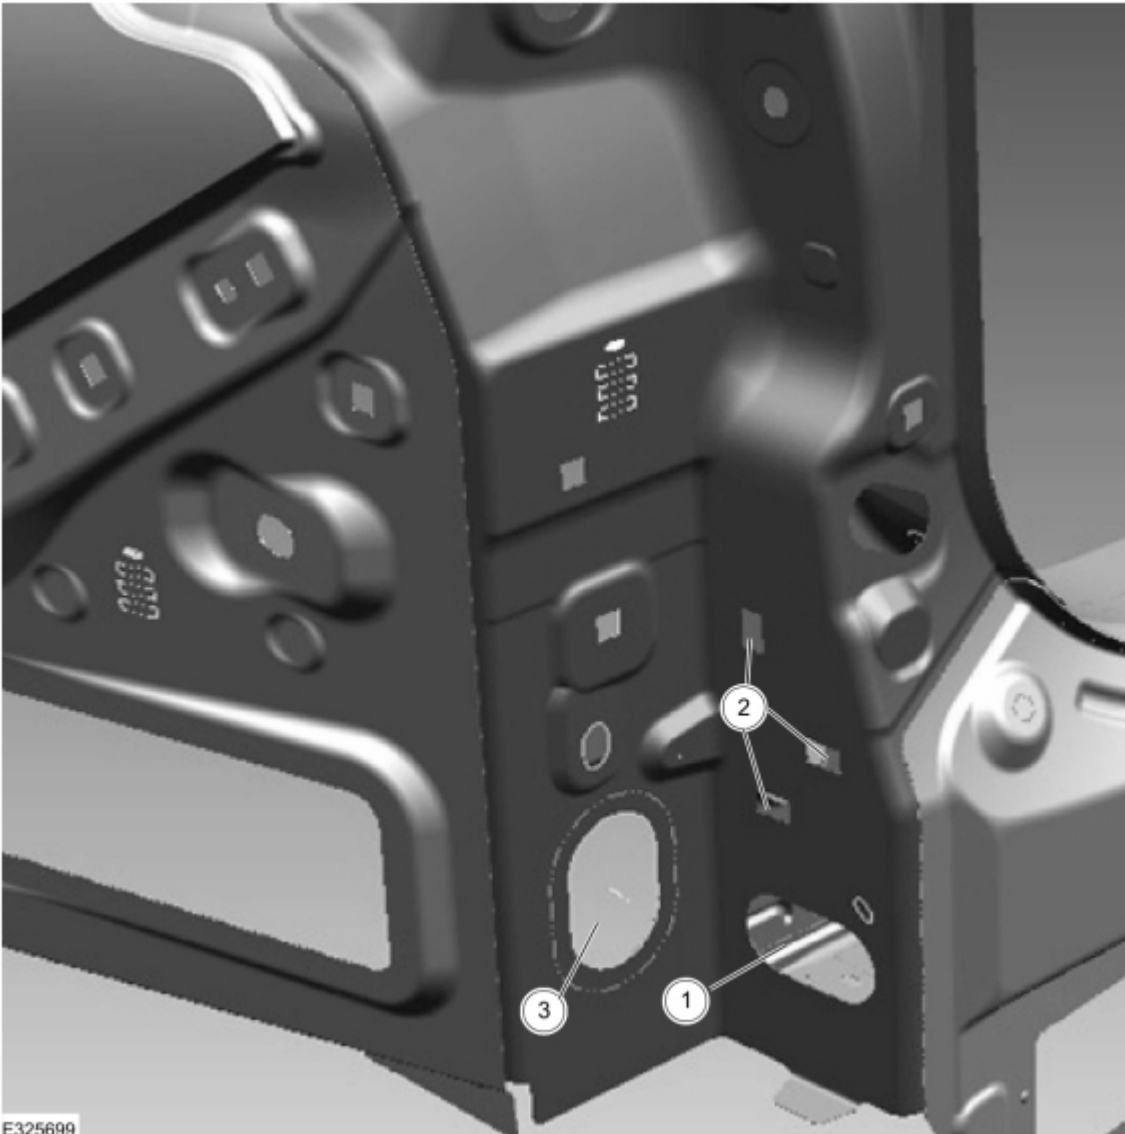
6. Inspect the left side rear corner area under the rear bumper cover for the following loose, disconnected, or missing items:

- (1). Visually inspect for delete tape completely covering the body hole. (Figures 7-9 Callout 1)
- (2). Press down on the BLIS module to make sure the BLIS module is fully seated into the body. (Figures 7-9 Callout 2)
- (3). Visually inspect the BLIS module wire harness grommet is seated. (Figures 7-9 Callout 3)

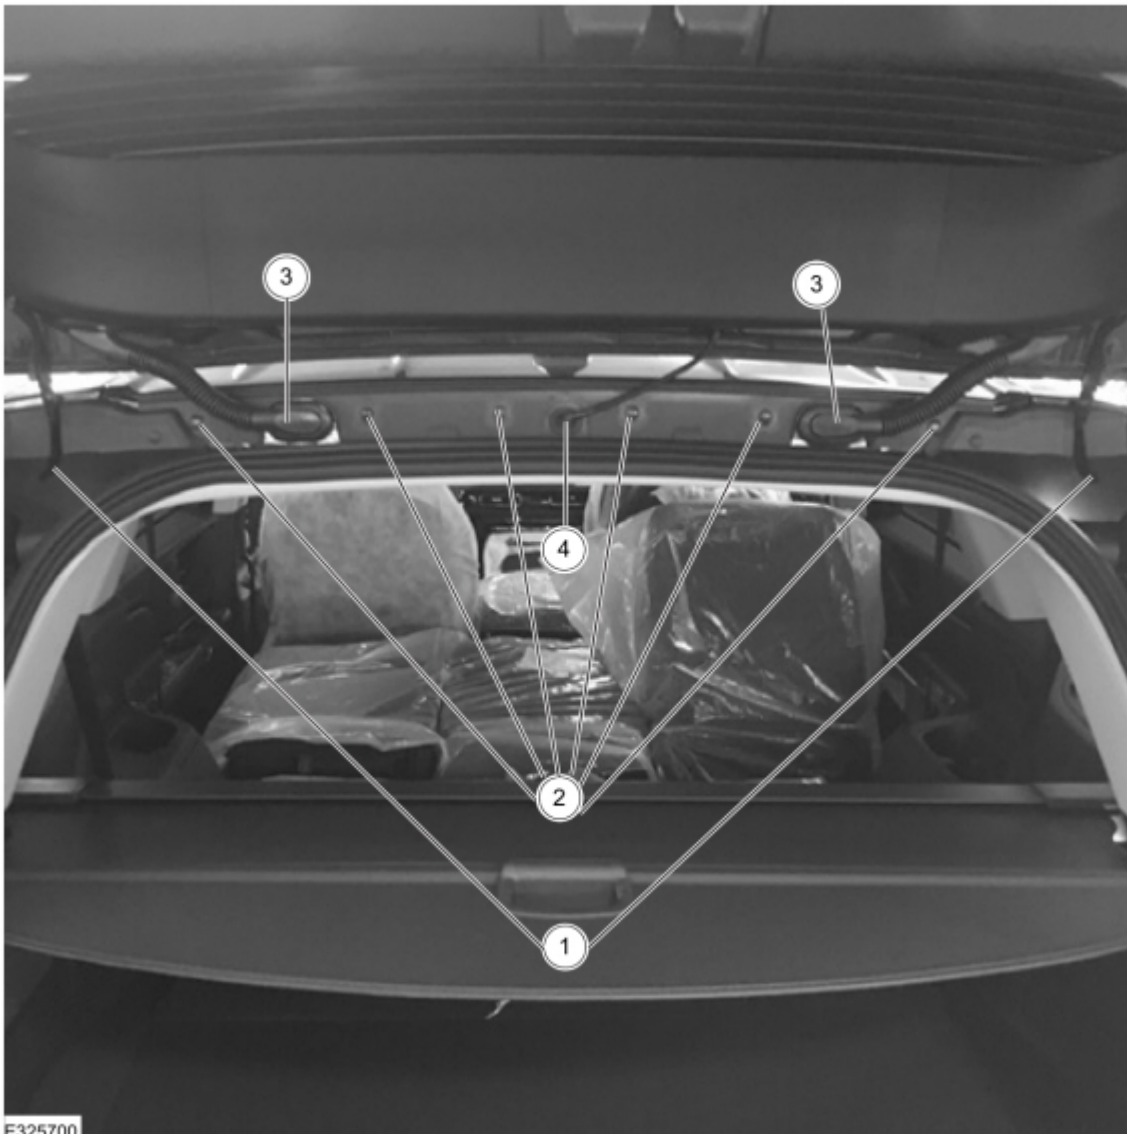
Figure 10

1. Open the rear liftgate.
2. Inspect and make sure the following components are correctly seated by pushing:
 - (1). Power liftgate grommet. If not properly seated, replace the affected power liftgate strut. (Figure 10 Callout 1, Figure 11)
 - (2). Margin seal and margin seal pushpins. (Figure 10 Callout 2)
 - (3). Electrical wiring grommet. (Figure 10 Callout 3)
 - (4). Rear washer hose. (Figure 10 Callout 4)

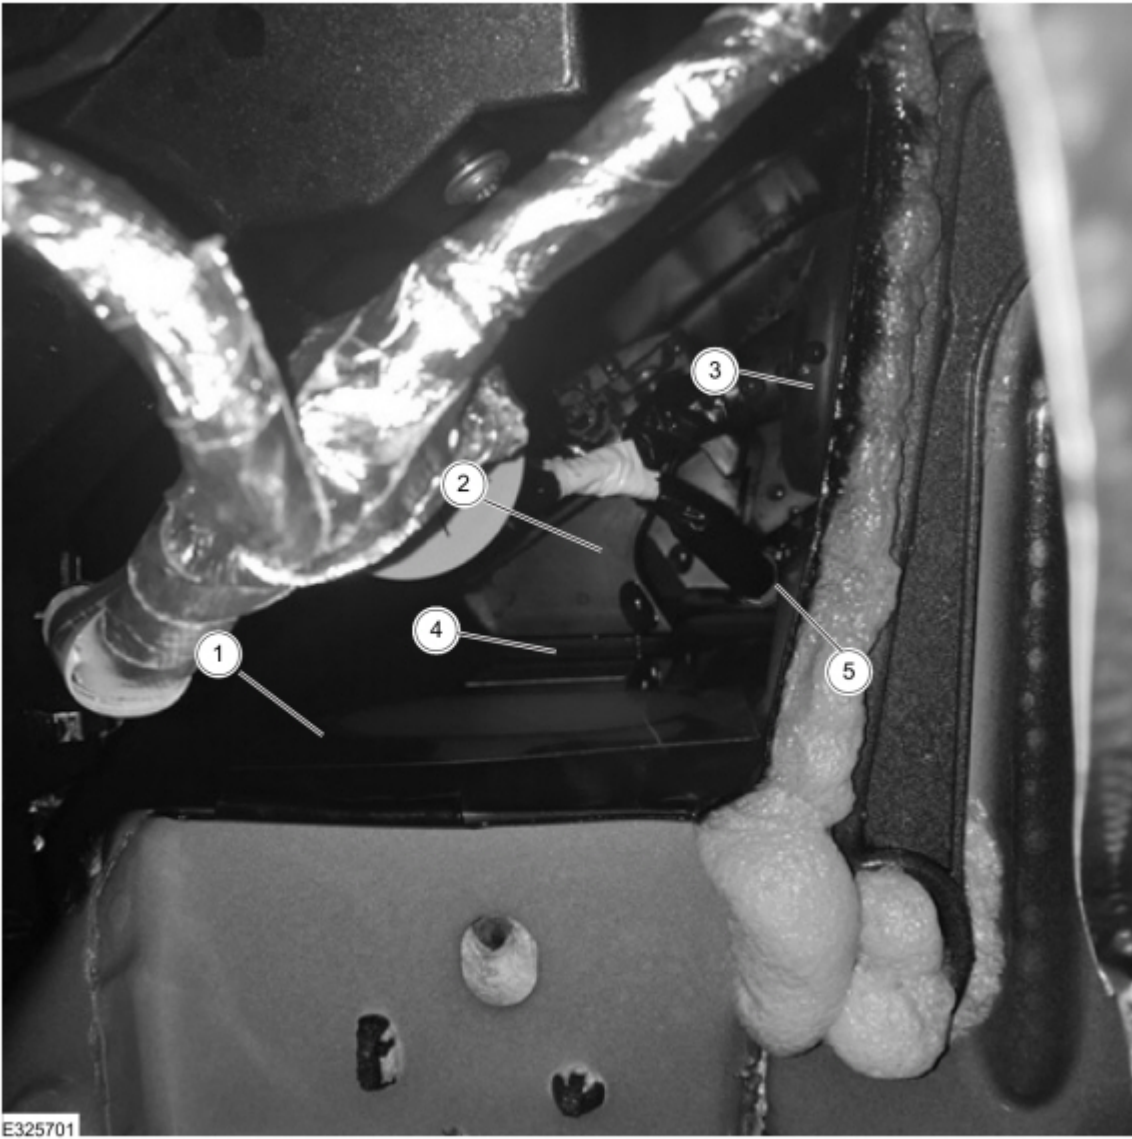
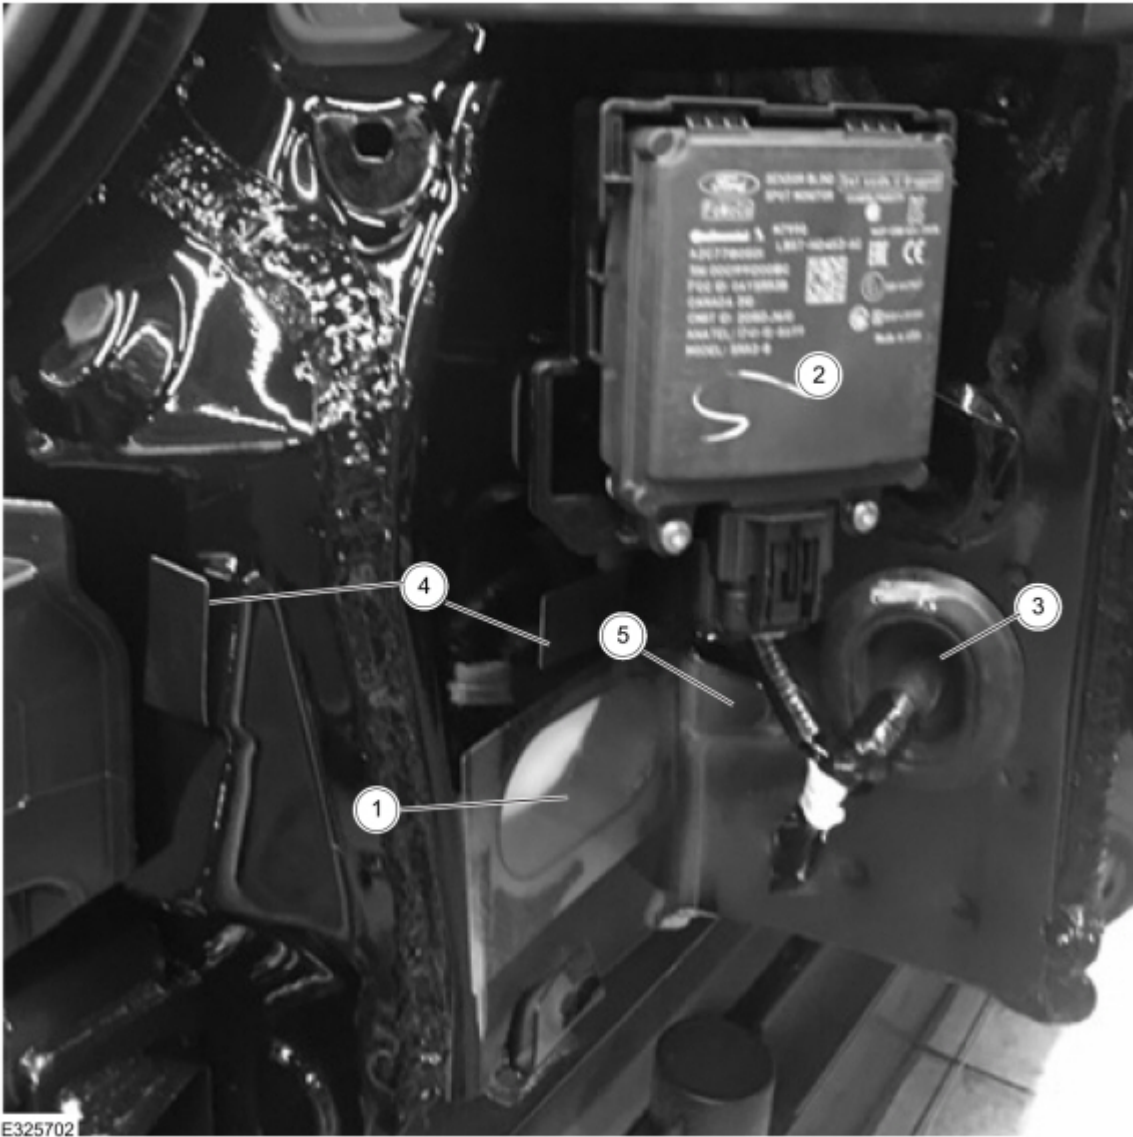
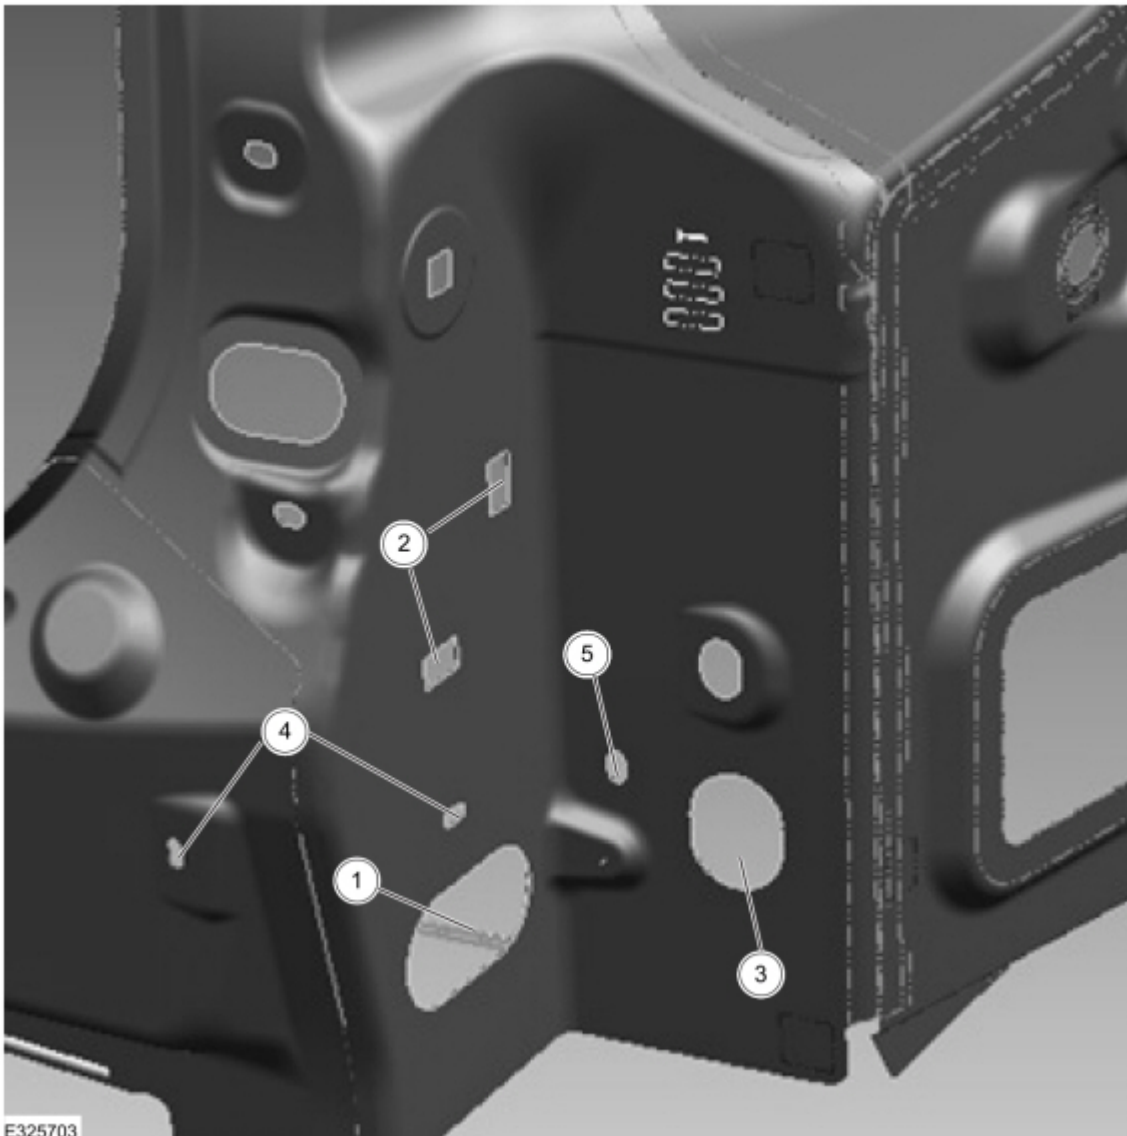
3. If a water leak is present on the right side of the vehicle, replace the ACM.
4. Raise the vehicle on a hoist.
5. Inspect the right side rear corner area under the rear bumper cover for the following loose, disconnected or missing items:
 - (1). Visually inspect for delete tape completely covering the body hole. (Figures 12-14 Callout 1)
 - (2). Press down on the BLIS module to make sure the BLIS module is fully seated into the body. (Figures 12-14 Callout 2)
 - (3). Visually inspect the BLIS module wire harness grommet is seated. (Figures 12-14 Callout 3)
 - (4). Make sure the wire harness grommet for the phone as a key feature is seated or the delete tape is completely covering the body hole. (Figures 12-14 Callout 4)
 - (5). BLIS grommet to module wire. (Figures 12-14 Callout 5)

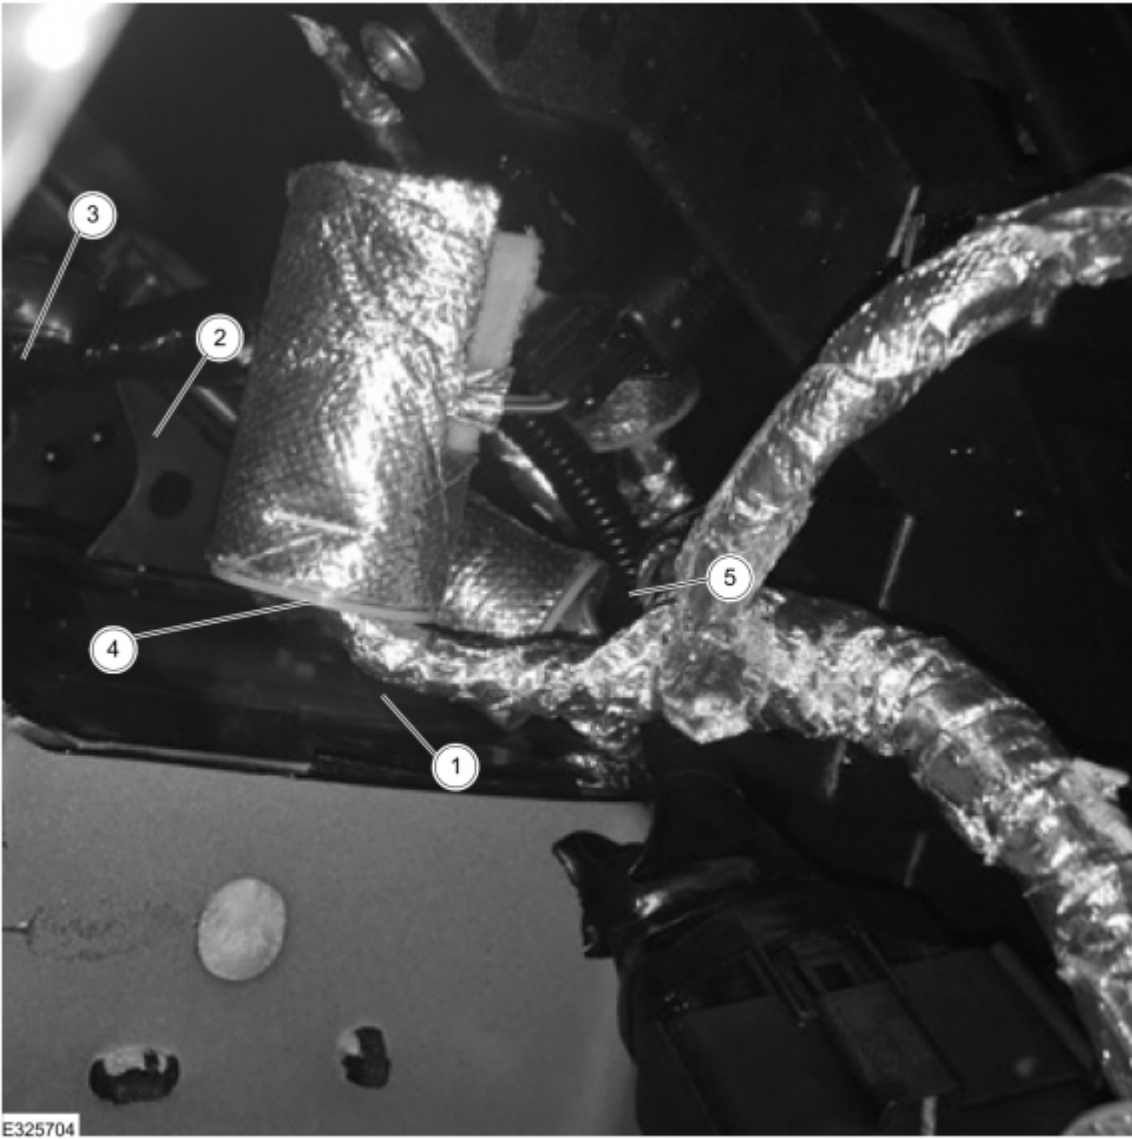
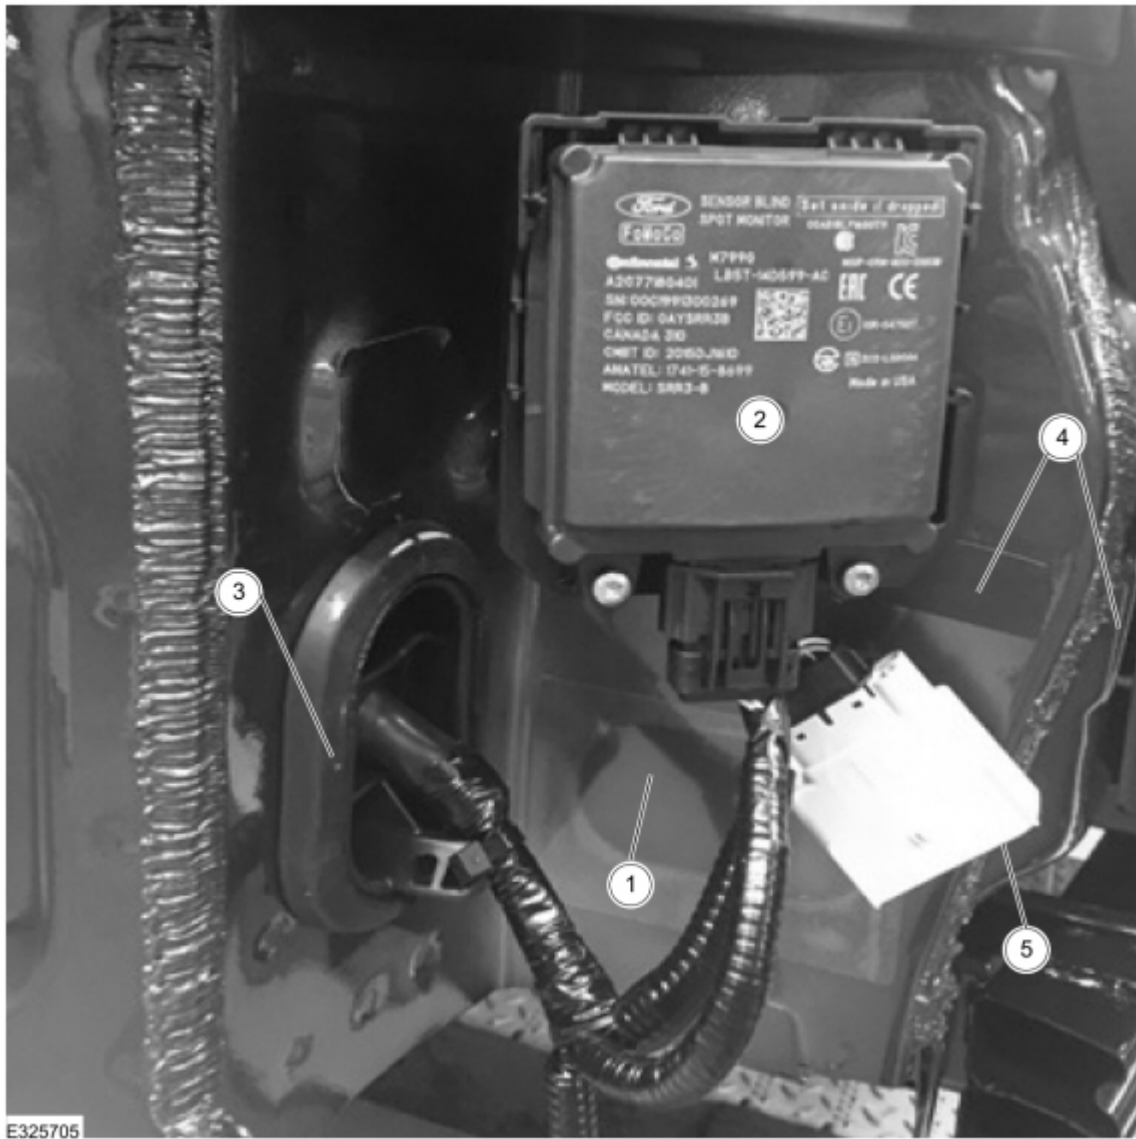
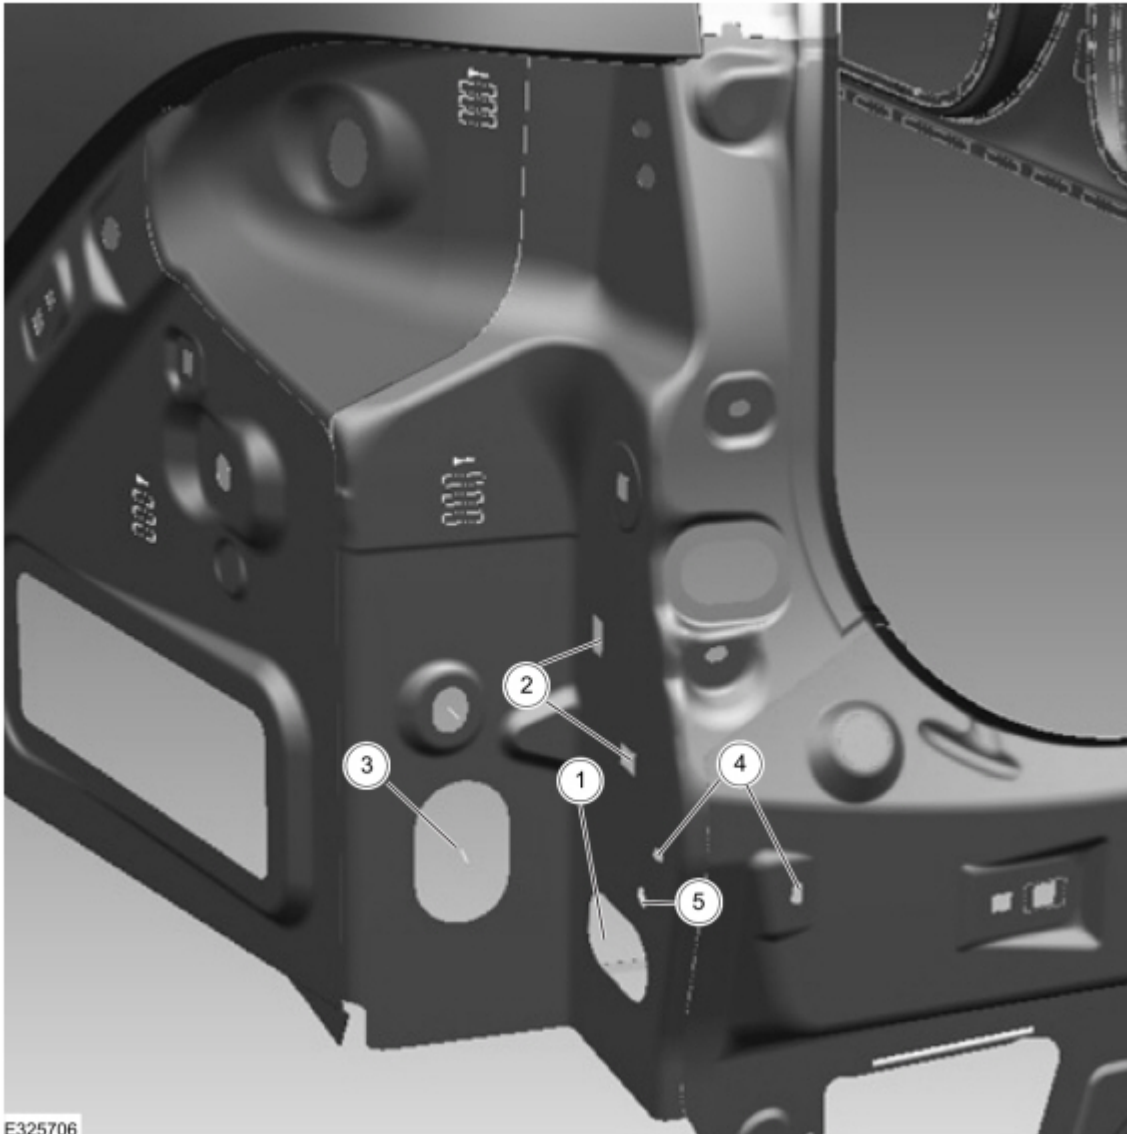
- 6.** Inspect the left side rear corner area under the rear bumper cover for the following loose, disconnected or missing items:
- (1). Visually inspect for delete tape completely covering the body hole. (Figures 15-17 Callout 1)
 - (2). Press down on the BLIS module to make sure the BLIS module is fully seated into the body. (Figures 15-17 Callout 2)
 - (3). Visually inspect the BLIS module wire harness grommet is seated. (Figures 15-17 Callout 3)
 - (4). Make sure the wire harness grommet for the phone as a key feature is seated or the delete tape is completely covering the body hole. (Figures 15-17 Callout 4)
 - (5). Rear fascia wire. (Figures 15-17 Callout 5)
