TECHNICAL SERVICE BULLETIN

Hard Top Roof - Front Roof Panels - Uneven Height Causing Poor Appearance, Excessive Wind Noise, Water Leaks And/Or Difficulty Latching

22-2288

Ford 2021-2022 Bronco	Hard top roof
---------------------------------	---------------

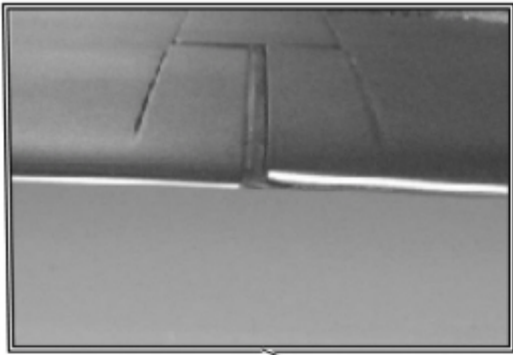
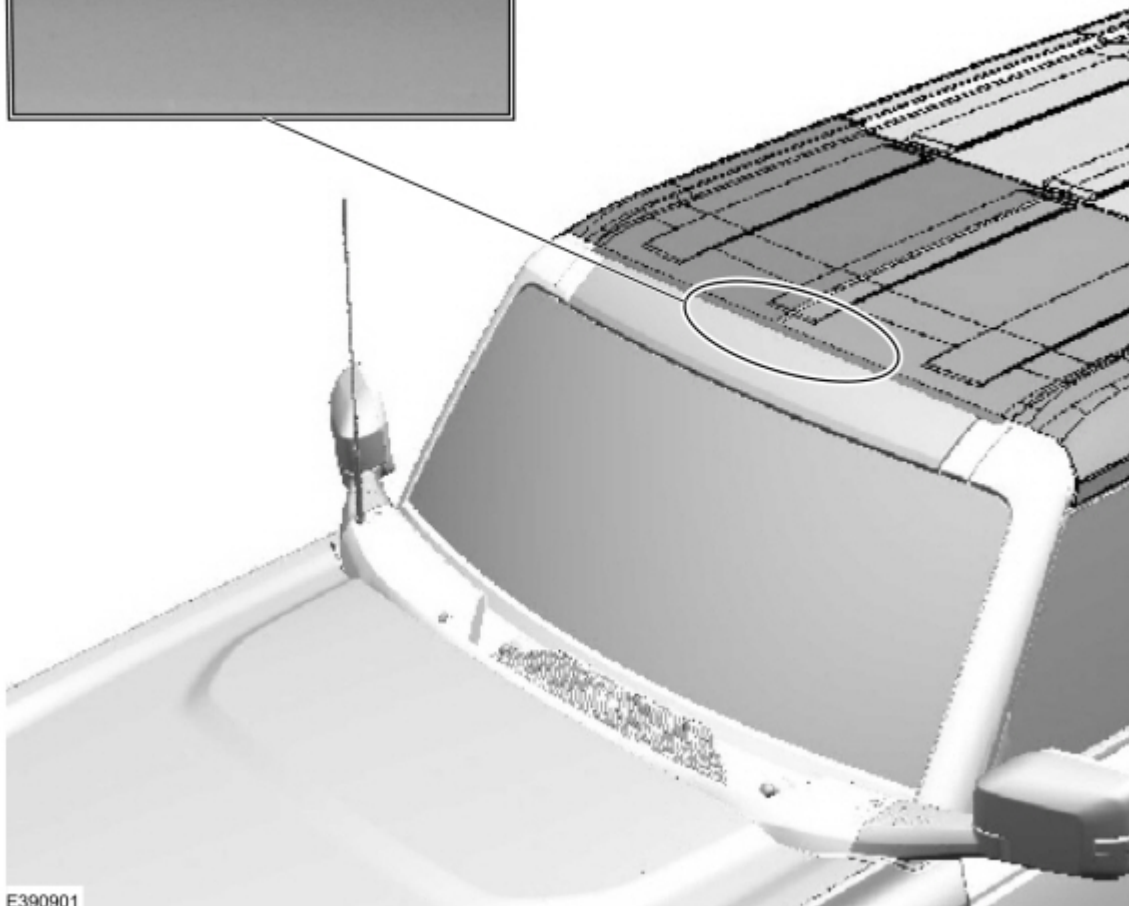
Figure 1

Issue: Some 2021-2022 Bronco vehicles equipped with a hard top roof may exhibit symptoms from the front roof panels that sit at an uneven height which may result in a poor appearance, excessive wind noise, water leaks and/or difficulty latching. This may be due to incorrect vertical adjustment of the front roof panel latch strikers. To correct this condition, follow the Service Procedure to adjust the front panel latch strikers.

1. Do the front roof panels sit at an uneven height? (Figure 1)

6. Adjust the position of the strikers as needed to obtain a flush appearance between the 2 front roof panels. It may be necessary to hand tighten the striker bolts to hold them in place during inspections. Once flushness is achieved, test the roof latching effort to be sure it is not excessive.

7. Once correct striker placement and latching effort is achieved, tighten the front striker bolts to 20 Nm (15 lb-ft).
8. Install the windshield header trim panel. Refer to WSM, Section 501-05.
