TECHNICAL SERVICE BULLETIN

2021-2022 Bronco - Whistle Noise From Left Exterior Mirror

22-2297

Ford 2021-2022 Bronco

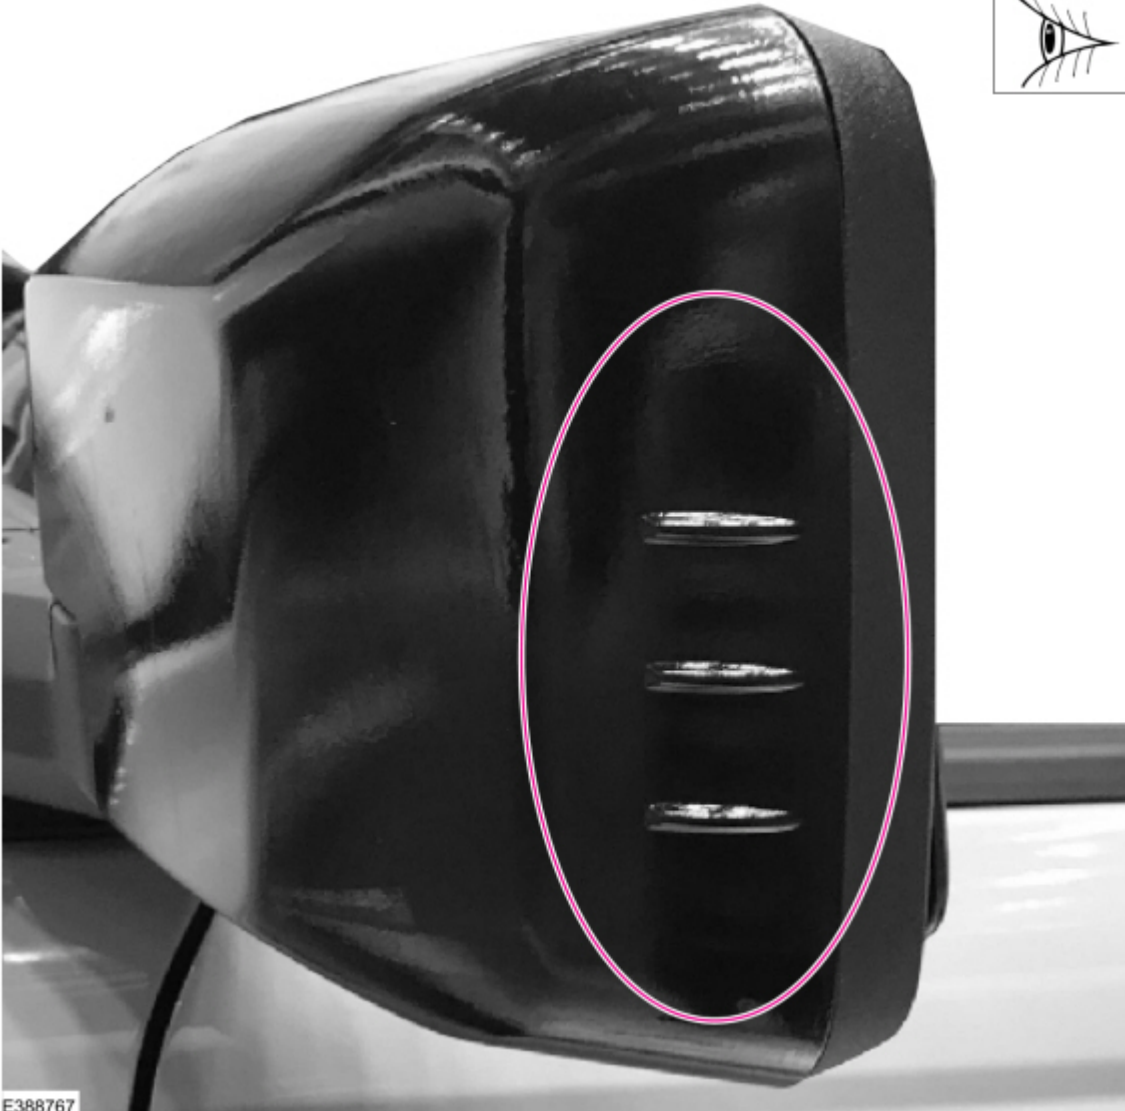
Figure 1 - Left side shown, right side similar

Issue: Some 2021-2022 Bronco vehicles equipped with base exterior mirrors (does not have integrated puddle lamps and/or turn signal lamps) may have a whistle noise that originates from the left exterior mirror. This may be due to the design of the exterior mirror cover. To correct this condition, follow the Service Procedure to replace both the left and right exterior mirror covers.

1. Does the left exterior mirror have 3 horizontal fins on the outboard side of the mirror cover? (Figure 1)

- (1). Yes - this article does not apply. Refer to Workshop Manual (WSM), Section 100-04 and continue with normal diagnostics.
- (2). No - replace both the left and right exterior mirror covers. Refer to WSM, Section 501-09. Both the left and right exterior mirror covers must be replaced to maintain a consistent vehicle appearance.
