TECHNICAL SERVICE BULLETIN

5.0L Engine - MT-82 Manual Transmission – Loss Of Movement And/Or Difficulty Shifting

22-2302

22 July 2022

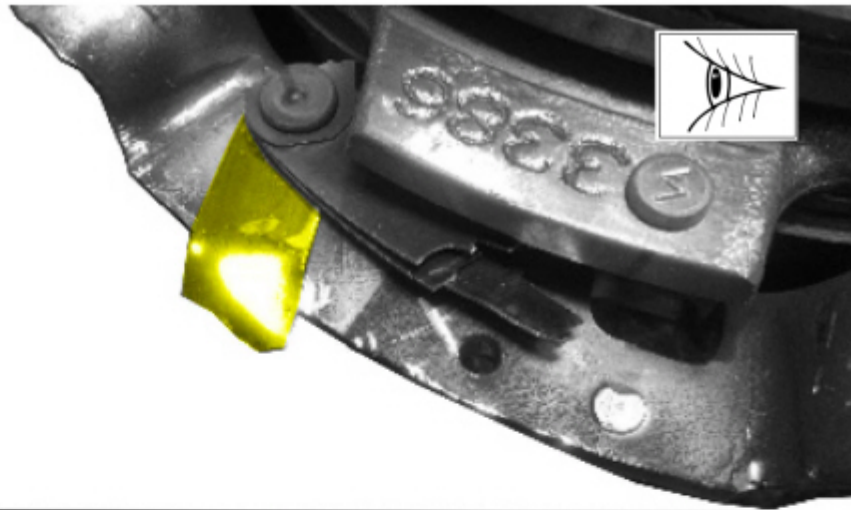
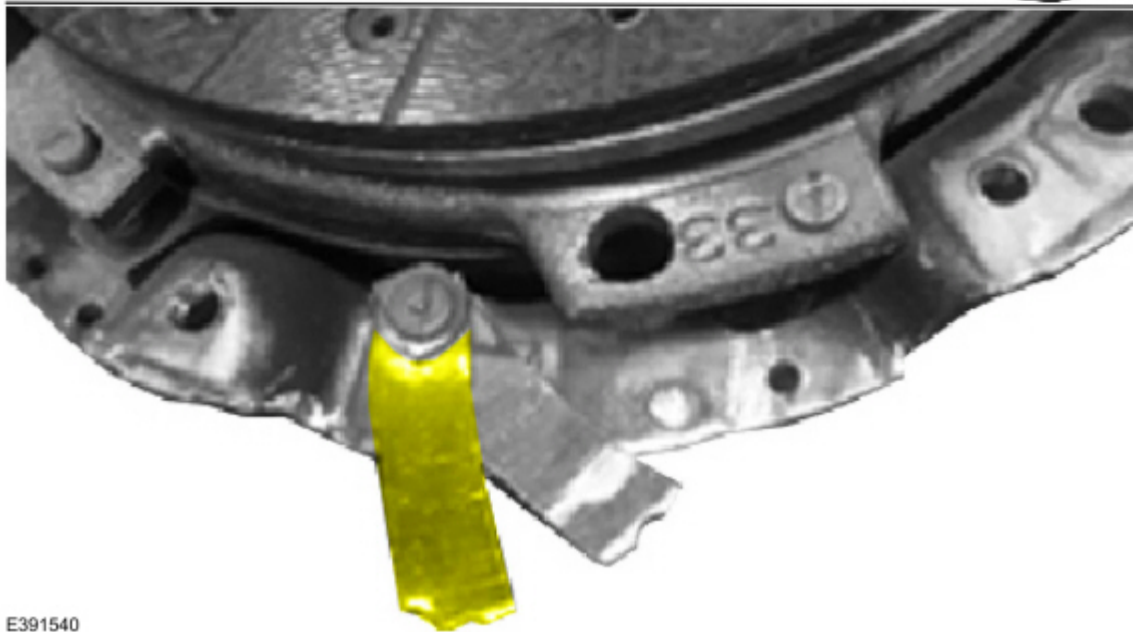
E391540

Figure 1 - A torn strap of the intermediate pressure plate on clutch

- (1). Yes - proceed to Step 3.
- (2). No - this article does not apply. Refer to WSM, Section 308-03A and continue with normal diagnostics.
- 3.** Replace the clutch, dual mass flywheel and any other damaged components. Refer to WSM, Section 308-01 and 303-01.
- 4.** Replace the peak torque limiter.
 - (1). Disengage the 2 retention clips (1 clip must have been disengaged during transmission removal).
 - (2). Install the new peak torque limiter, making sure it is fully seated into the transmission and line (during transmission installation) and that both clips are fully engaged. (Figure 4)

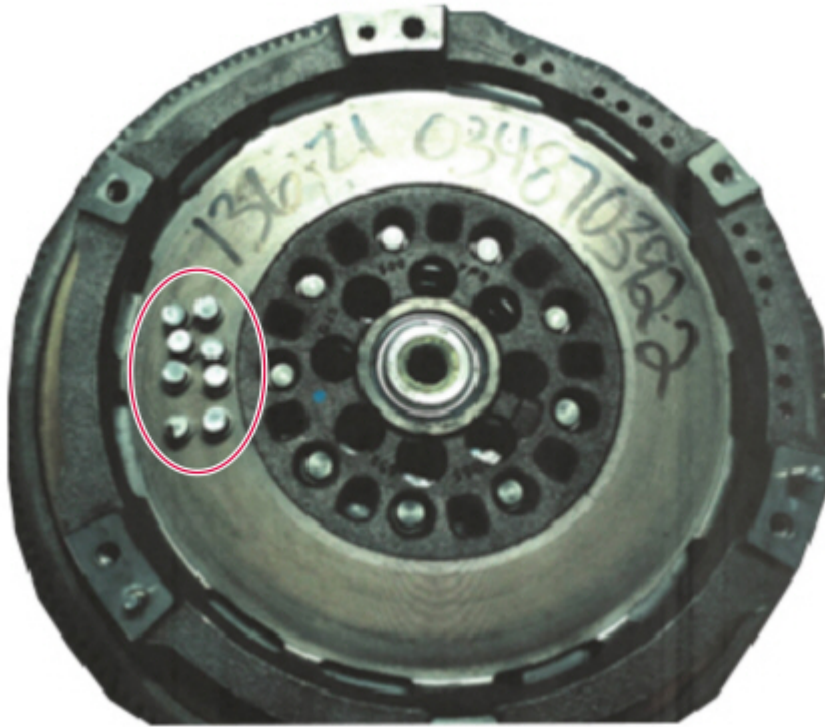
E391541

Figure 2 - Dual mass flywheel rivet failure

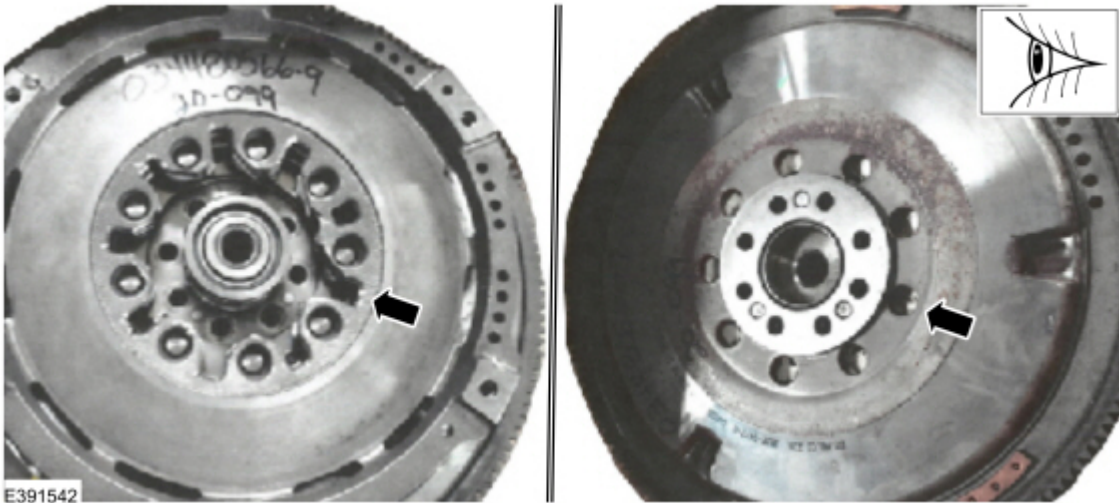
E391542

Figure 3 - Stuck dual mass flywheel due to spring breakage. Bolt access requires cutting through the flywheel.
