SERVICE BULLETIN

APPLICABILITY: 2013-20MY BRZ **NUMBER:** 02-136-12R
SUBJECT: Oil Seepage Diagnosis and Repair Procedures **DATE:** 09/26/12
REVISED: 07/11/22

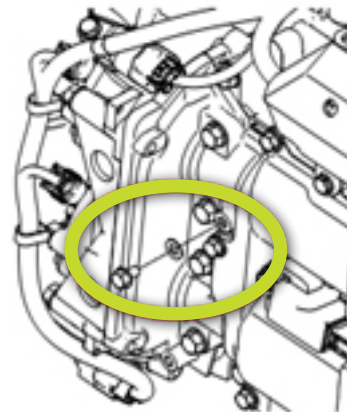
If oil seepage is verified coming from the 6mm threaded hole in the left-hand camshaft cap, install the specified bolt and flat washer.

Bolt: Part# 800206180

Washer: Part# 031106000

Tightening Torque: 6.4 +/- 0.5 Nm
(57 +/- 4 inch-pounds)

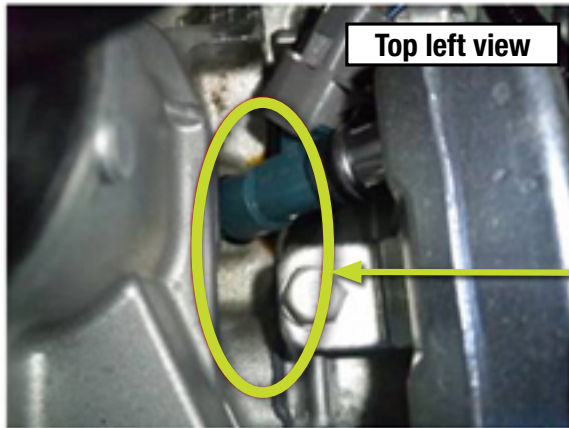
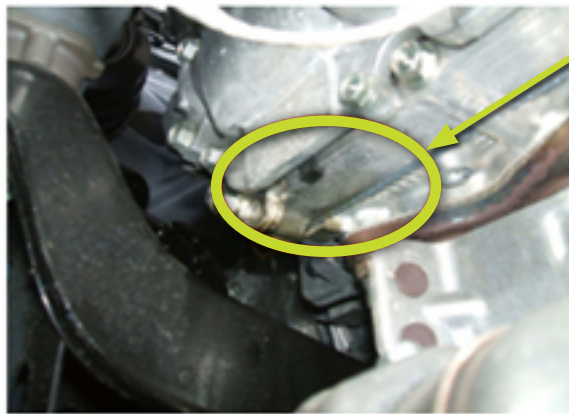
Cam carrier seepage seen from top left and lower right side of engine

If oil seepage is verified coming from between the cam carrier and the cylinder head as shown in the photos below, remove the cam carrier. Clean the machined sealing surfaces thoroughly and then re-seal using Liquid Gasket ThreeBond 1217H (SOA868V9610) or equivalent*. As shown in the photos below, the o-rings between the cam carrier and the cylinder head will need to be replaced as they are not re-usable. This would also be a good time to clean the Active Valve Control System (AVCS) filter screens which are contained in the cam carriers and shown in the photos below. **NOTE:** The filter screens are one-time use and must be replaced if they need to be removed. The replacement filter part # is 14451 AA 050.

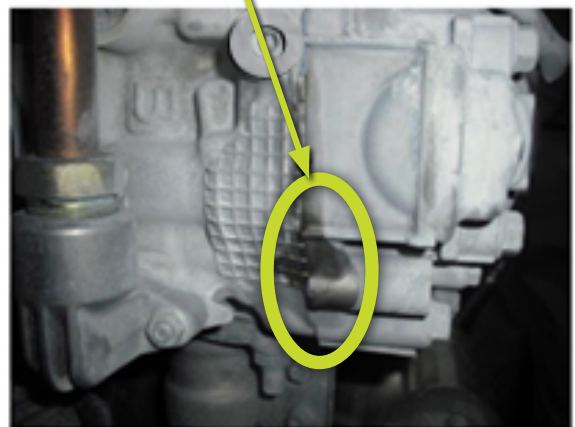
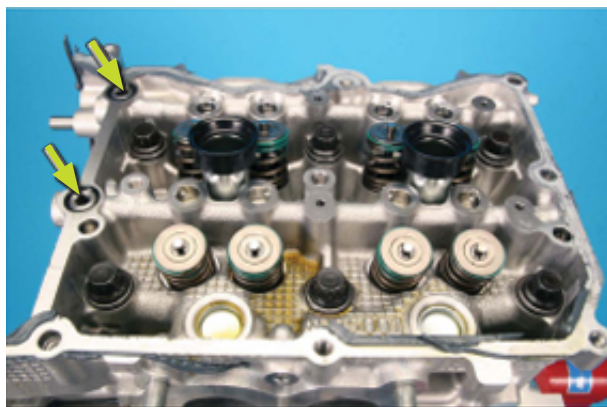
One-time use cam carrier o-rings which must be replaced.

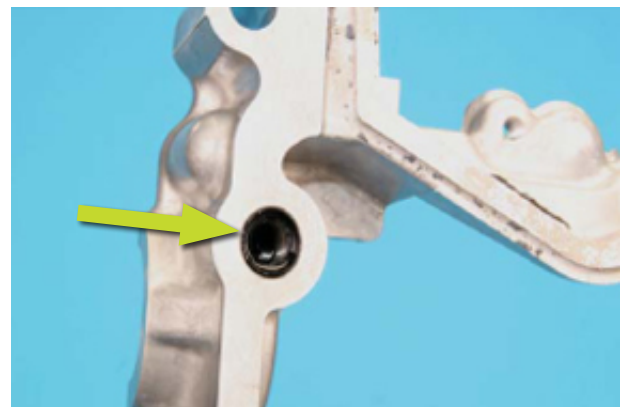
AVCS filter screens must be replaced if removed.

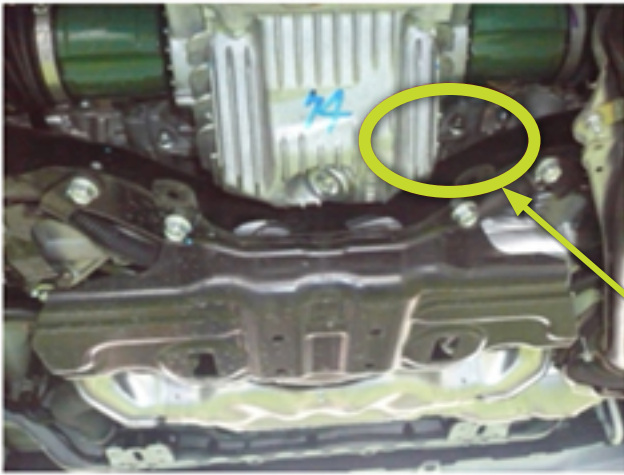
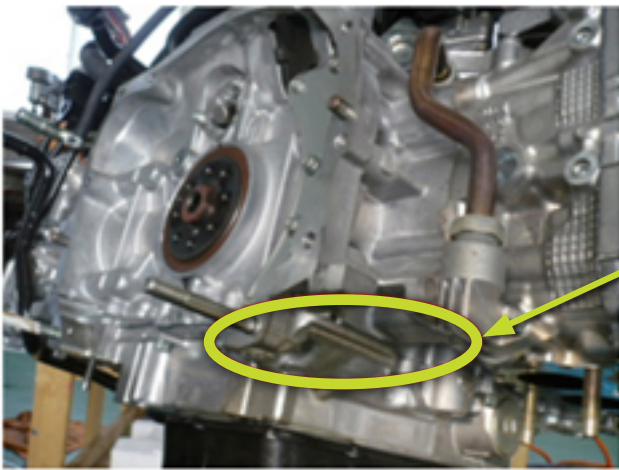
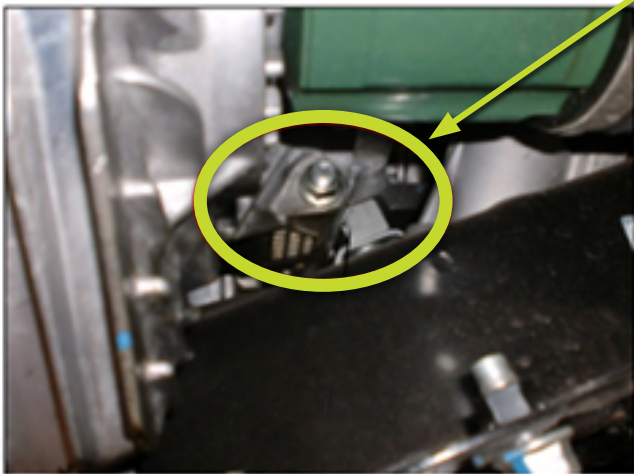
These photos show areas of seepage coming from the upper oil pan to engine block sealing surfaces.

If you find oil seepage between the cylinder block and upper oil pan, remove the upper oil pan, clean the machined sealing surfaces thoroughly and then re-seal using Liquid Gasket ThreeBond 1217H (SOA868V9610) or equivalent*. In addition, the o-rings between the upper oil pan and the cylinder block along with those between the upper and lower oil pan will need to be replaced as they are also one-time use items.

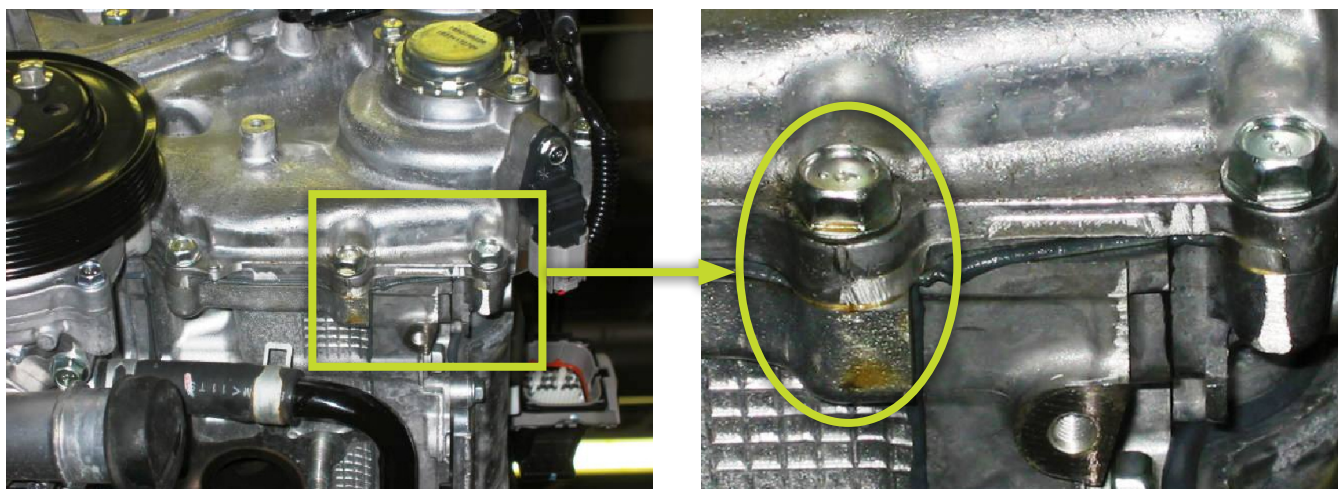
NOTE: Only reseal the front chain cover **AFTER** confirming there is no oil seepage coming from the either cam retainer cap (area 1) and / or the cam carrier (area 2) as previously described.

1. If there are no oil droplets found on the engine under-cover or the lower radiator hose, thoroughly clean the chain cover sealing area along with the surrounding cylinder head and crankcase areas. Re-check for oil seepage again at the next service interval.
2. If the front chain cover is leaking and needs to be resealed, follow the repair procedure in the applicable Service Manual. Thoroughly clean and inspect the sealing surfaces then re-seal using Liquid Gasket ThreeBond 1217H (SOA868V9610) or equivalent*.

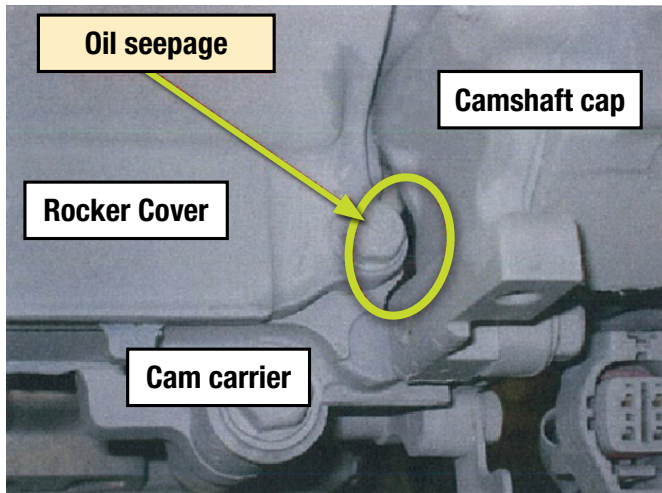
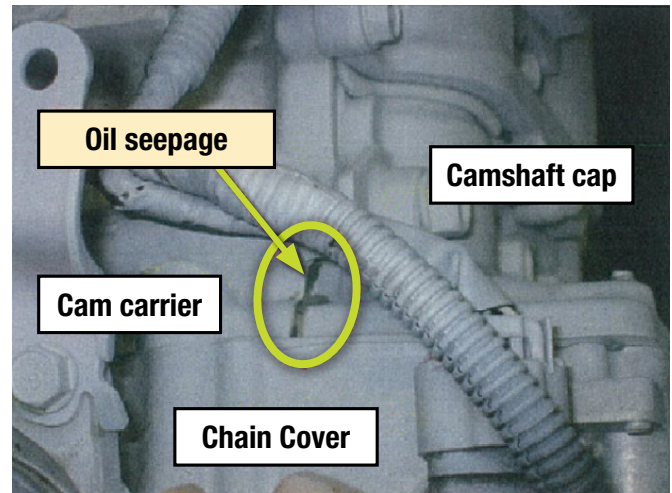
If oil seepage is verified coming from the front camshaft cap and/or camshaft carrier as shown in the photos below, remove the cam cap and clean both surfaces thoroughly before applying sealer. **Note:** The 2 o-rings between the camshaft cap and the cam carrier will need to be replaced as they are not re-usable.

Apply Liquid Gasket, ThreeBond 1217H (SOA868V9610) or equivalent* as shown below:

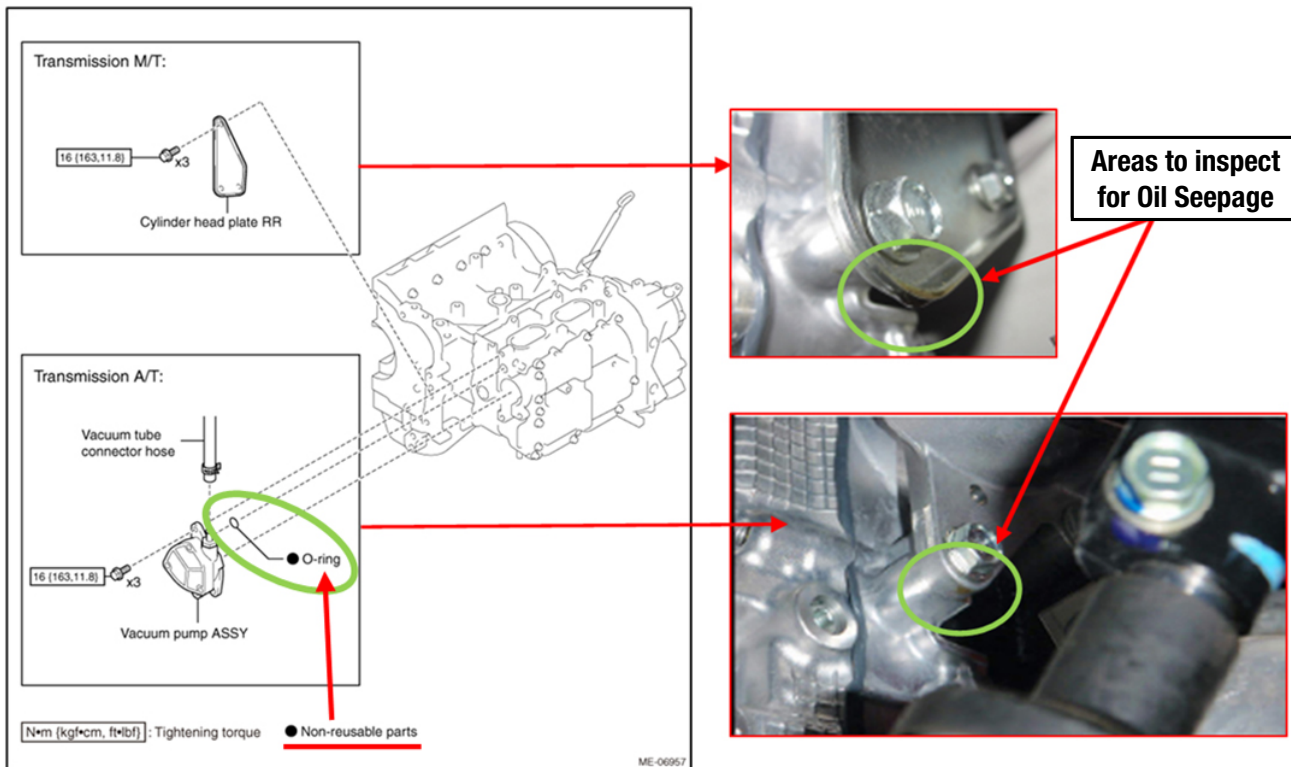
If oil seepage is verified at the bottom of the cylinder head block-off plate (on M/T models) or bottom of the vacuum pump assembly (on A/T models), the source may be the area between the cam carrier and the intake cam cap. The seeped oil then collects at the bottom of the block-off plate or vacuum pump as shown in the photo and illustration below.

IMPORTANT: ALWAYS replace the small vacuum pump o-ring as it is a **one-time use item**.

Remove the cylinder head block-off plate (or vacuum pump) following the procedure outlined in the applicable Service Manual and thoroughly clean all the machined sealing surfaces. Be sure to trim away any sealant which may have squeezed out during installation of the intake cam cap onto the cam carrier. Apply ThreeBond 1217H (SOA868V9610) sealant as shown in the reference illustrations below.
