## TECHNICAL SERVICE BULLETIN Equipped With A Gas Engine - Loose/Sagging Underbody Insulator

**22-2247**  
09 August 2022

<b>Ford</b> 2017-2022 Super Duty	Gas engine
-------------------------------------	------------

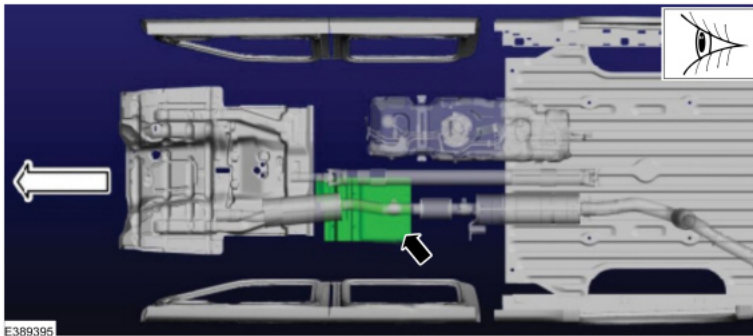
Figure 1 - Crew Cab

**NOTE:** The underbody insulator is located directly above the exhaust. The insulator is highlighted for illustration purposes only in Figures 1-2.

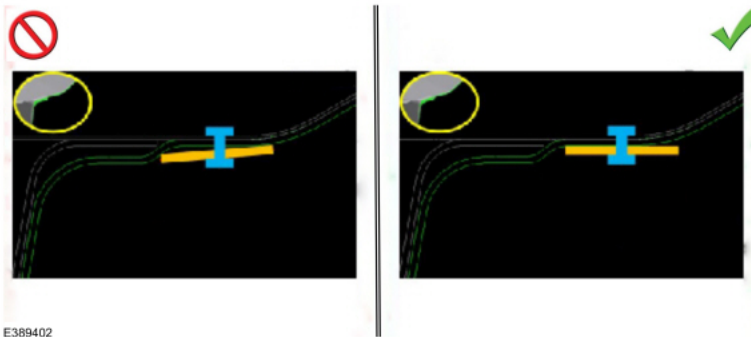
Figure 8 - Yellow line indicates the washer, blue line indicates the rivet

(1). For Super Cab vehicles with a 192 in. wheelbase, lay the washer on the flat surface and follow the dimensions as shown for the pilot hole center. Refer to Figure 8 where the yellow line is the washer and the blue line is the rivet.
