## TECHNICAL SERVICE BULLETIN

### 2020-2022 F-Super Duty - Illuminated ABS Indicator, Engine Will Not Turn Off And/Or Various Electrical Symptoms

**22-2313**

04 August  
2022

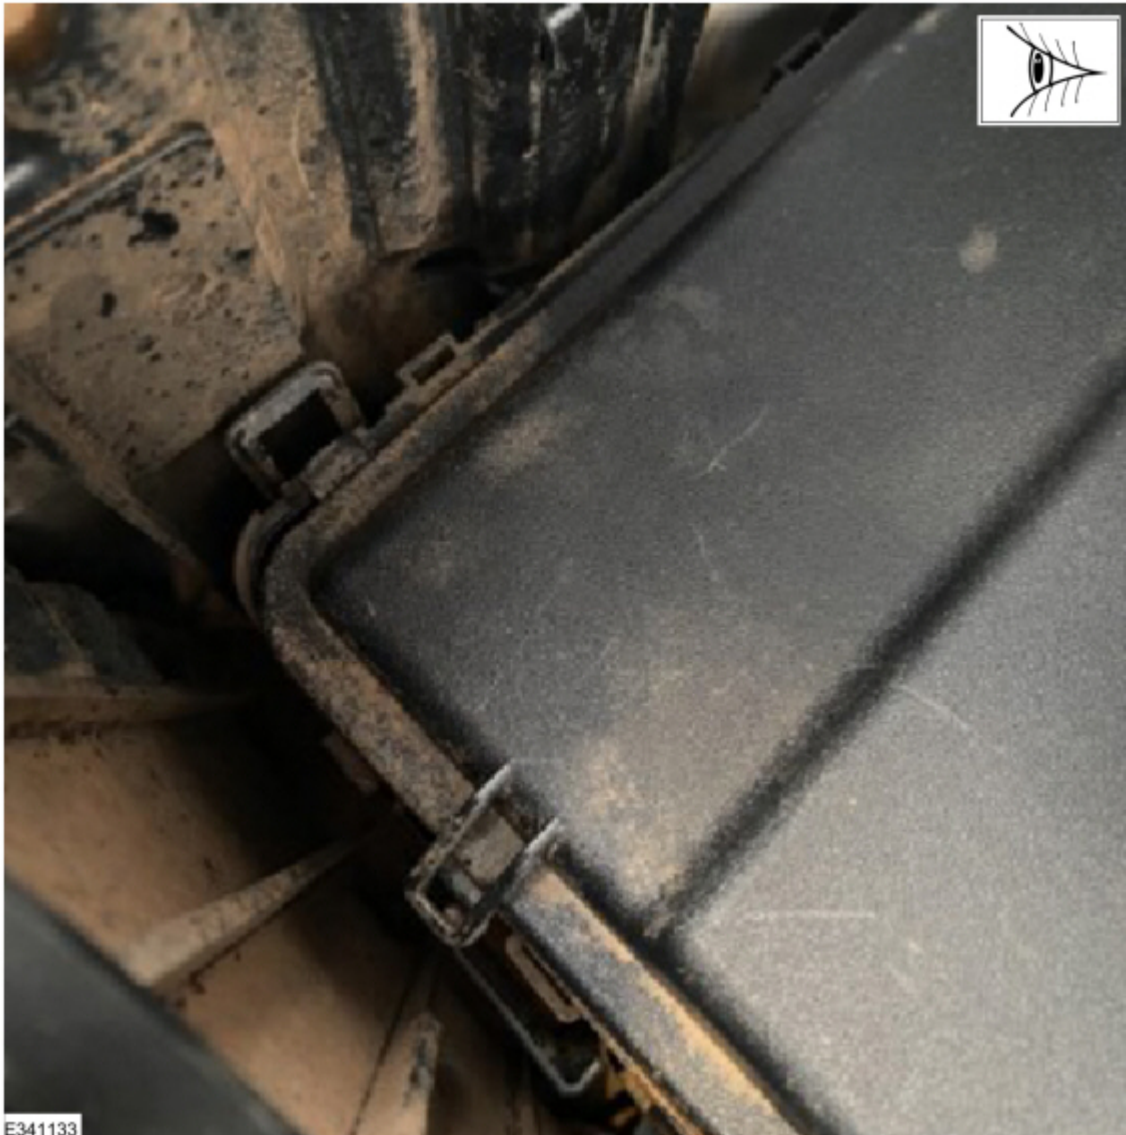
1. Visually inspect the BJB for signs of water/moisture intrusion. Are there signs of water/moisture intrusion into the BJB and/or broken cover tabs/locking fingers?

Figure 1 - Example of moisture intrusion with BJB cover on

## 2. Replace the BJB assembly.

- (1). Remove the battery and battery tray. Refer to the Workshop Manual, Section 414-01.
- (2). Remove the BJB cover.
- (3). Loosen the two BJB connector bolts and remove the battery power cable nut. Disconnect the battery power cable from the BJB.

- (4). Release the BJB from the two locking tabs on each side of the BJB.
- (5). Lift the BJB to allow access to both BJB connectors. Disconnect both connectors and remove the BJB.

- (6). Remove the cover from the new BJB and connect both connectors to the new BJB.
- (7). Install the new BJB into both locking tabs.
- (8). Attach the battery power cable and tighten the battery power cable nut to 10.5 Nm (93 lb-in). Tighten the connector bolts to 5.4 Nm (48 lb-in).

- (9). Install the new BJB cover making sure the cover tabs/locking fingers are installed correctly.
- (10). Install the battery tray and battery back into the vehicle. Refer to WSM, Section 414-01.
