# TECHNICAL SERVICE BULLETIN

## Tailgate Snap, Click, And/Or Pop Noise When Closing

**22-2327**

<b>Ford</b> 2021-2022 F-150
--------------------------------

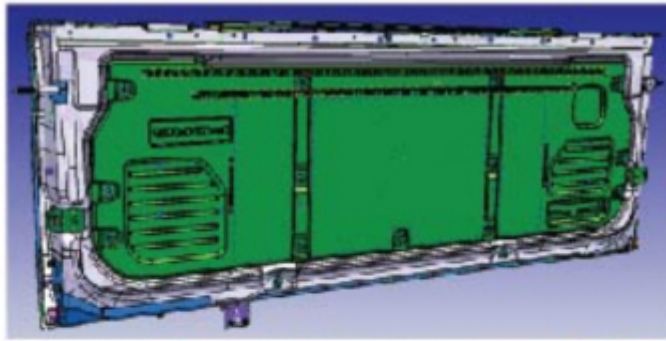
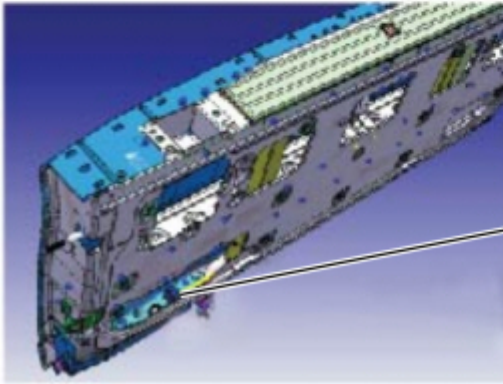
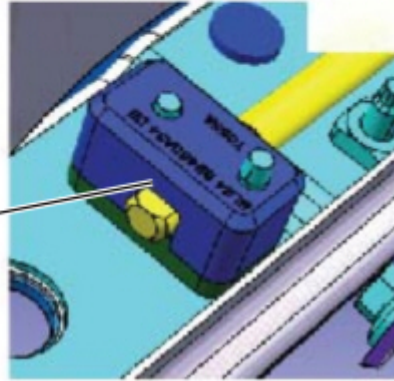
Figure 1

1. Remove the tailgate. Refer to Workshop Manual (WSM), Section 501-04 > Pickup Bed and Platform Body.
2. Remove the tailgate panel. Refer to WSM, Section 501-04 Pickup Bed and Platform Body > Power Tailgate Motor > Step 2.
3. If equipped, reposition the power tailgate motor to gain visual access to the torsion rod and clamp block. Refer to WSM, Section 501-04 Pickup Bed and Platform Body > Power Tailgate Motor.
4. Visually inspect the tailgate torsion rod and clamp block interface. (Figure 1) Is there a gap between the blocks? (Figure 2)

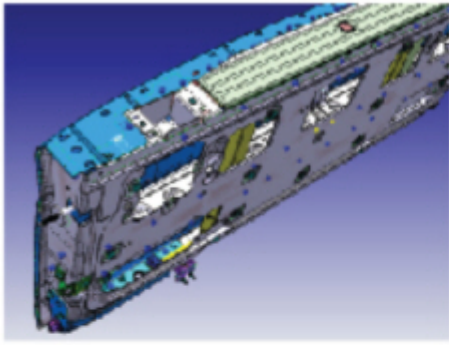
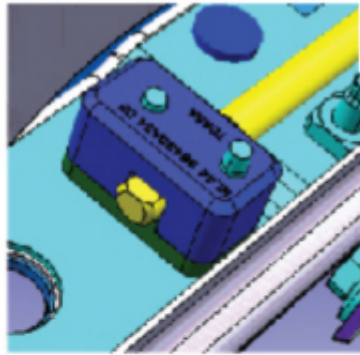
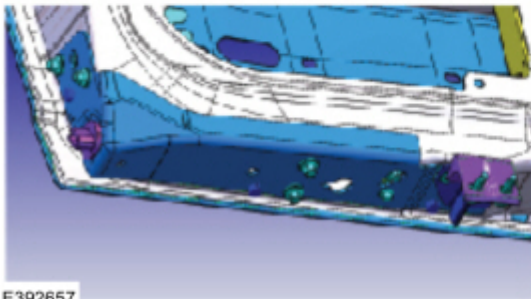
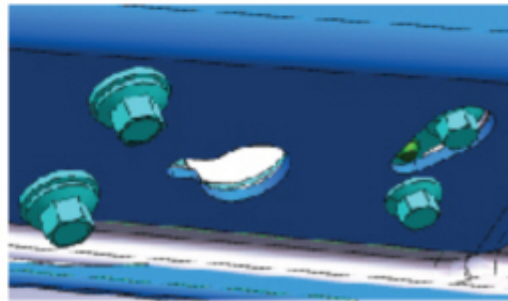
Figure 3

**5.** Verify the tailgate torsion rod is correctly aligned in the clamp block and the bolts are properly tightened. (Figure 3)

- (1). Loosen or remove the shorter bolt.
- (2). Loosen the longer bolt 1-2 rotations (as little as possible) to allow the tailgate torsion rod to rotate.
- (3). Rotate the tailgate torsion rod to verify the machine flat on the rod properly aligns with the top block (flat) mating surface. (Figure 4)
