# Service Bulletin

Bulletin No.: 22-NA-067

**Subject: Poor Engine Performance in Extremely Cold Weather Conditions, PCV Bypass Hose and Charge Air Cooler Icing for LUV Engines, Malfunction Indicator Lamp (MIL) Illuminated - DTC P0299, P0234, P0236, P2261, P2227, P00C7 Set**

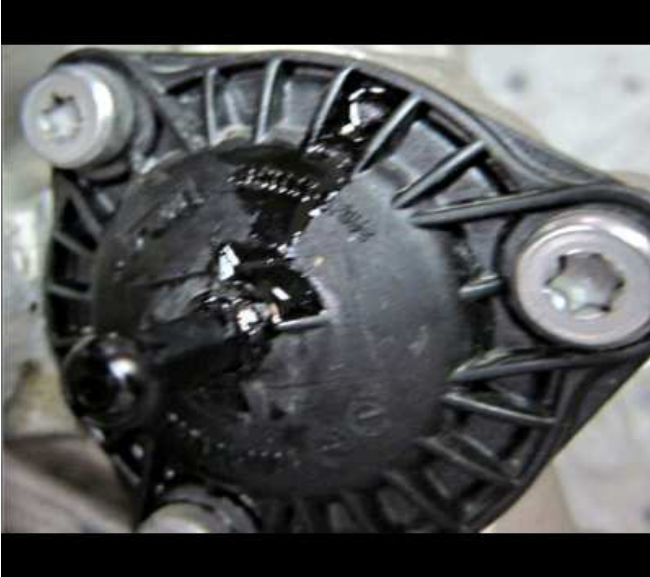
5590615

1. Inspect the charge air bypass valve for ice/oil/water/sludge build-up in the vacuum side port.

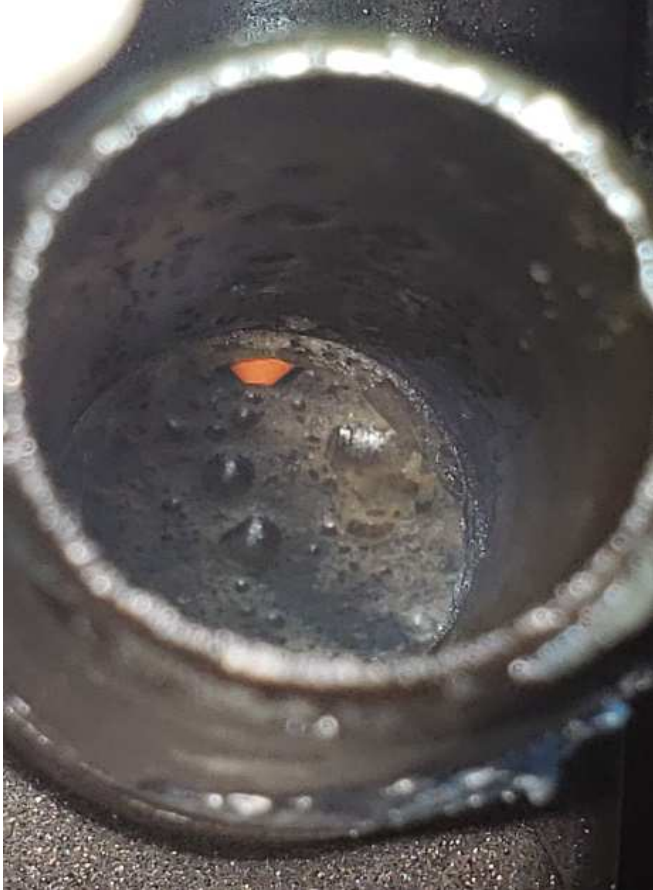
5286434

3. Inspect the vacuum ports of the intake manifold for ice/water/oil accumulation.

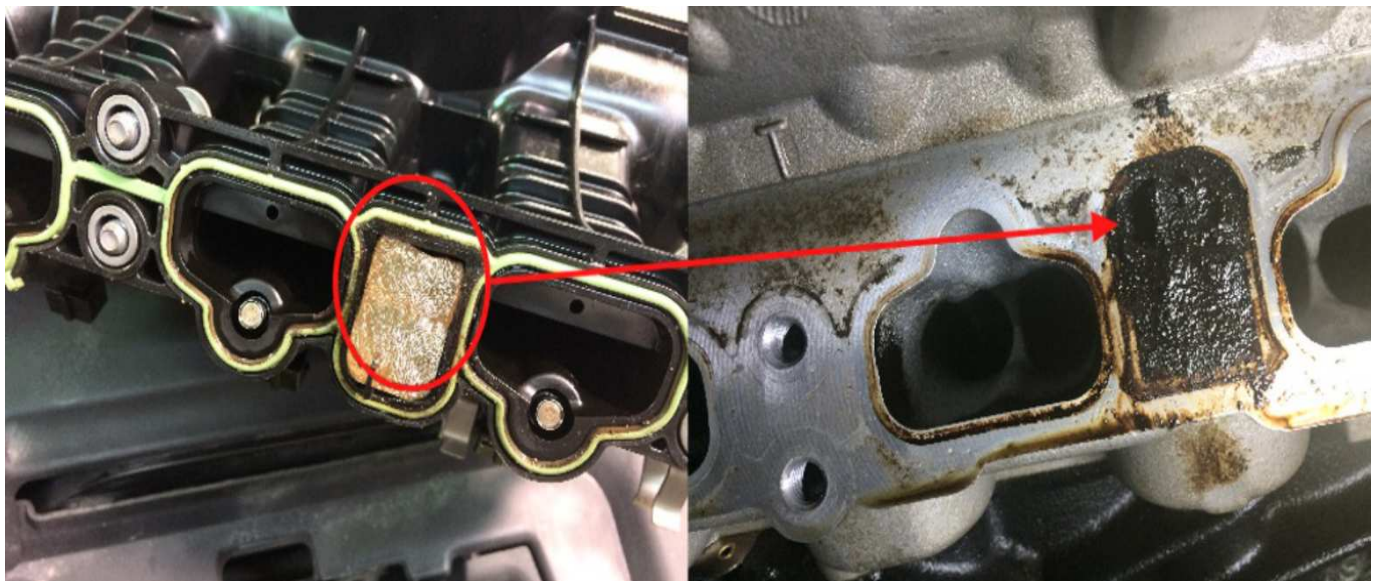
5286457

4. Inspect the PCV intake runner for ice build-up blocking the cylinder head as shown above.

If above condition exists, then replace the intake manifold. Refer to *Intake Manifold Replacement* in SI.
