Service Bulletin

Bulletin No.: 18-NA-020

Subject: Malfunction Indicator Lamp Illuminated with DTCs P0300, P0299, P0234 and/or P2227 Set

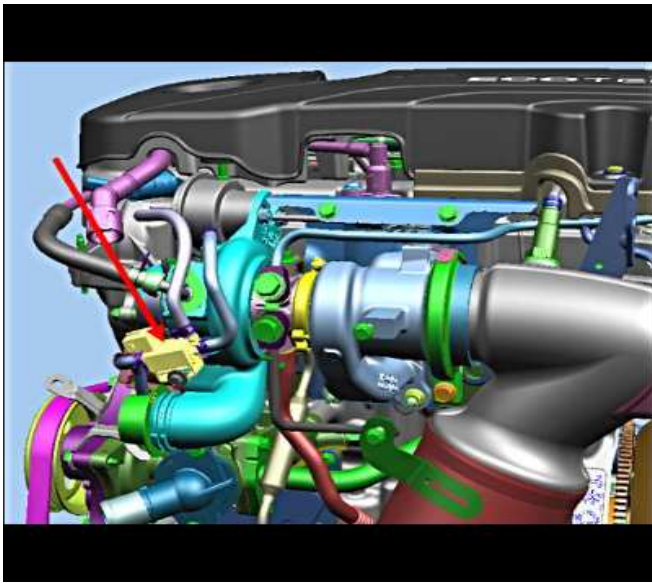
6055063

Inspect the Turbocharger Control Valve (TCV) to ensure it is not frozen.

1. Remove Turbocharger Wastegate Regulator Solenoid Valve.
2. Drain Turbocharger Wastegate Regulator Solenoid Valve (TCV) by turning valve upside down.

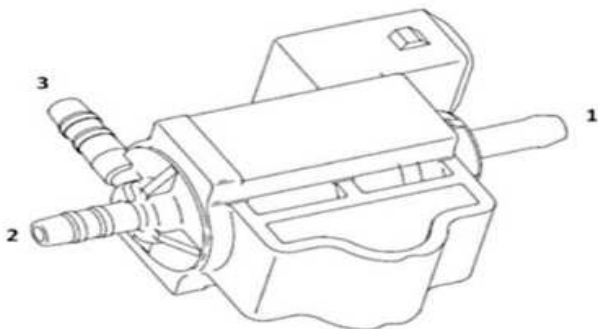
6055068

Note: Check port #2 to assure the spring gets lifted off the seat. This will be determined by the compressed air not dead heading when applied to port #2. When applying air to this port a small amount of air should be observed at port #3 and even less air will be noticed at port #1. If this does not happen, the TCV plunger may have hardened deposits from hot operating conditions which will impede TCV plunger movement, and the Turbocharger Wastegate Regulator Solenoid Valve should be replaced.

3. Using clean shop air regulated to 80-100 PSI (551-689 kPa), blow through all three ports (1, 2 & 3) for 5 seconds each. Repeat this step twice.
