Service Bulletin

Bulletin No.: 22-NA-151

Subject: DTC P0BBD Diagnosis and Repair

Brand:	Model:	Model Year:		VIN:		Engino	Transmission:
		from	to	from	to	Engine:	Transmission.
Chevrolet	Bolt EV	2017	2019	_	_	_	_
		2022	2022				
	Bolt EUV	2022	2022

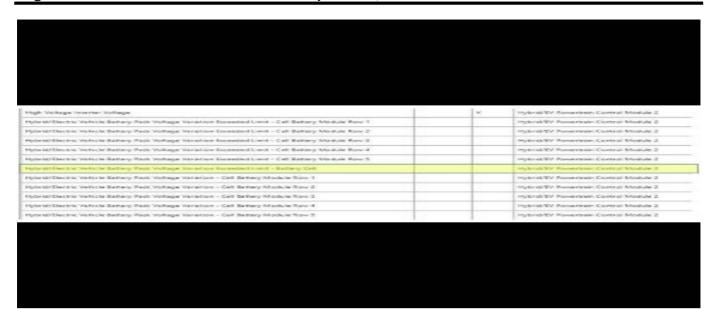
6124692

Use GDS2 to observe the following data parameter: Hybrid/Electric Vehicle Battery Pack Voltage Variation Exceeded Limit - Battery Cell

This parameter is available in GDS2 by navigating to: Module Dlagnosis —> K114B Hybrid/EV Powertrain Control Module 2 —> Data Display Folder —> Data Display Icon —> Voltage Data

- If the parameter Hybrid/Electric Vehicle Battery Pack Voltage Variation Exceeded Limit — Battery Cell reads cell number 40, 67, or 87, then it is suspected that the customer drives in a way that may set P0BBD without an actual battery cell problem. The K114B Hybrid/EV Powertrain Control Module 2 will need to be reprogrammed to solve this condition.
 - If field action N222369400, N212343881, N212343882, N212345750, N222369401, N212345941, or N212345943 are open for the vehicle being repaired, perform the applicable field action, which includes programming of the HPCM2. If none of these field actions are open, refer to K114B Hybrid/EV Powertrain Control Module 2: Programming and Setup in SI.

2. If the value in GDS2 is any other cell number, then proceed with a pack replacement. If N212343881, N212345941, N212345943 or N212343882 is open, perform that field action. If those field actions are closed, follow the battery exchange bulletin
