SERVICE BULLETIN

APPLICABILITY: 2020-2022 Outback & Legacy **NUMBER:** 15-270-20R
SUBJECT: FOTA (Firmware Over-The-Air) Reprogramming for DENSO Gen 4 Audio / Navigation Infotainment Systems **DATE:** 8/19/2020
REVISED: 08/02/2022

INTRODUCTION:

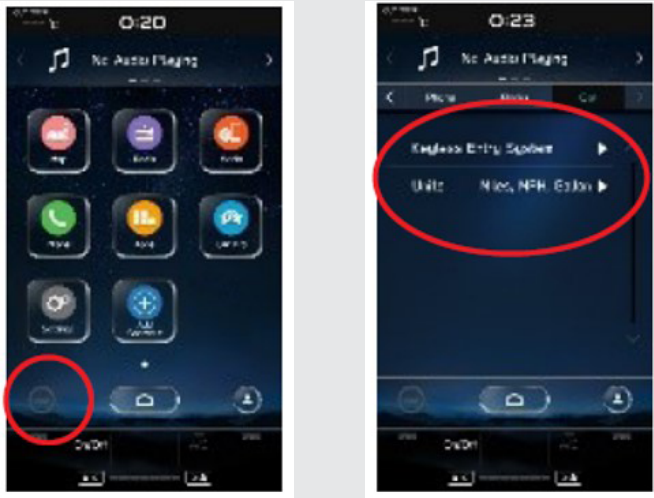
8	<p>Vehicle Setting Icon in <Home> menu is grayed out. Menu list in the “Car” tab in the Setting Menu is not displayed.</p>

USB ONLY
9	<p>Incorrect translation for X-Mode in Spanish language</p>	USB ONLY

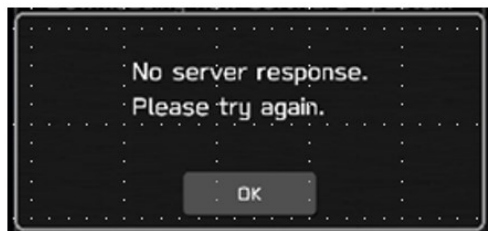
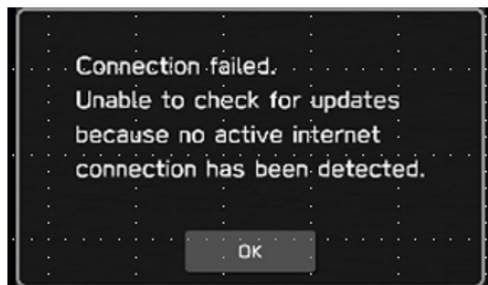
2. If you receive one of the following two messages during the update process:

Tips:

- a. Check the internet connection to ensure it is active and shows full signal strength.
 - i. Select General tab under “Setting” screen and change the “Wi-Fi” to Off once then turn it back to On again.

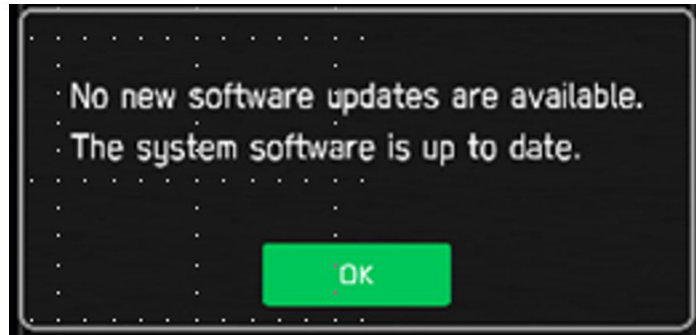
3. If the system says I'm up to date when checking for updates:

Tips:

- a. If current software version is the latest, you don't need an update and no action is necessary.
- b. If the software version is not the latest, you are likely not eligible for FOTA update at this time. Please proceed with USB update following TSB 15-261-20.

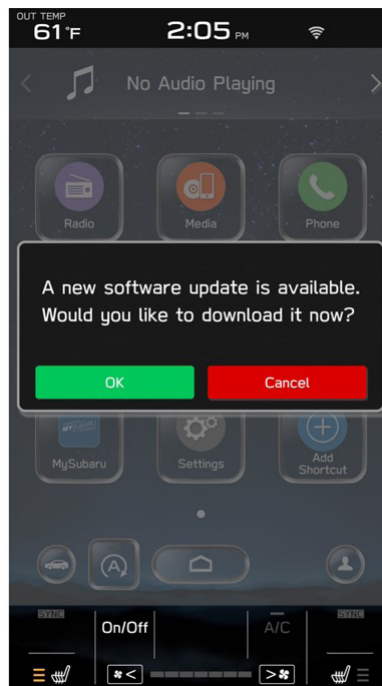
4. If the "OK" button does not respond when I begin the update process:

a. If CarPlay application is running at the time the pop-up screen comes up, the screen is being disabled for OK operation. Please press the home button on the display, go to Settings, Software Updates, Update, and begin again.

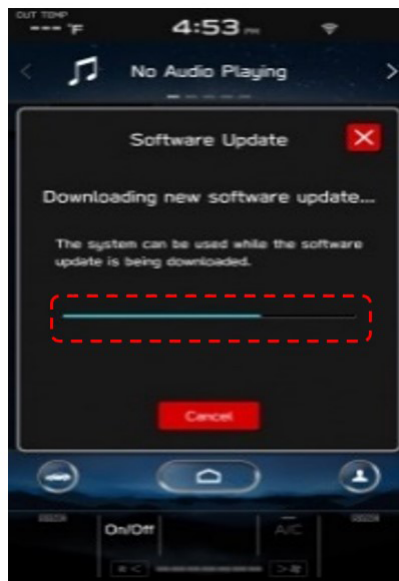
5. If the “progress bar” does not progress after selecting “Download” or, if you receive a “Connect to Wi-Fi” popup while downloading:

Tips:

a. Check your internet connection to ensure its active and shows full bars of connectivity.

- b. Try moving the vehicle closer to the Wi-Fi source. If that is not possible, try a different Wi-Fi connection such as a phone hotspot.

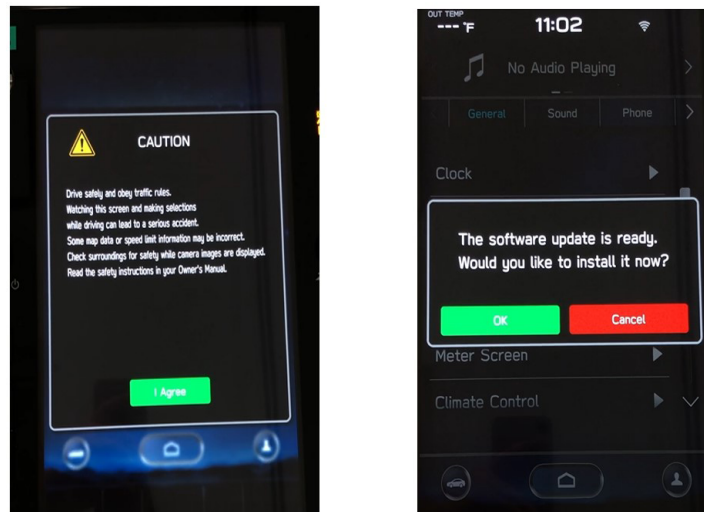
6. If you encounter a blank screen and the update restarts during the installation process:

Tips:

- a. If the display screen goes blank during the installation process, leave the vehicle on and allow the system to restart. After up to two minutes, you will receive the message: “The software update is ready. Would you like to install it now?”. Press OK to continue.

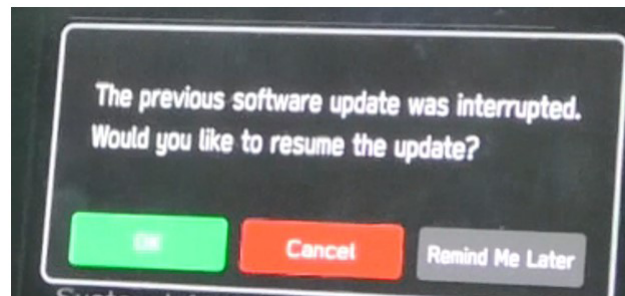
7. If you receive the following message during the update:

- a. The above message will display if the vehicle is turned off during the software update process. Select “OK” to resume the process.
