**SERVICE BULLETIN**

**APPLICABILITY:** 2017-18MY Impreza  
 2018MY Crosstrek  
 2018MY Legacy and Outback  
 2018MY BRZ\*

**NUMBER:** 15-211-17R  
**DATE:** 06/13/17  
**REVISED:** 08/12/22

**SUBJECT:** Reprogramming File Availability for Additional Optimization of Harman Gen 3 Audio and Navigation Head Units

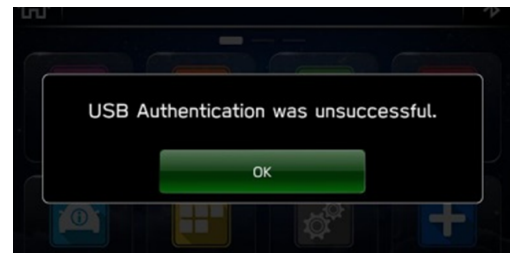
**CAUTION: NEVER** attempt to install this software on any 2019 MY vehicles as they are equipped with Gen 3.1 Audio/ Navigation systems. This update is **ONLY** for models equipped with Gen 3.0 Audio/ Navigation systems. Should an attempt be made to install any of these files into a Gen 3.1 head unit, the authentication error screen to the right will be displayed.

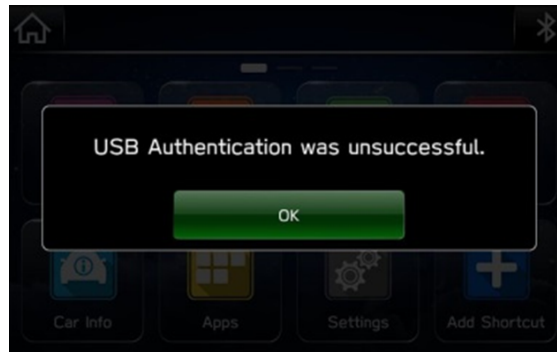
**NOTE:** If an attempt is made to install the wrong “grade” file into the wrong grade head unit (EXAMPLE: “Base” update file into a “Mid” or “High” head unit), the USB Authentication error screen below will be displayed:

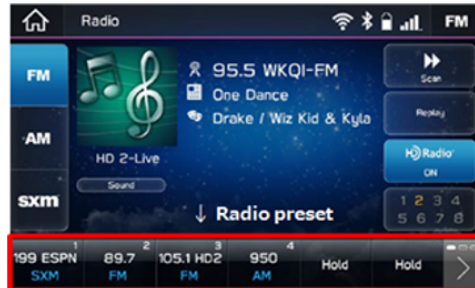
- Update to address some or all AM/FM station presets becoming lost and replaced by “Hold”

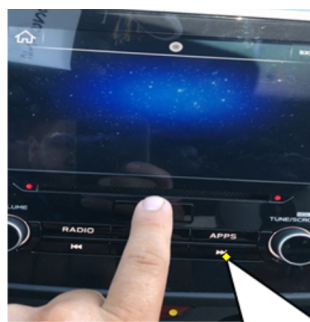
**Background shown, but no icons**

- On 2018MY Legacy / Outback models with Navigation (High) head units, the update corrects a condition where the head unit remains powered even after the ignition is OFF and the driver door is opened.
- Update for a condition where the SXM presets become lost and only “Initializing” appears as shown below.
- Update for condition where only the star field background is displayed (without icons) after the HOME button is pressed.

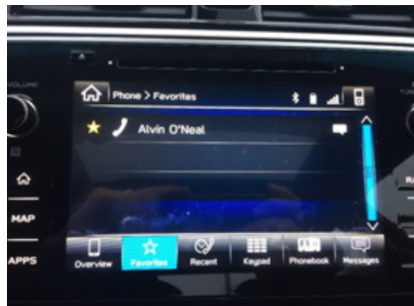
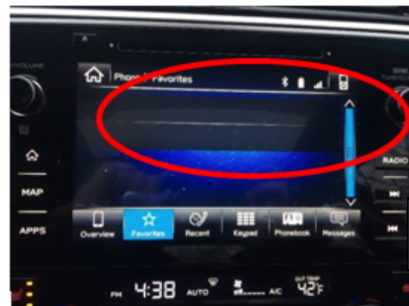
**List is blank**

- Update for a “Pop” or “Crackling“ sound concern when listening to AM radio.
- Update for a concern of the head unit continually resetting itself.
- Update for a concern of after selecting a contact to be a “Favorite” and the “Favorite” list display is blank.

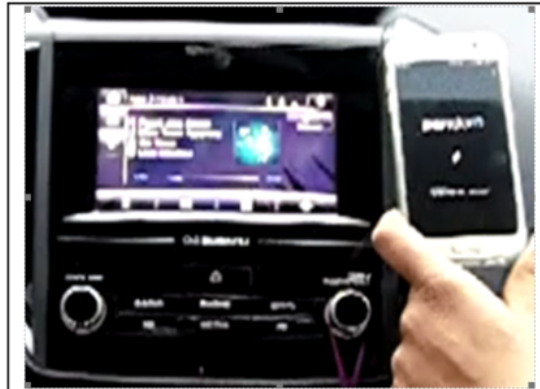
- 1- No streaming audio; when using the Pandora® app, there is no audio output.

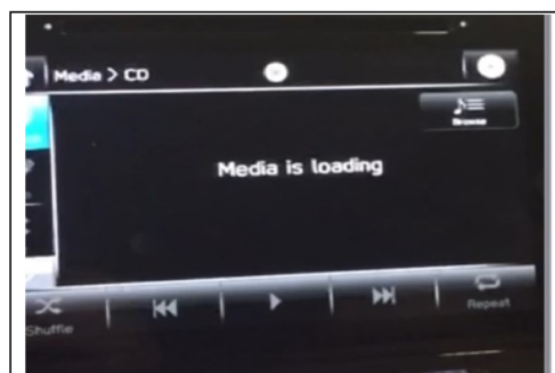
- 2- “Media is loading” is displayed on the screen but, the media never completes loading.

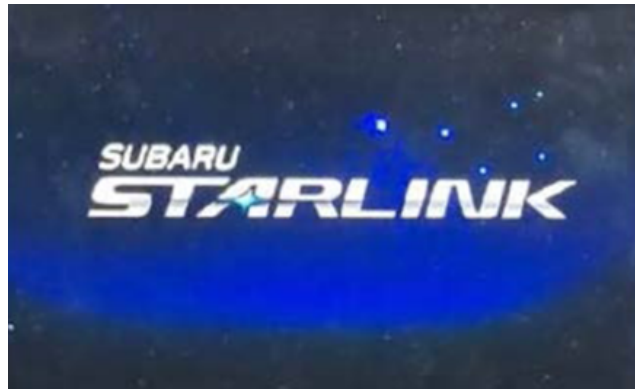
- 3- The screen freezes when the STARLINK screen is displayed.

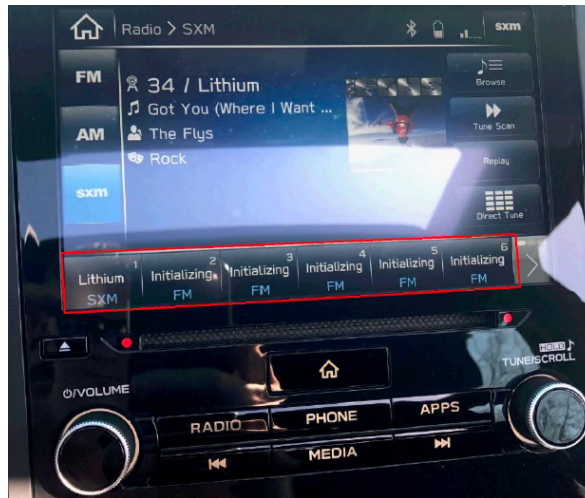
- 1- Radio station presets disappear (touch screen buttons return to “Initializing”).

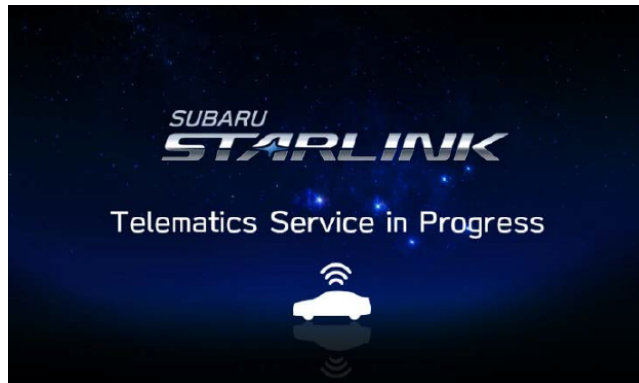
- 2- STARLINK “Telematics Service in Progress” screen freezes.

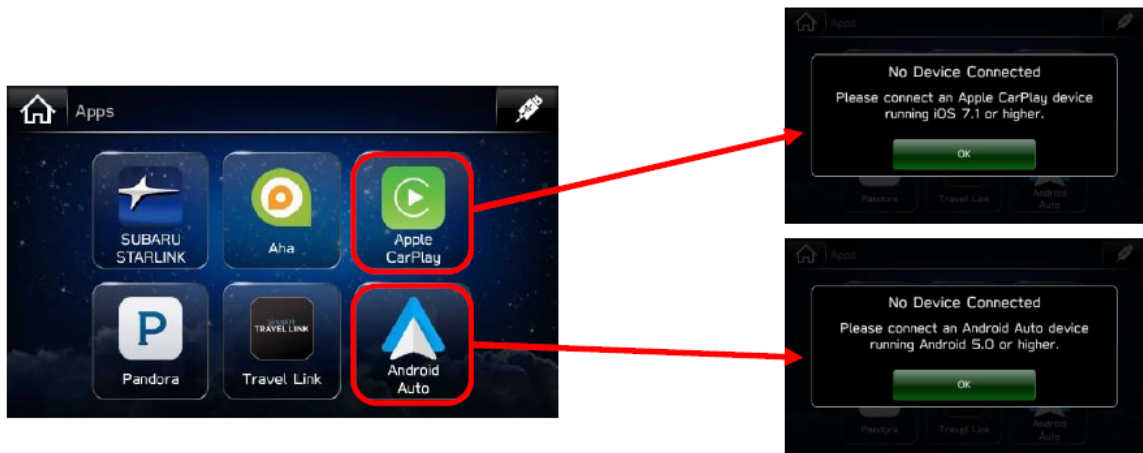
3- Apple Car Play / Android Auto function does not operate (“No Device Connected”).

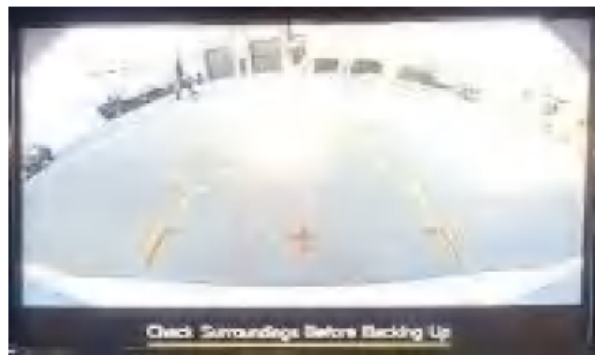
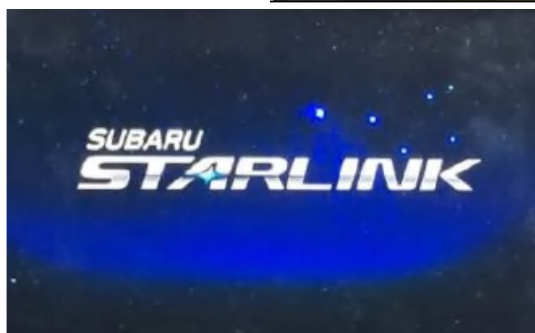
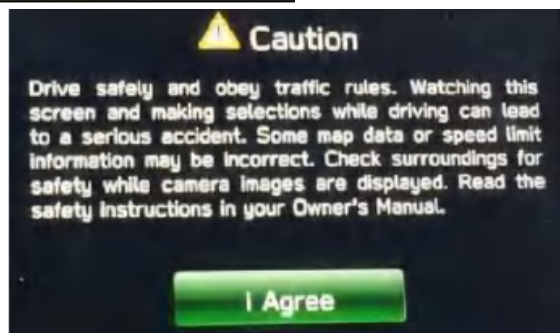
For reference, the previously released WTN-74R symptoms are also provided below. The main purpose of WTN-74R was to address display screen freeze-up during Back-Up Camera display (when the shifter is in “R”). In addition, the screen may also freeze when either the Subaru STARLINK or Disclaimer Caution / I Agree screen is displayed.

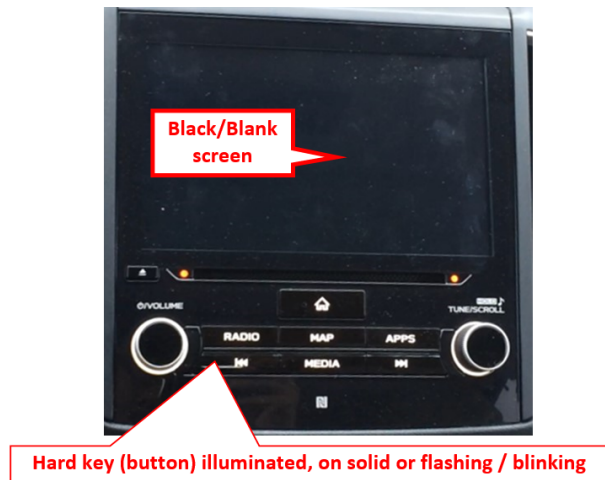
- 1) After switching the vehicle (ACC or IGN) on, the display screen goes black with no audio output and the hard key buttons are illuminated (on solid, or flashing / blinking).

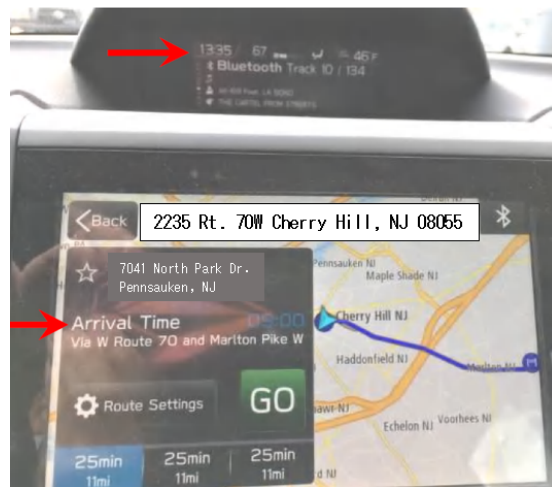
- 2) Time of day displayed in the MFD is incorrect and the arrival time displayed in Navigation unit is also incorrect.

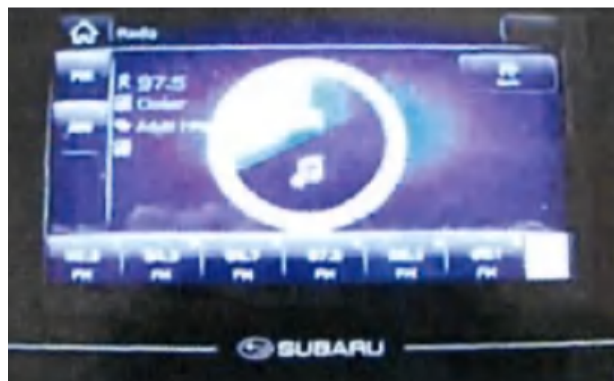
- 3) The time in the MFD automatically reverts to a “default” setting, even after setting the time using “Manual” mode.
- 4) Audio volume goes to maximum automatically after one click of the volume up button on the steering wheel. In some cases, this condition may also occur without input from the operator. Maximum volume is also displayed on the screen.
