SERVICE BULLETIN

APPLICABILITY: 2019-22MY Impreza
 2019-22MY Crosstrek (Including Hybrid Model)
 2019-22MY Forester
 2019MY Legacy/ Outback
 2019-21MY WRX
 2019-21MY WRX STI
 2019-21MY BRZ- Navigation -equipped ONLY
 2019-22MY Ascent

NUMBER: 15-236-18R

SUBJECT: Reprogramming File Availability for Optimization of Harman Gen 3.1 and Gen 3.1α Audio and Navigation Head Units

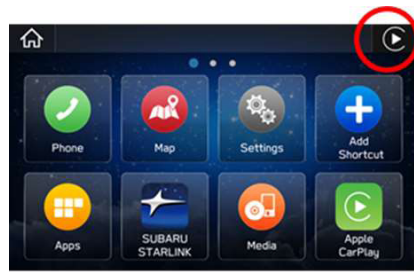
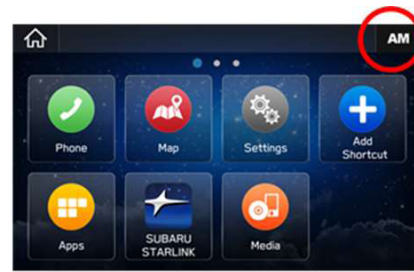
On Ver. 6.0 and before:

Music playing via iPhone in CarPlay.

After disconnecting, the music source changes to Radio automatically.

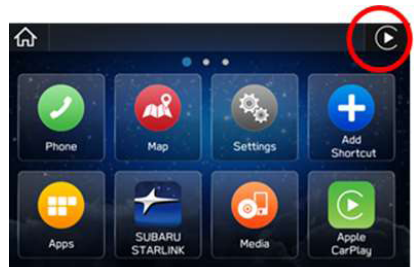
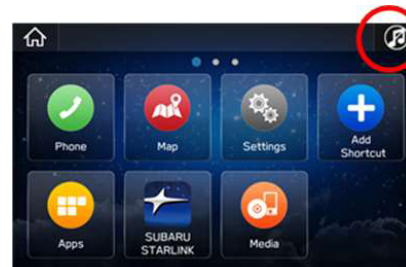
Music playing via iPhone in CarPlay.

After disconnecting, no music source is selected automatically.

If a source of music other than CarPlay has been playing when the iPhone is disconnected, the music source remains same (it is not turned off.)

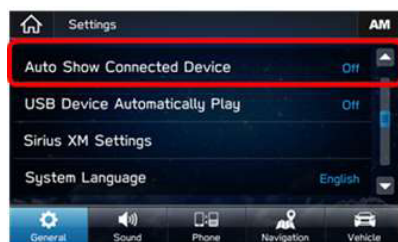
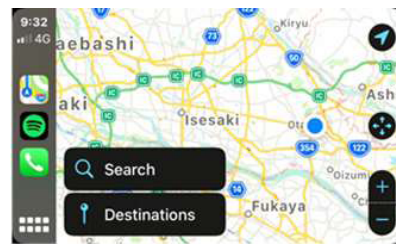
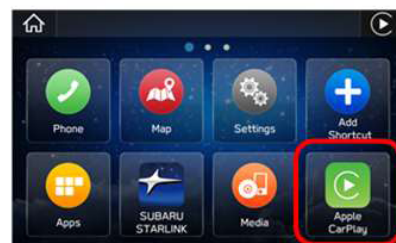
In a case where the iPhone was disconnected while playing music then reconnected while it is playing music, the system moves to CarPlay screen no matter what is set in <Auto Show Connected Device> in Setting (depending on iOS version of the iPhone.)

Move to CarPlay.

Move to HOME and CarPlay icon is displayed.

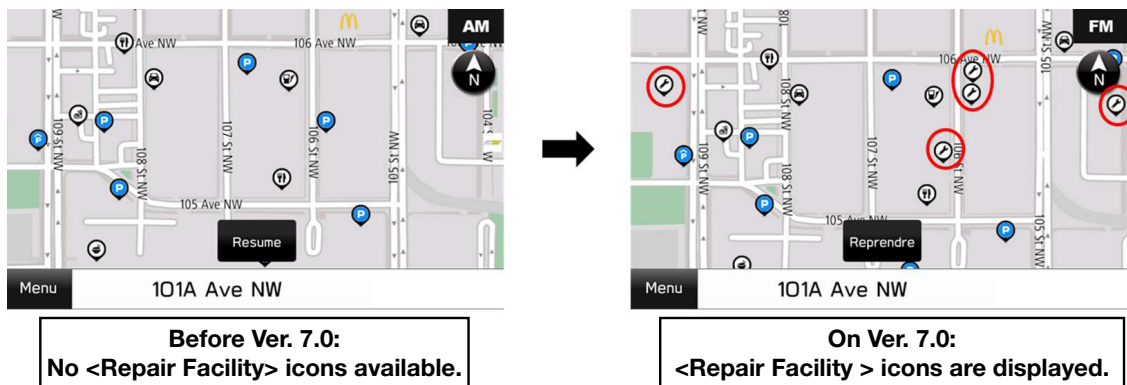
NOTE 4: Displaying Repair Facility POI icons:

<Repair Facility> Icons can be displayed in the NAVI Map.

<Repair Facility> Icons can be turned On or OFF by going to: Settings > Navigation > POI Icons.

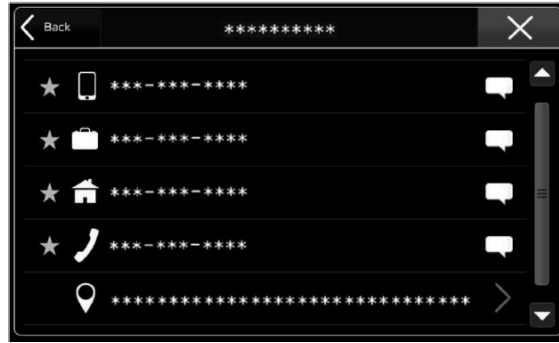
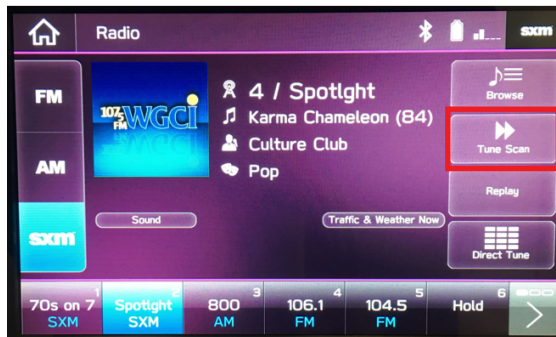
<Scan> previously displayed on SXM screen was changed to <Tune Scan> (a.k.a. SEEK).

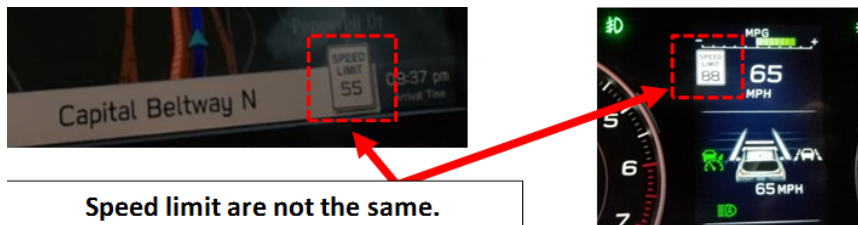
12) Mismatch of Speed Limit between Navigation display and the Speed Limit displayed in the Combination Meter Multi-Function Display (MFD).

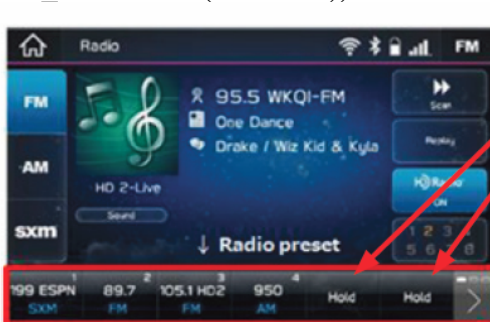
1) Station presets are lost. Touch buttons read “Hold”. (Applicable for software versions Rel_4.18.25.50 (or before)). Included in software version Rel_U1.18.38.50.
