## SERVICE BULLETIN

**APPLICABILITY:** 2022MY Forester

**NUMBER:** 07-209-22R

**SUBJECT:** EyeSight® Reprogramming  
DTC B28A6 Internal Stereo Camera  
Communication 1

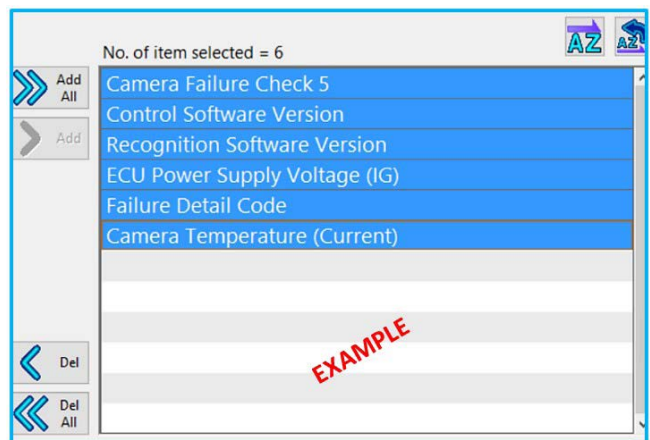
**STEP 1:** Confirm the EyeSight® Stereo Camera assembly is suitable for reprogramming. Using the Data Monitor feature within SSM, select the following signal items.

- 1. Camera Failure 5
- 2. Control Software Version
- 3. Recognition Software Version
- 4. ECU power Supply Voltage (IG)
- 5. Failure Detail Code
- 6. Camera Temperature

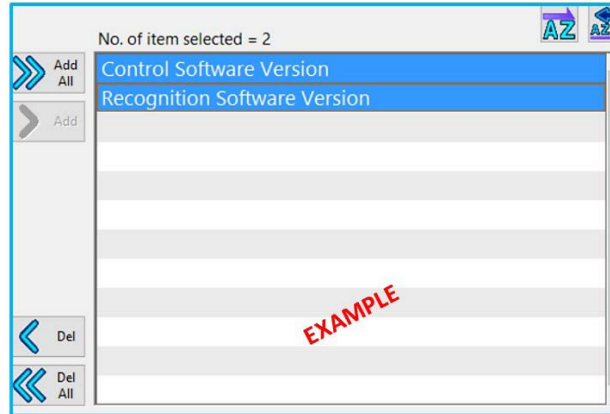
**STEP 1:** Confirm the EyeSight® Stereo Camera assembly reprogramming has been performed **SUCCESSFULLY**. Using the Data Monitor feature within SSM, select the following signal items.

- 7. Control Software Version
- 8. Recognition Software Version

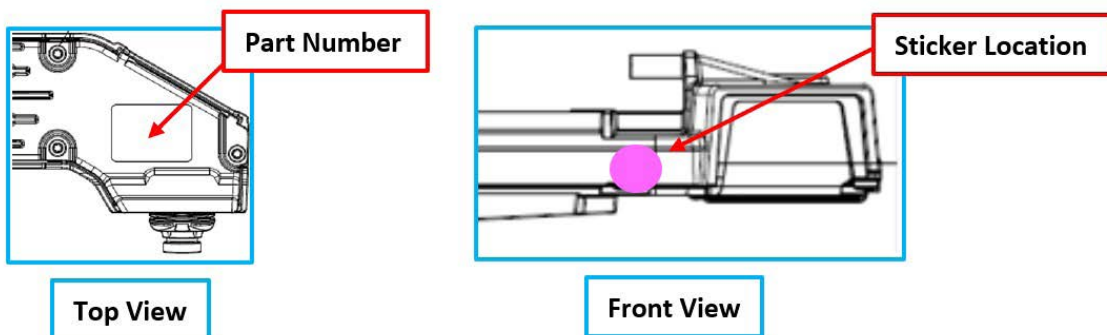
If EyeSight® Stereo Camera assembly replacement is required for any reason, it is important to confirm the replacement parts contain the updated software. This can be confirmed by the pink colored sticker located on the camera assembly. If the sticker is present, the software has been updated.
