SERVICE INFORMATION BULLETIN

APPLICABILITY: 2020-2021MY Outback
 2019-2021MY Forester
 2019-2021MY Ascent

NUMBER: 07-199-21R

SUBJECT: Measurement of Dark Current
 (Standby Current Draw)

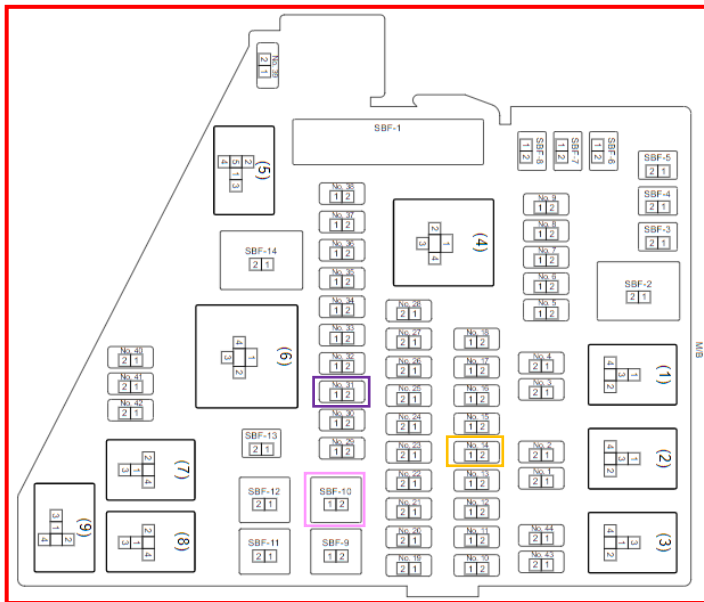
Ascent & Forester

VDC Fuse

Fuse No.31

SBF No.10

Power Rear Gate Fuse

Fuse No.14

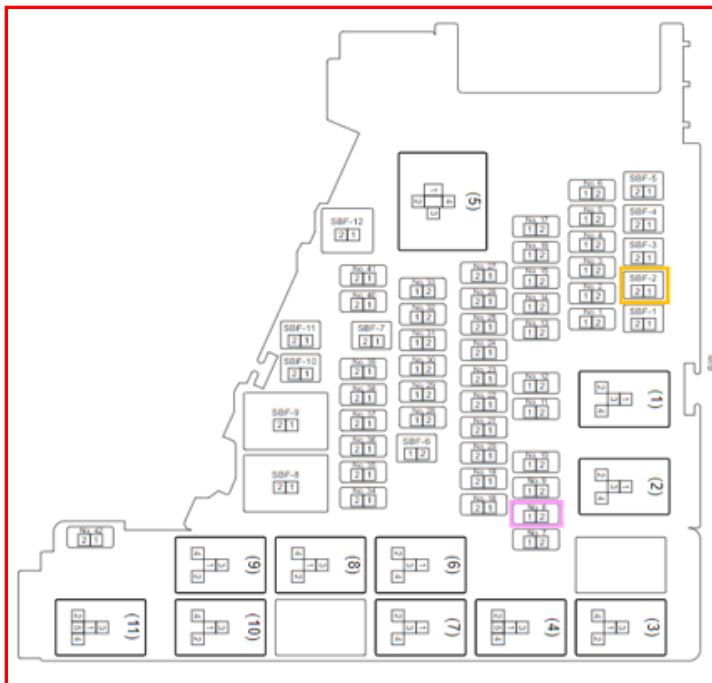
Outback

VDC Fuse

Fuse No.8

Power Rear Gate Fuse

SBF No.2

Fuse No.37

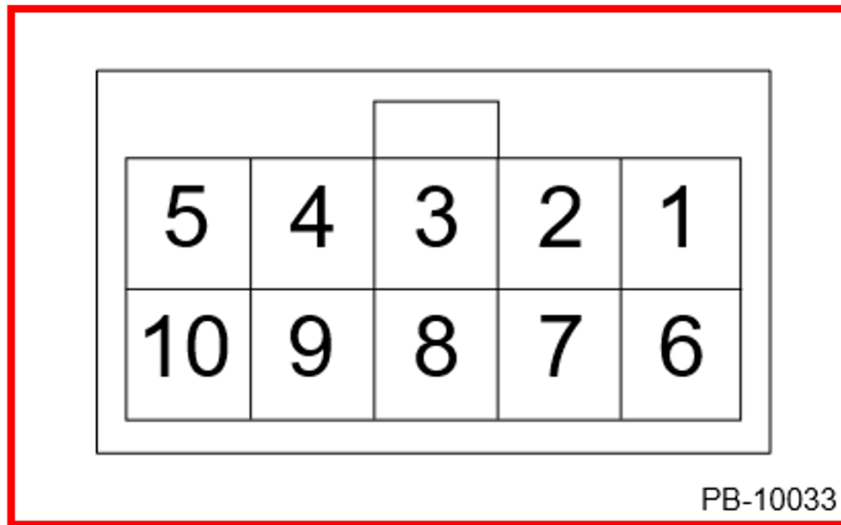
NOTE 2) How to check resistance between EPB switch terminals.

- Confirm the ignition is switch OFF:
- Disconnect the EPB switch connector, and check if Dark Current decreases. If Dark Current decreases by disconnecting the EPB switch connector, replace EPB switch and continue diagnosis.
- Check resistance between terminals per the illustrations below.

Switch Position	Terminal No.	Standard
Neutral	1-2	1MΩ and higher
	4-5	
	1-5	Less than 1Ω
	2-4

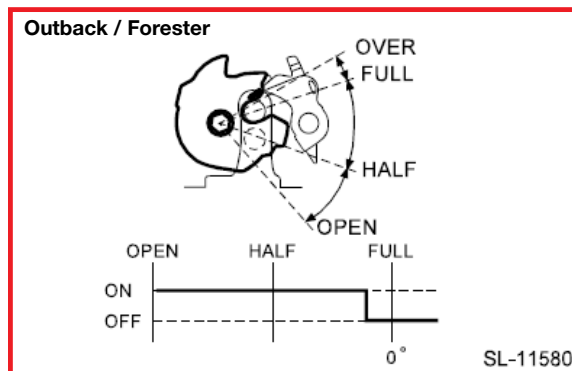
NOTE 5) How to check resistance between terminals for Courtesy Switch.

- Check the resistance between the terminals specified in the charts below.

Terminal No.	Inspection Conditions	Specification
7 to 8	Open	Less Than 1 Ω
7 to 8	Half	Less Than 1 Ω
7 to 8	Full	1MΩ or More
