Service Bulletin

Bulletin No.: 22-NA-179

Subject: Right Rear Door Alignment

Brand:	Model:	Model Year:		VIN:		Engine:	Transmission:
		from	to	from	to		
Cadillac	Escalade Models	2021	2023				
Chevrolet	Suburban Tahoe Models						
GMC	Yukon Models

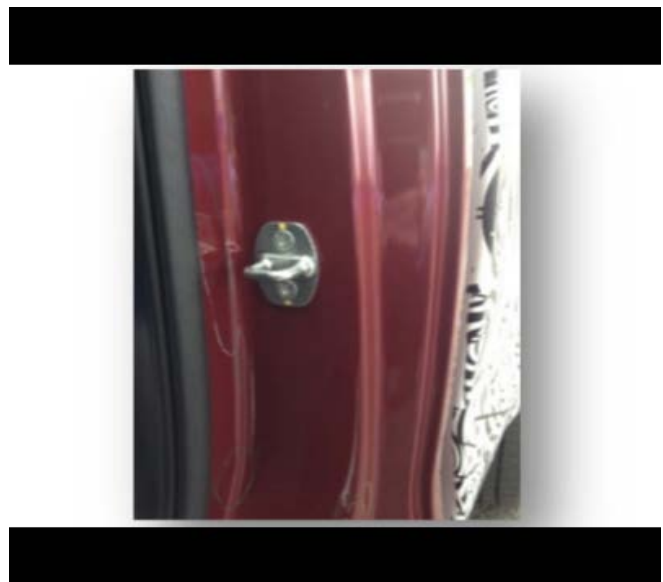
6146967

Involved Region or Country	U.S., Canada, Mexico, Europe, Middle East
Additional Options (RPOs)	
Condition	Some customers may comment on the right rear door not sitting flush and/or the right rear door sticks out excessively at the bottom when closed.
Cause	The cause of the condition may be the door is in need of alignment.
Correction	Use the procedure below to help correct the above conditions.

1. Open the door, get T45 bit and wrench and remove the striker on the door that can not be adjusted to spec. You need to remove the striker to gain access to the door striker net slots in the body.
