## TECHNICAL SERVICE BULLETIN

### Shift Knob Rotates Without Brake Pedal Depressed, Transmission Remains In Park (P)

**22-2343**  
19 September 2022

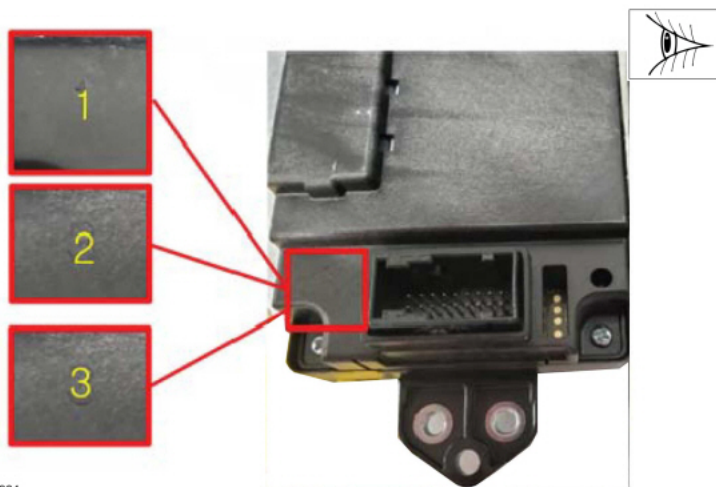
Figure 1

2. Inspect the GSM at the location identified in Figure 1.

(1). If the GSM is marked with numbers 1, 2, or 3, proceed to Step 4.

(2). If the GSM is marked with number 4 or blank, re-install GSM and proceed to Step 3.

3. Reprogram the GSM using the latest software level of the Ford Diagnostic and Repair System (FDRS). Repair is complete.

4. Replace the GSM. Follow the WSM Section 307-05.
