TECHNICAL SERVICE BULLETIN

Level 3 Charging - Illuminated Charger Service Required Indicator In The IPC And/Or Multiple DTCs

22-2355

19 September
2022

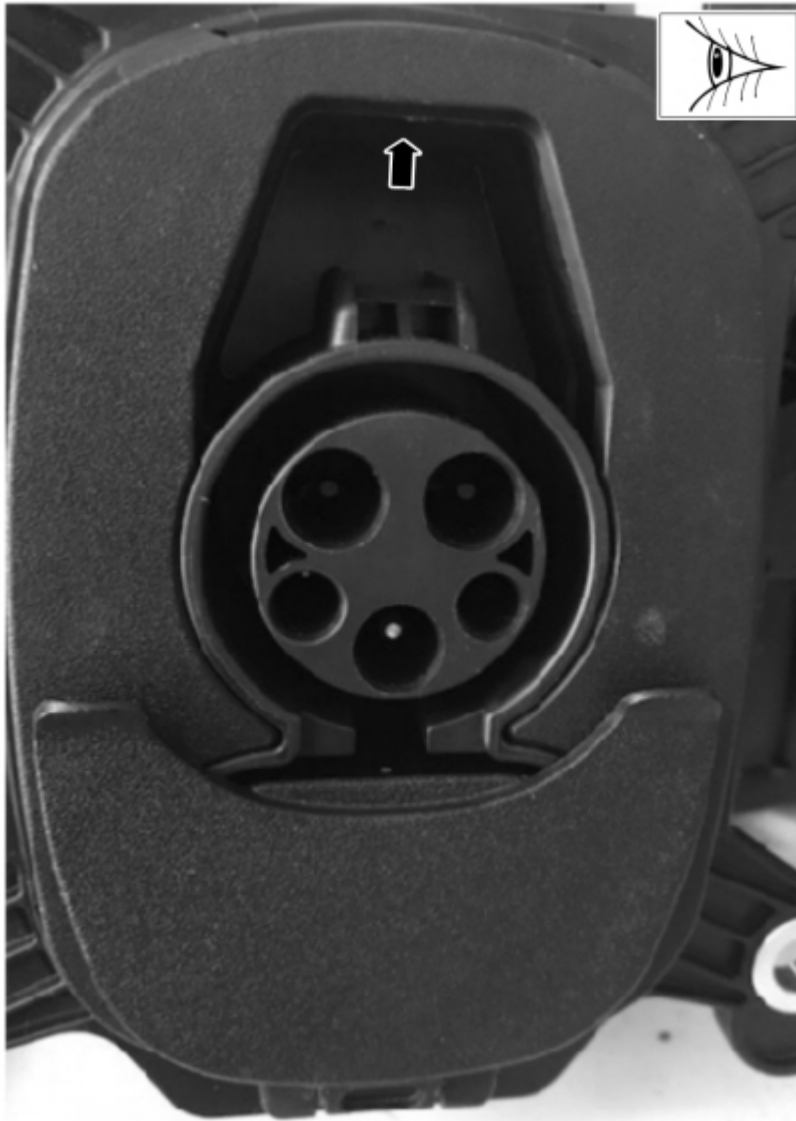
Figure 2

1. Inspect the charge port lock actuator pin. (Figure 2) Is the charge port lock actuator pin missing or loose?

- (1). Yes - proceed to Step 2.
 - (2). No - this article does not apply. Refer to Workshop Manual (WSM), Section 414-03B High Voltage Battery Charging System.
2. De-energize the high voltage system. Refer to WSM, Section 414-03A High Voltage Battery > Mounting and Cable > General Procedures.
3. Gain access to the charging port.
- (1). For e-Transit vehicles, remove the front bumper cover. Refer to WSM, Section 501-19 Front Bumper Cover > Bumpers > Disassembly and Assembly.
 - Remove the retainers and the charge port cover. (Figure 3)
