TECHNICAL SERVICE BULLETIN

Transmission Fluid Leak Due To A Cracked Transmission Case Or Transmission Fluid Pan

22-2356

Ford 2015-2019 F-Super Duty

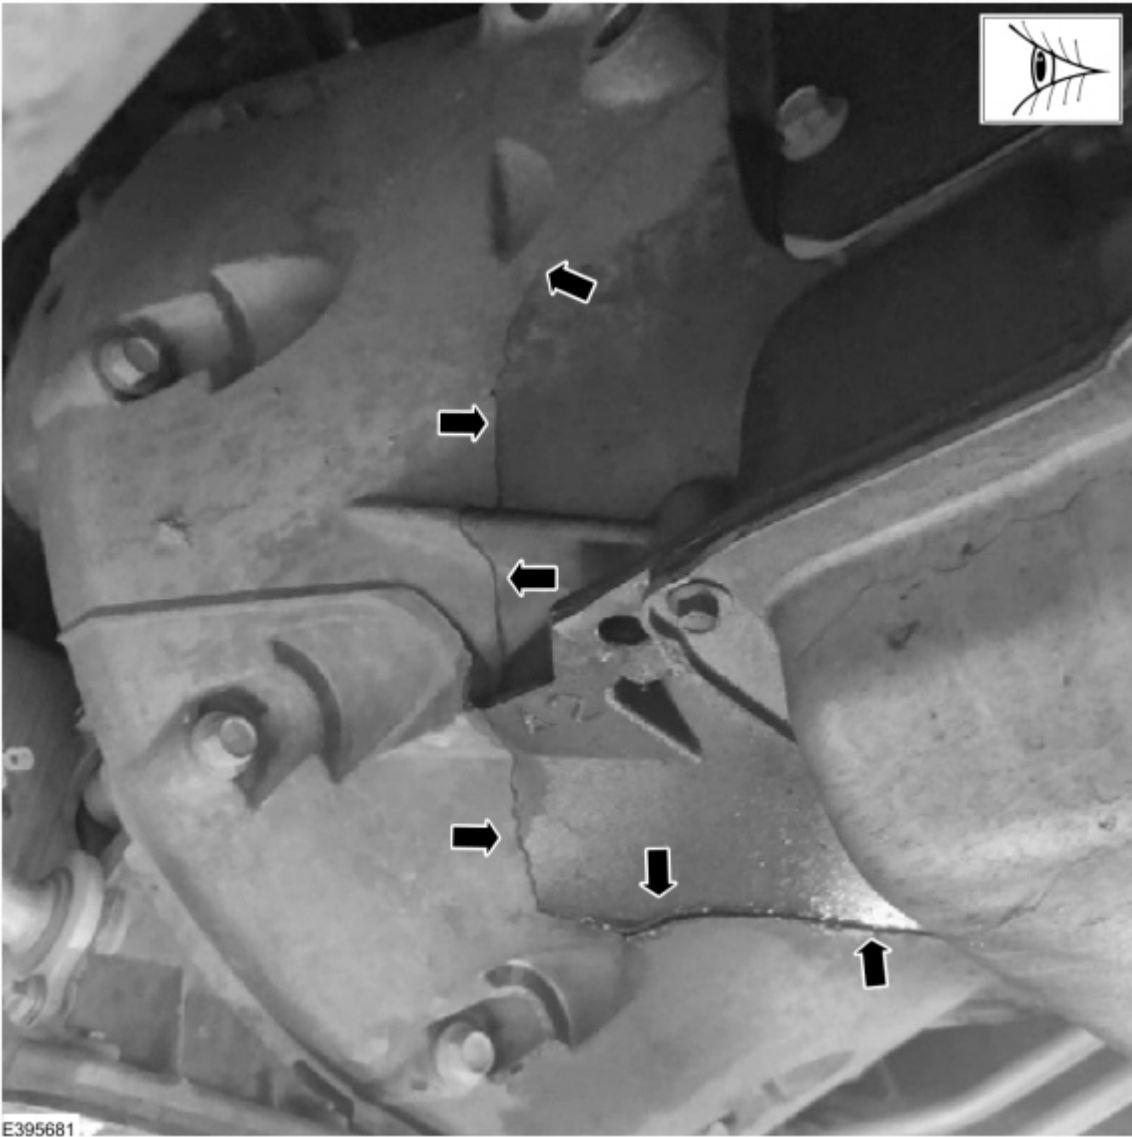
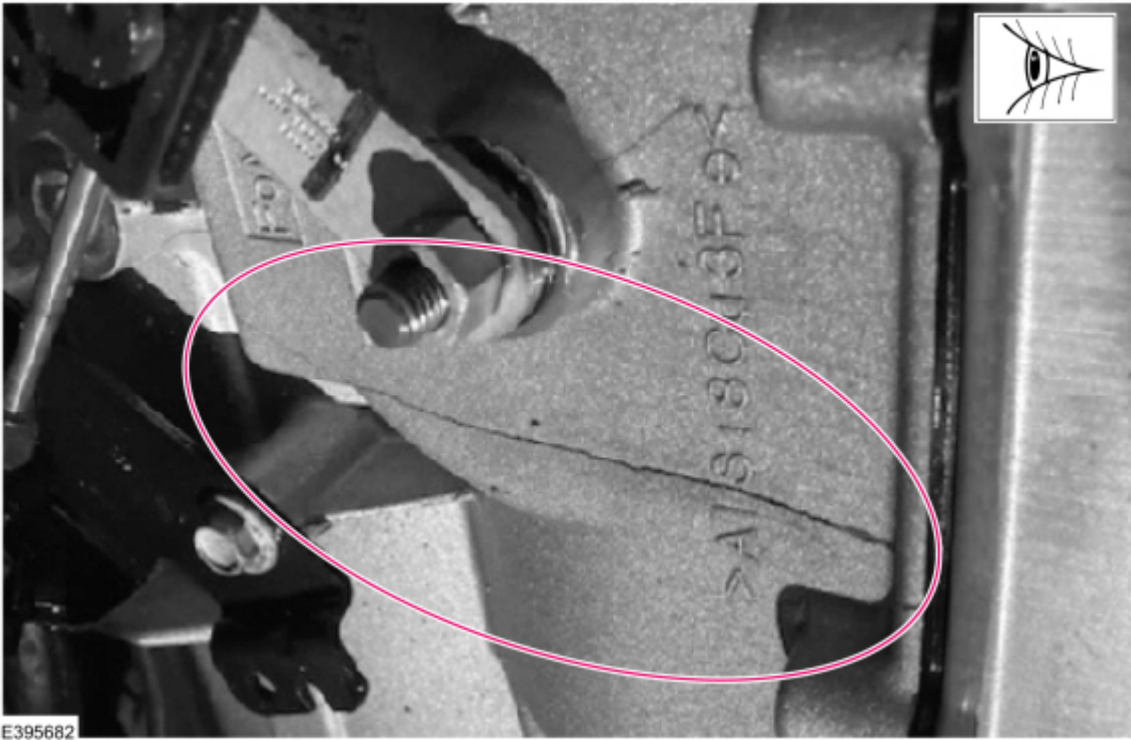
Issue: Some 2015-2019 F-Super Duty vehicles may experience a transmission fluid leak from a cracked transmission case or transmission fluid pan. This may be due to a driveline vibration condition. For vehicles that have a concern with a cracked transmission case (Figures 1-2) or fluid pan (Figures 3-4), the rear driveline imbalance most often is the root cause of this concern. To correct the condition, follow the Service Procedure to replace the rear driveline.

For vehicles that have a concern with a cracked transmission case (Figures 1-2) or fluid pan (Figures 3-4), the driveline imbalance most often is the root cause of this concern.

1. Replace the following rear driveline components with the transmission repair per Workshop Manual (WSM), Section 205-01:
 - Driveshafts
 - Rear flanges

- Rear universal joints
 - Center support bearings
 - Transfer case
2. After repair and prior to vehicle delivery to the customer, confirm all of the following are within specification.

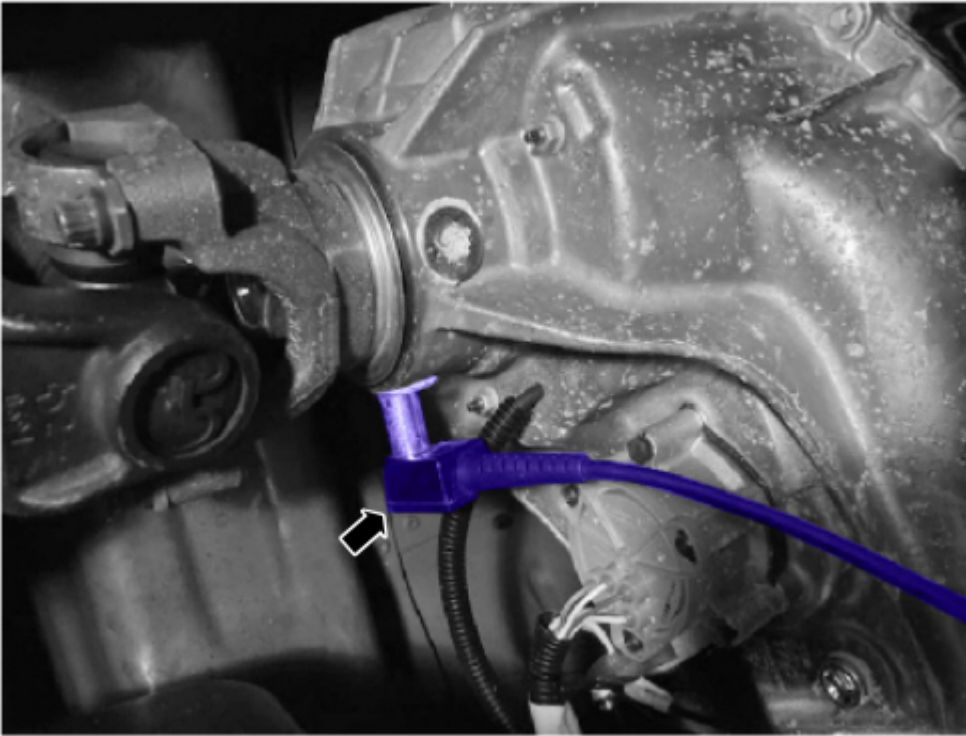
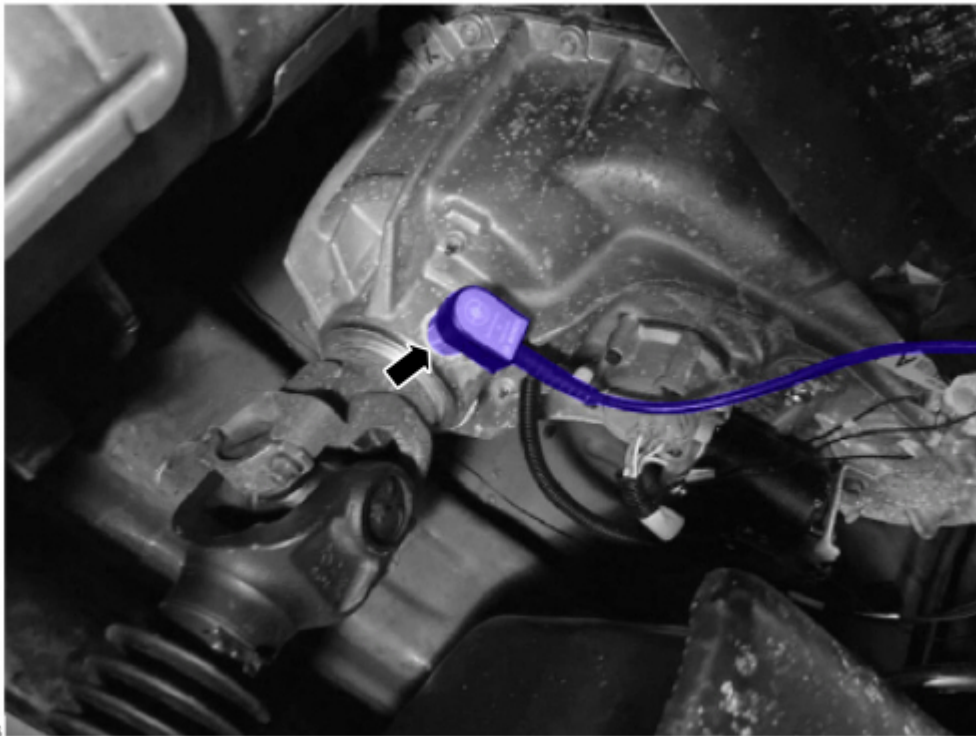
- (7). Verify the driveline vibration analysis at maximum vehicle highway speed with Rotunda VMS or equivalent. For accelerometer placement, refer to Figures 5-6.
