Service Bulletin

Bulletin No.: 00-06-01-026P

Subject: Engine Replacement After Severe Internal Engine Damage – Replace Intake Manifold

Models: 2023 and Prior GM Passenger Cars and Trucks (including Medium Duty)
Equipped with Gasoline, CNG or LPG Engine

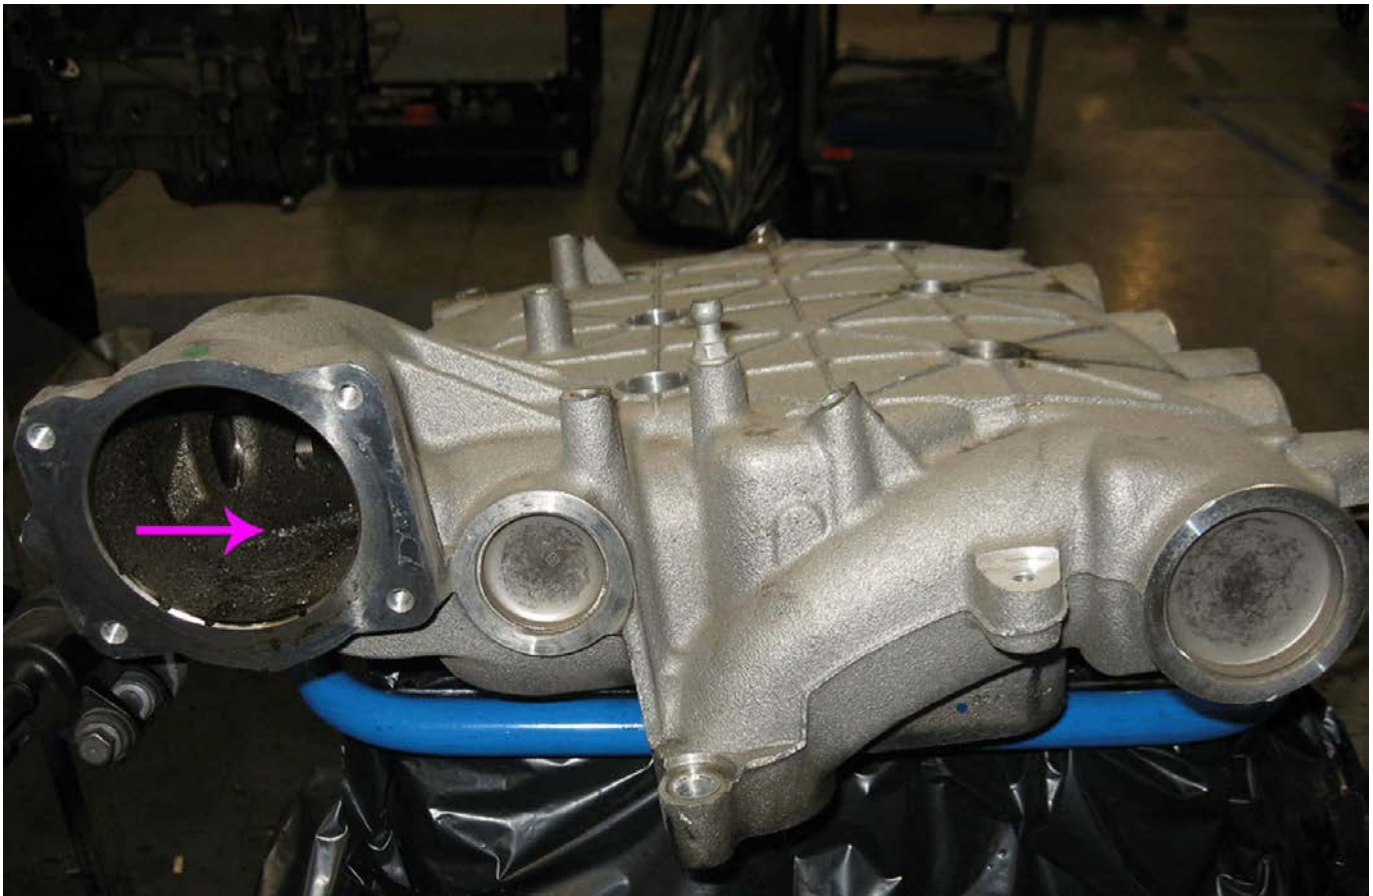
4246245

View of Debris in Aluminum Intake Manifold – Throttle Body Opening

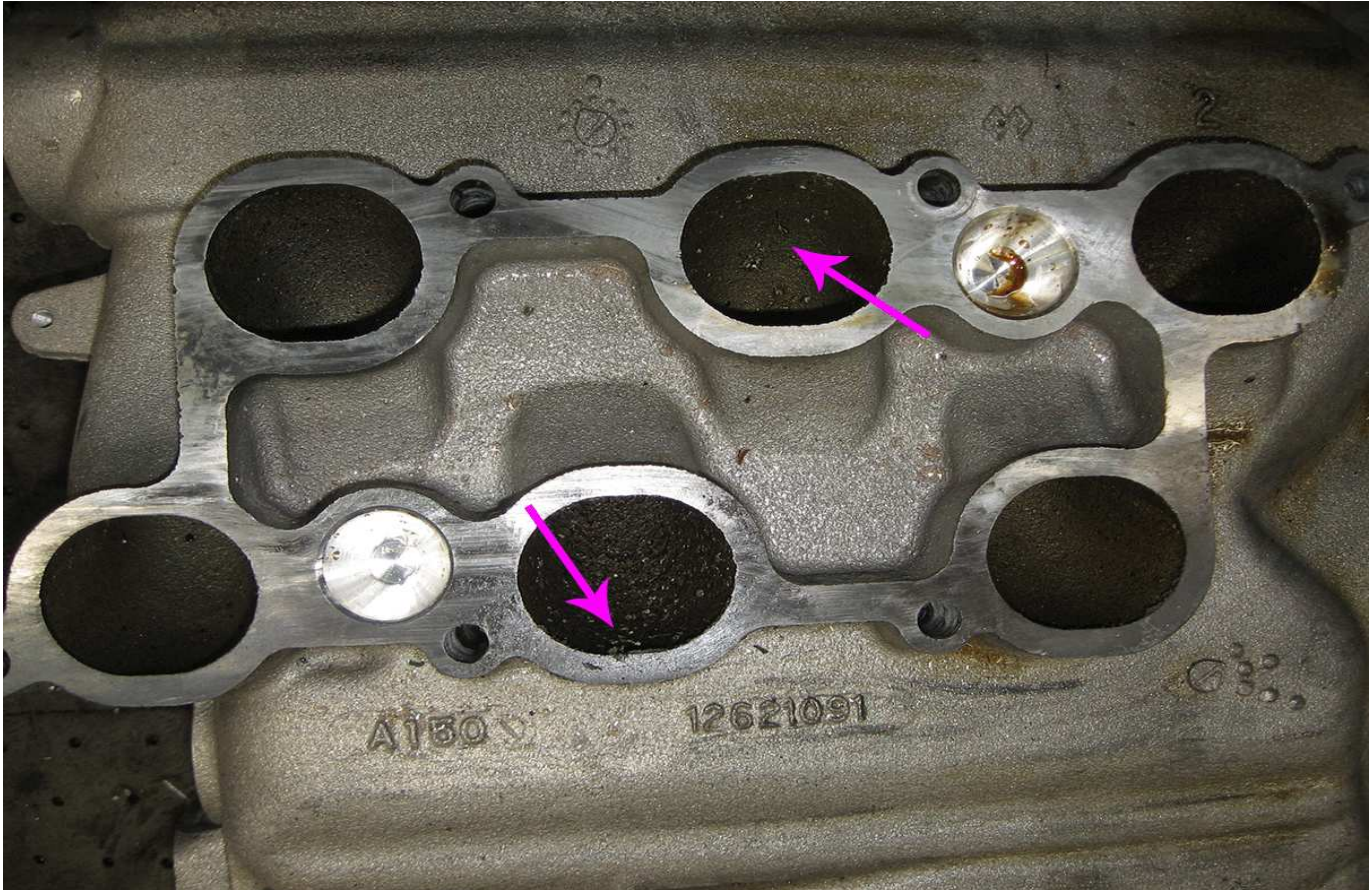
4247214

View of Debris in Aluminum Intake Manifold – Ports to Cylinder Heads

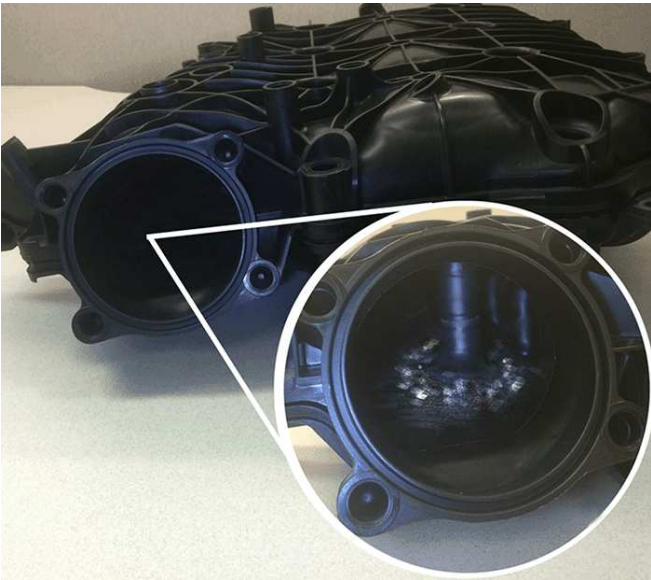
4246791

View of Debris in Plastic Intake Manifold – Throttle Body Opening

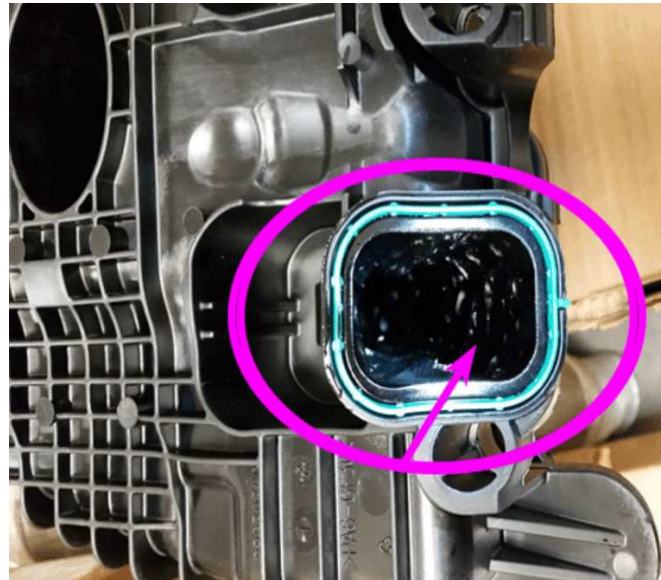
4565447

View of Broken Valve that Blew Debris Back into the Intake from the Combustion Chamber

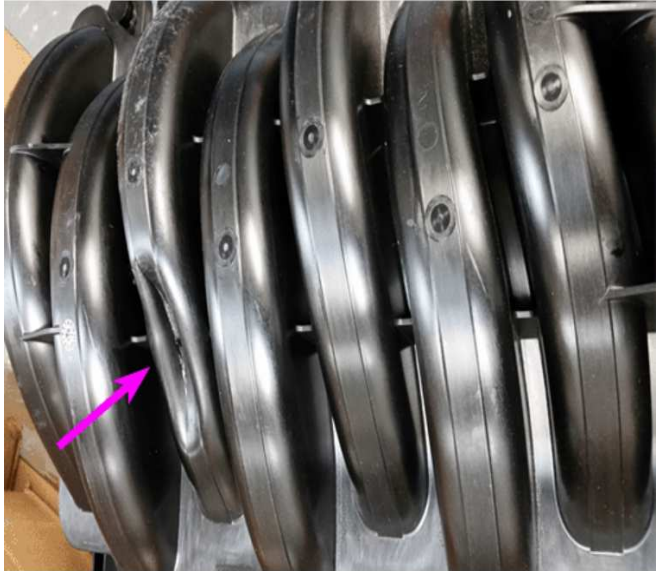
4565440

View of Intake from GEN 5 V8 that Experienced Lifter Collapse and/or Broken Valve Spring

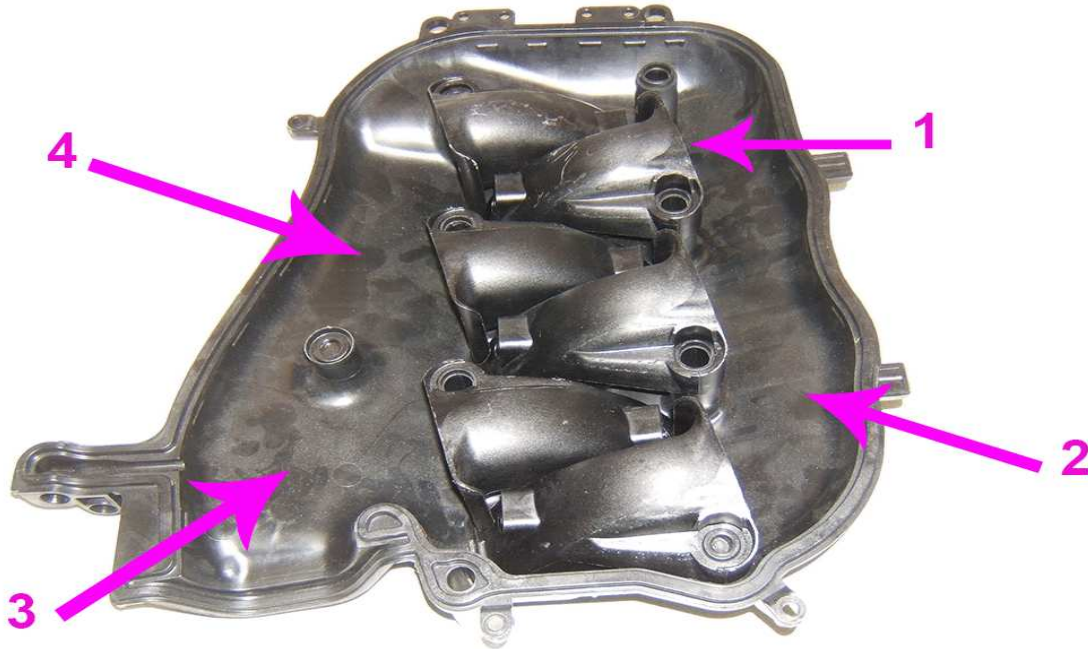
4247259

Internal View of Plastic Intake Manifold Lower Half – Plenum and Runner Complexity

This internal view shows the plenum and runner complexity and is the reason why the intake manifold CANNOT be completely cleaned of debris.

1. Intake port to cylinder head opening.
2. Areas where debris can collect.
3. Areas where debris can collect.
4. Areas where debris can collect.

Notice: The plastic intake manifold CANNOT be disassembled.
