TECHNICAL SERVICE BULLETIN

4WD - Grinding/Clicking/Ratcheting Noise From Front Wheel Area

22-2219

20 June 2022

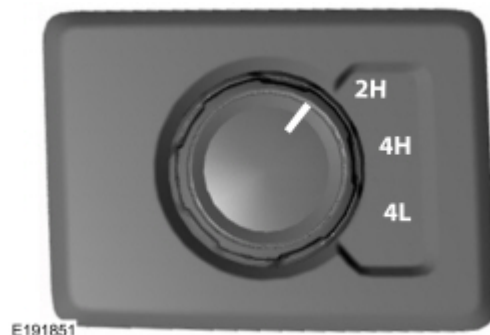
E191851

1. Does the vehicle have a MSS that only includes 2H, 4H and 4L positions (does not include 4A)? (Figure 1)

Figure 1 - Example of MSS without 4A selection

- (1). Yes - proceed to Step 2.
 - (2). No - proceed to Step 4.
2. Is the vehicle a 2017-2018 F-150?
- (1). Yes - reprogram the TCCM using the latest version of the appropriate Ford scan tool.

NOTE: The new TCCM calibration changes IWE operation at start up. When ambient temperature is above 0°C (32°F) the IWEs stay engaged regardless of a 4WD mode selection for approximately 0.8 km (0.5 miles). IWE engagement only occurs once per key cycle and is not reset when shifting between PARK and DRIVE. The TCCM uses this strategy to delay vacuum use until vacuum-intensive engine startup has completed and sufficient vacuum is available to fully disengage IWEs.

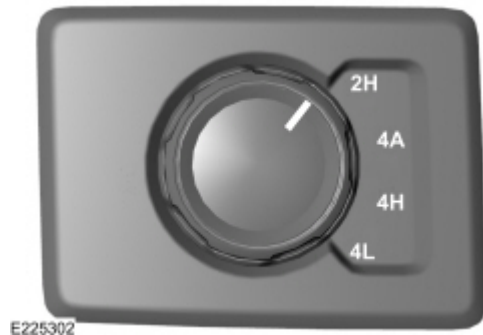
4. Does the vehicle have a MSS that includes a 4-wheel auto (4A) option? (Figure 2)

Figure 2 - Example of MSS with 4A selection

(1). Yes - proceed to Step 5

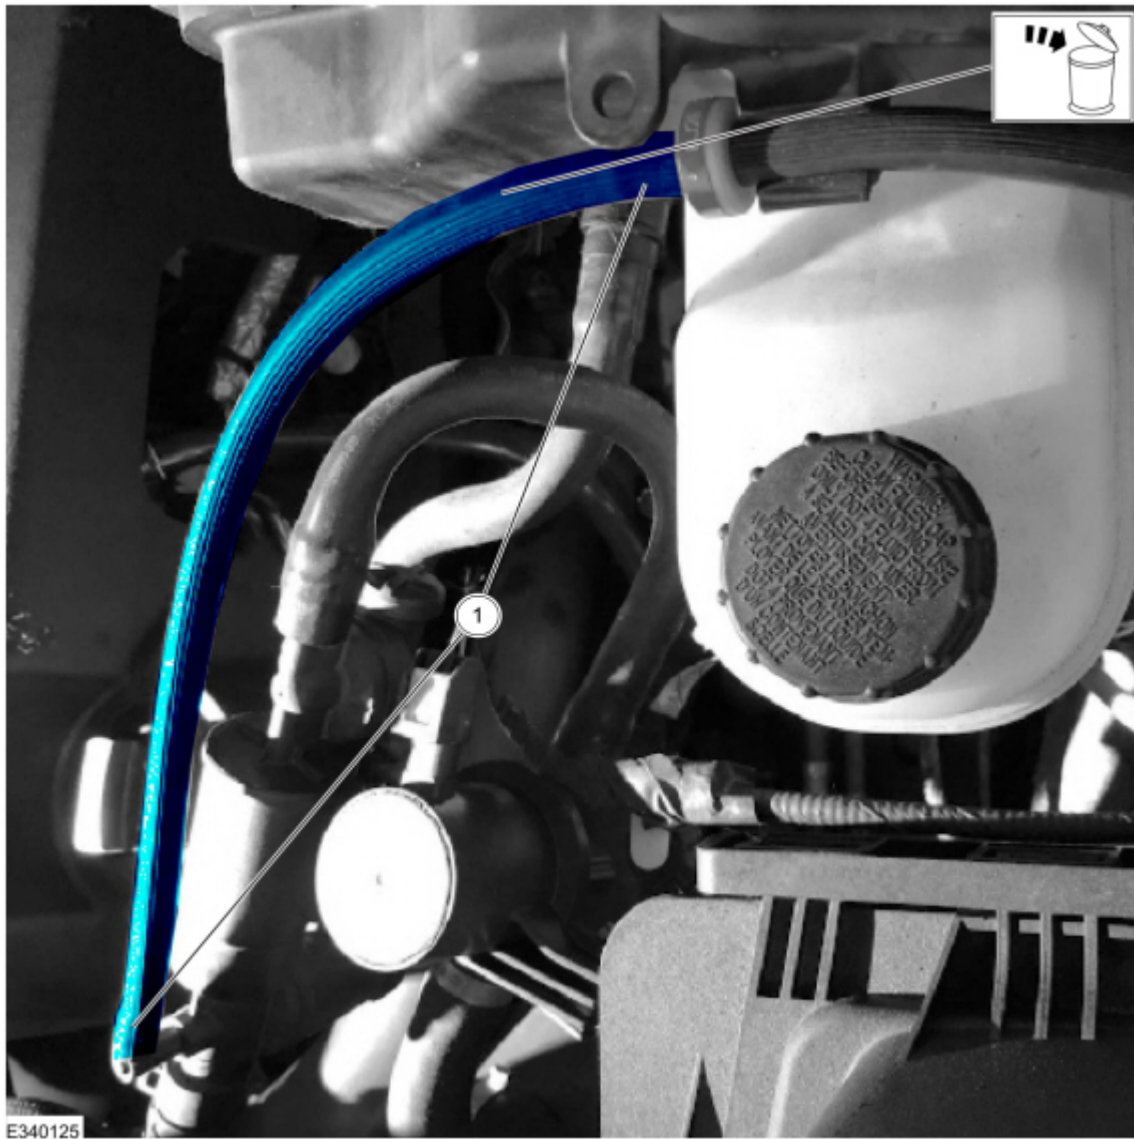
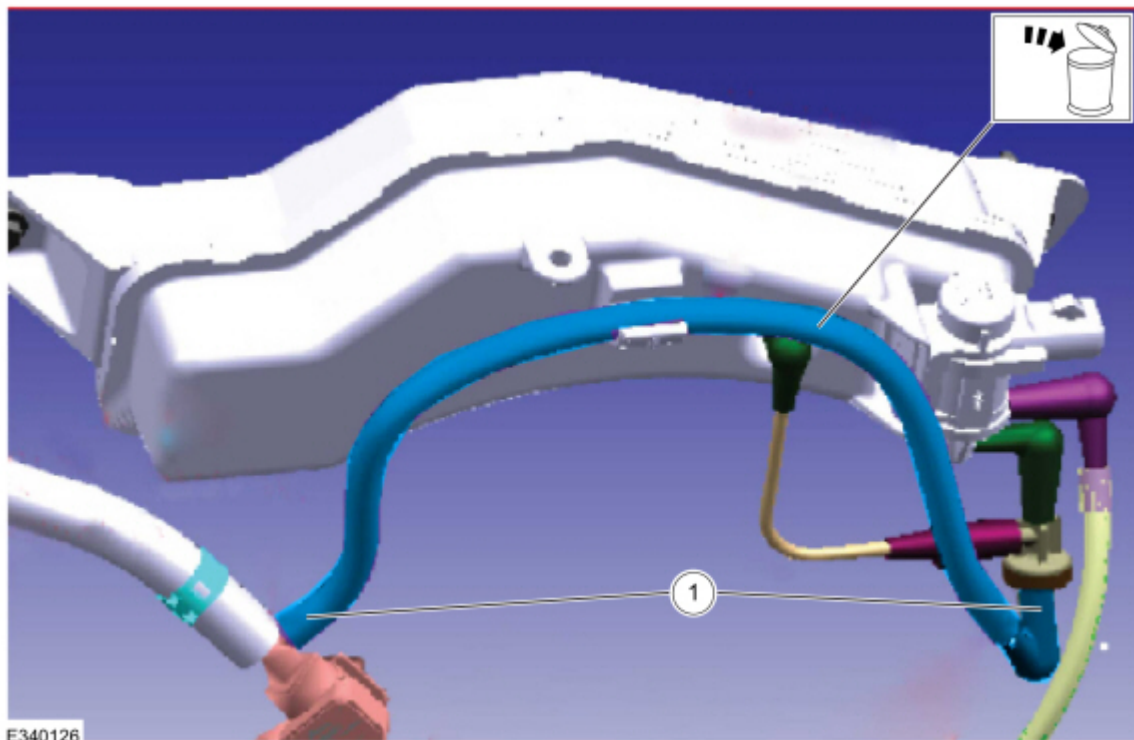
5. Locate the vacuum supply line between the source vacuum and the IWE check valve. Refer to WSM, Section 308-07A. (Figures 3-4)

6. Remove the vacuum supply line.

7. Install the vacuum caps at the IWE check valve and the vacuum source.
