SERVICE BULLETIN

APPLICABILITY: 2019-22MY Ascent
2020-22MY Legacy & Outback 2.4L Turbo

NUMBER: 16-136-22R

SUBJECT: Vibration & Possible Judder Concern on Turns Under Acceleration

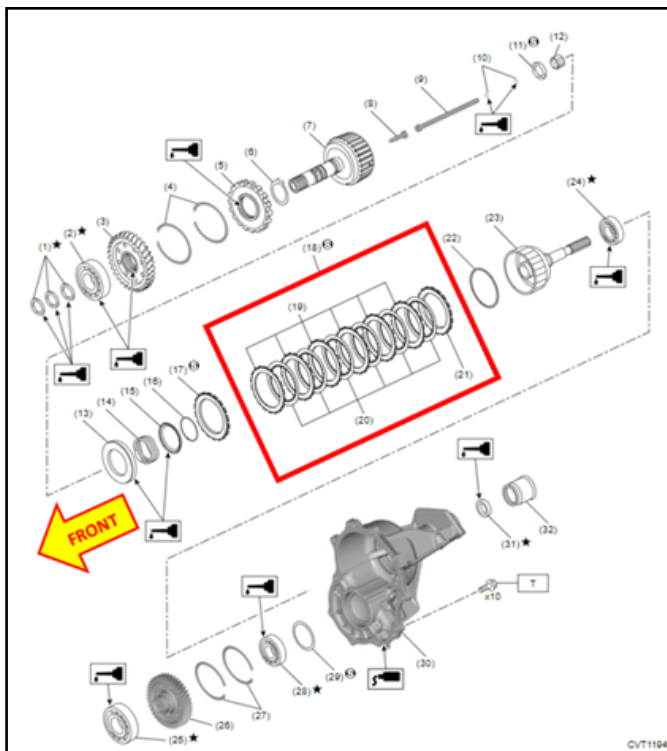
There is a specified sequence of assembly for the Driven Plates (19) and the Drive Plates (20).

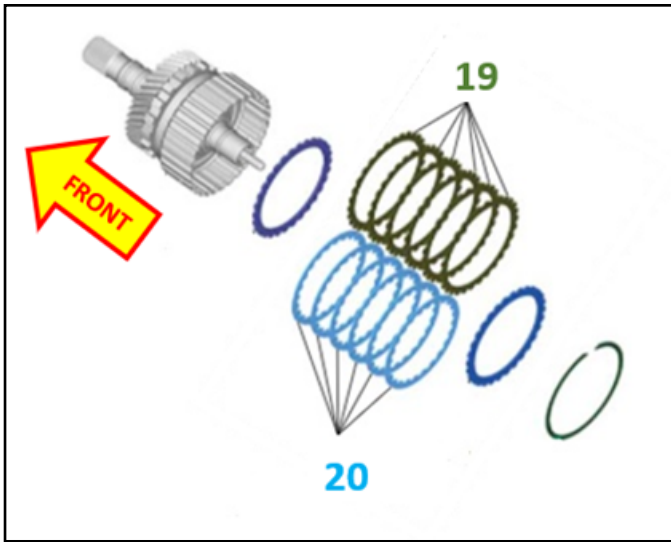
As per the applicable Subaru Service Manual, assembly of the Plates must start with the external toothed Driven Plates (19) and then alternately assembled with the internally toothed Drive Plates (20).
