Service Bulletin

Bulletin No.: 22-NA-022

Subject: Diagnostic Tip for LM2 Diesel with a Rear Main Oil Leak with or without DTC P06DD set

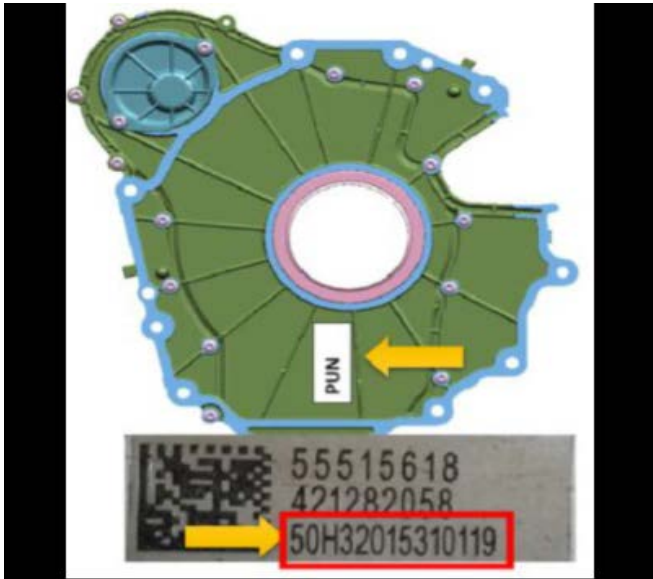
5786767

Record the Part Unique Number found on the white label attached to the back of the cover as shown in the picture below.

Example: PUN 50H32015310119

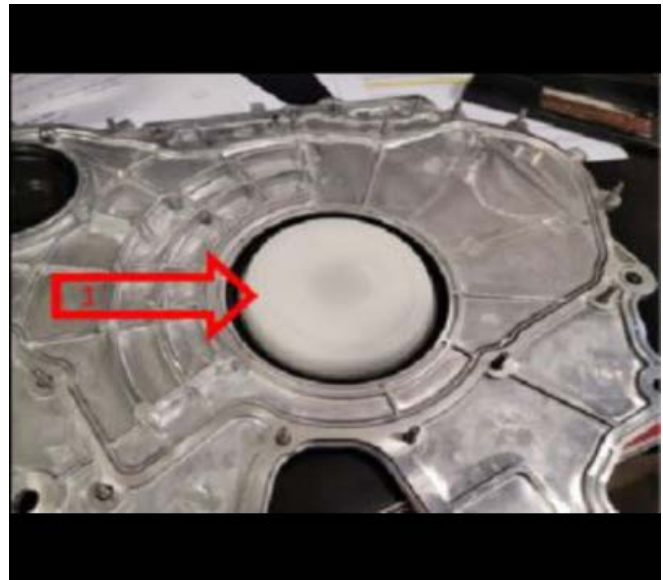
5786654

The Timing Chain Lower Cover comes with a 2 piece protector/installer.

The inner piece becomes an installation tool.

The outer piece simply holds them together for shipment.

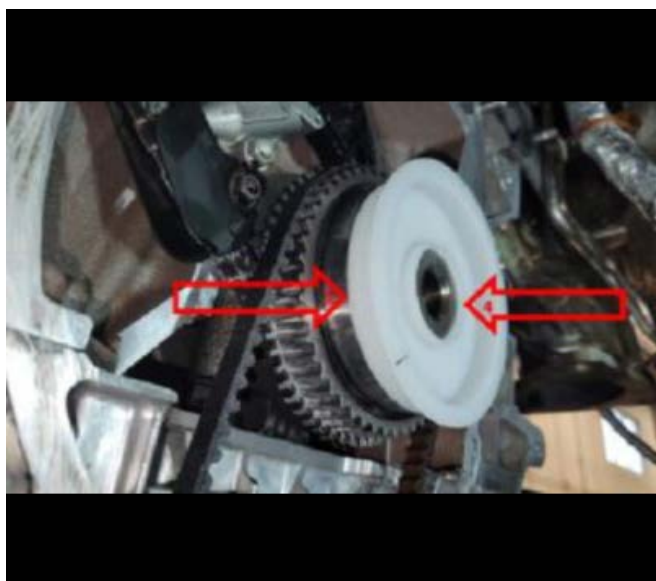
5786655

Note: The inner piece is an installation tool designed to be a substitute for the EN52466-2 installation tool. It fits over the bevel on the end of the crankshaft to facilitate installation. Be extremely mindful that the inner lip of the seal slides over the rear of the crankshaft without rolling or a repeat oil leak will occur. The protector/installer has a snug fit to the pilot of the crankshaft.

The picture below is shown without the cover for clarity.
