Service Bulletin

Bulletin No.: 22-NA-182

Subject: Information on 6L80 6L90 8L90 10L80 10L90 10L000 Equipped Vehicles With A Harsh Shift, Shudder, Surge, Stall, Transmission Overheating and/or High Transmission Fluid Temperature

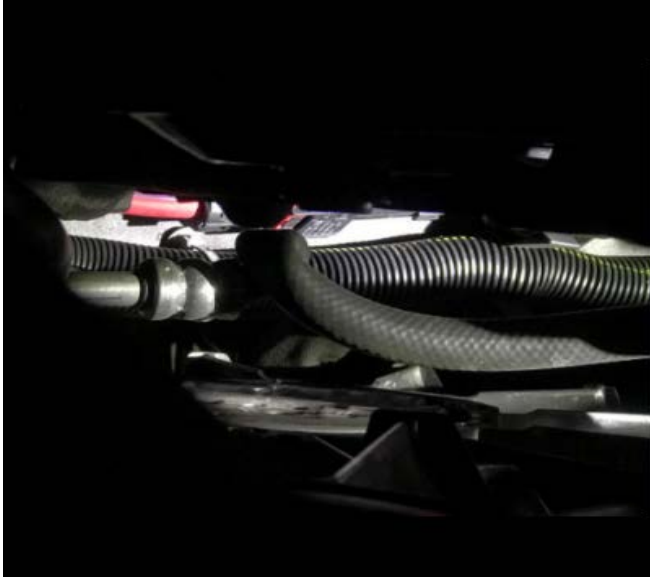
Involved Region or Country	North America, Uzbekistan, Middle East, Brazil (Mercosur), Colombia (West), Ecuador (West), Peru (West), Japan, Cadillac Korea (South Korea), Thailand (ASEAN), Europe, Australia, New Zealand.
Condition	<p>Some customers may comment on one or more of the following before or after the transmission has been overhauled:</p> <ul style="list-style-type: none"> • Harsh shifting • Shudder • Surging • Stalling • Transmission overheating <p>Some customers may also comment on above normal transmission fluid temperature.</p>
Cause	This condition may be caused by a twisted cooler line on low mileage vehicles.
	<p>Note: A twisted cooler line may cause DTC P27EC to set in the TCM on ETRS transmissions. (RPO MHS MQC).</p>

<p style="text-align: right;">5758376</p> <p>Inspect for a twisted cooler line, example shown in the graphic above.</p> <p>In some cases, it may be necessary to remove the under body panels in order to clearly see the cooler lines.</p> <ul style="list-style-type: none"> • If the cooler line is twisted, disconnect the cooler line from the transmission auxiliary cooler and untwist it, then reconnect the cooler line. • If the cooler line remains misshaped after untwisting, the cooler line should be replaced then check the transmission fluid level following SI. Add fluid if needed. • If no concerns are found with the rubber line being misshaped, check the transmission fluid level following SI. Add fluid if needed. <p>The Thermal Bypass Valve (TBV) may be the cause of the overheat if a cooler line is not twisted or misshaped. The TBV will open at the following temperatures for the models listed in this TSB. 6 Speed (6L80, 6L90) - 158F (70C) - TBV is external to the transmission 8 Speed (8L90) - 194F (90C) – TBV is external to the transmission 10 Speed (10L80, 10L90, 10L1000) – 143F (61C) – TBV is within the valve body on all listed applications expect those equipped with 3.0 (LM2) Diesel. On the LM2 Diesel the TBV is external to the transmission</p>
