Service Bulletin

- Subject: Use of Surface Conditioning Disks When Cleaning Gasket Sealing Surfaces and/or Reused Parts
- Models: 2023 and Prior GM Passenger Cars and Trucks including Silverado 4500HD, 5500HD and 6500HD (Excluding Chevrolet Medium Duty Low Cab Forward Equipped with Diesel Engine).
- Attention: This bulletin also applies to any of the above models that may be North America Export vehicles.

This bulletin has been revised to add the 2023 Model Year and an Important statement under Recommended Cleaning Procedure. Please discard Corporate Bulletin Number 00-06-01-012K.

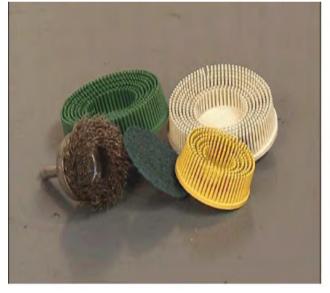
2726943

Notice: Do not use abrasive pad/bristle devices to clean the gasket surfaces of any engine, transmission, transfer case and axles as well as any other component that contains lubricant. Abrasive pads should not be used for some of the following reasons:

- Abrasive pads will produce fine grit that the oil filter will not be able to remove from the oil. THIS GRIT IS ABRASIVE AND HAS BEEN KNOWN TO CAUSE INTERNAL ENGINE DAMAGE. Abrasive pads can easily remove enough material to round cylinder head surfaces. This has been known to affect the gasket's ability to seal, especially in the narrow seal areas between the combustion chambers and coolant jackets.

- Abrasive pads, wire and abrasive rubber finger wheels can also remove enough metal to affect cylinder head, block, oil pan rail, and intake manifold runner flatness, which can cause coolant and oil leaks and air leaks. It takes about 15 seconds to remove 0.203 mm (0.008 in) of metal with an abrasive pad.

- Abrasive pads, Abrasive rubber fingers wheels & wire wheels with high speeds grinders produce airborne debris that can travel throughout the shop contaminating other work being performed outside of the immediate work area.

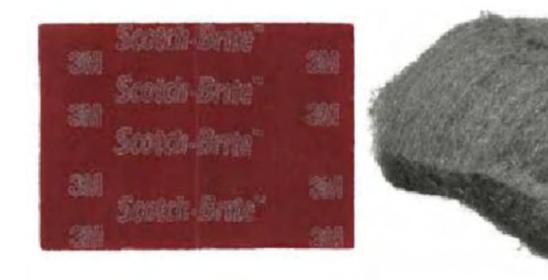
4809214

The use of an abrasive hand pads and/or steel wool can also create imperfections in the metal and therefore are not recommended for use when cleaning surfaces.

When cleaning gasket sealing surfaces and/or cleaning parts that are to be reused, surface conditioning disks, hand pads, or steel wool (typically constructed of woven fiber, steel or molded bristles) that contain abrasives, such as a high amount of Aluminum Oxide, should NOT be used.

The use of such surface conditioning items dislodges Aluminum Oxide (from the disk) and metal particles (from steel wool), which can lead to premature engine bearing failure.

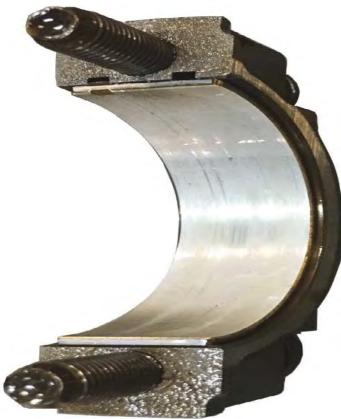
The presence of Aluminum Oxide in engine oil has been shown to cause premature engine bearing failure. In some cases, this failure occurs in as little as 2,200 km (1,367 mi) or less after the repair has been made.

The scratches on the bearings in the above picture were created when debris from an abrasive pad made its way into the bearing. This debris is a combination of the metal and particles from the abrasive pad that were removed when the engine was cleaned.

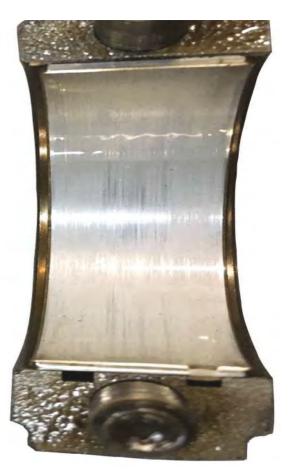
Surface conditioning disks may grind the component material and imbed it into the disk. This can result when more aggressive grinding of the gasket surface takes place.

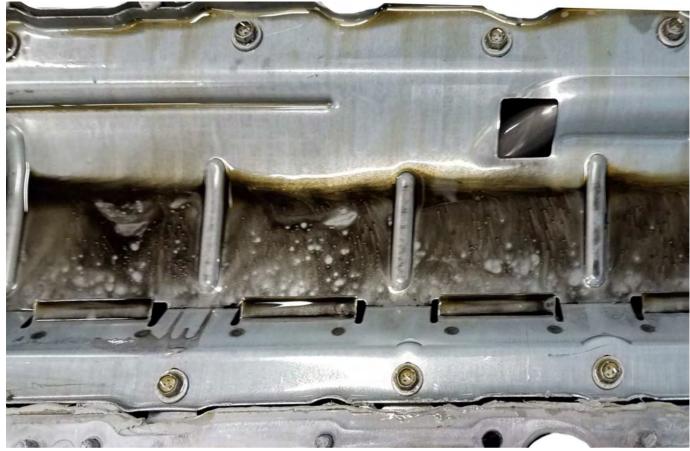
4789486

The crankshaft deflector in the picture above has debris that was left behind from the abrasive cleaning methods. Once the debris has gotten here, it can be distributed to any surface in the engine.

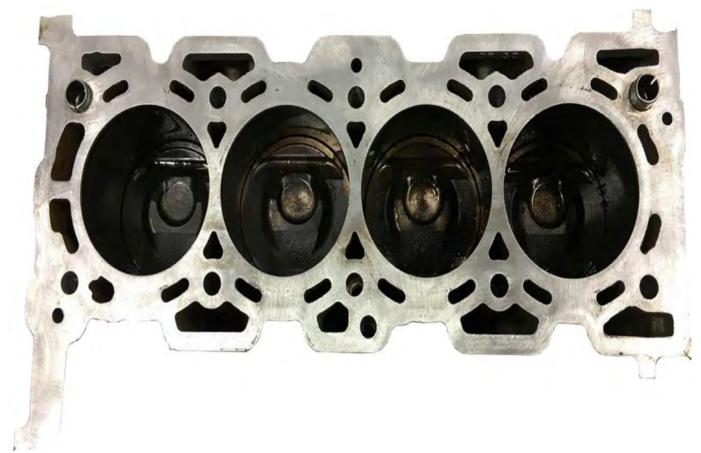
An overview of the deck face when it has been cleaned with an abrasive pad, left swirls on the surface and do not go in the same direction, which caused changes in the surface dimensions (flatness) of the block leaving it un-usable.

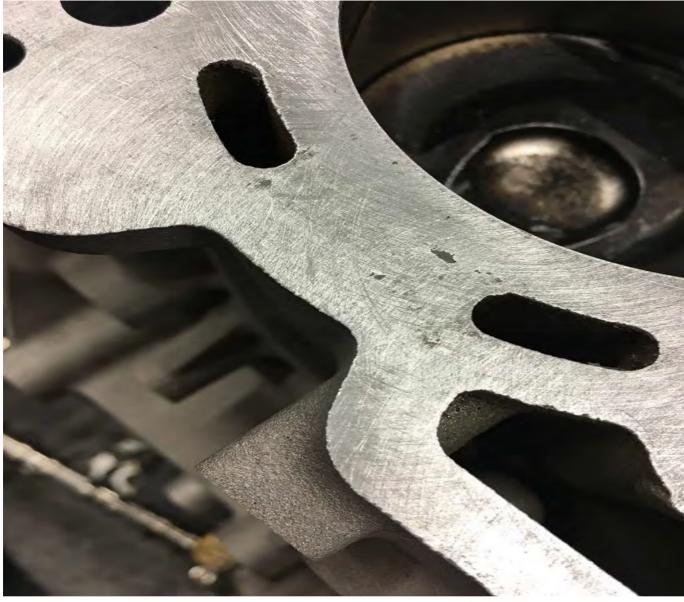
Scratches from the pad are deeper in some areas than others causing the gasket/seals not to properly seal against an uneven surface.

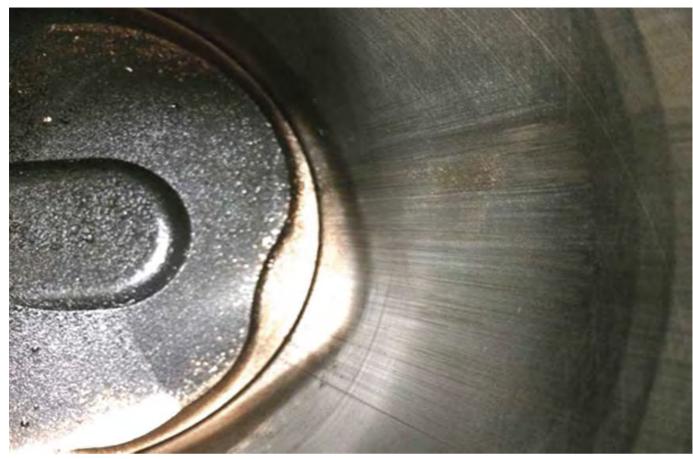
Note: Damage to the pistons and/or cylinder walls may result in an engine knocking, tapping and/or possible low compression.

The sides of this cylinder wall were scarred with scratches as a result of the debris created by the abrasive cleaning pads. This debris gets trapped between the piston head and the cylinder wall causing damage to the cylinder bore as the piston moves up and down.

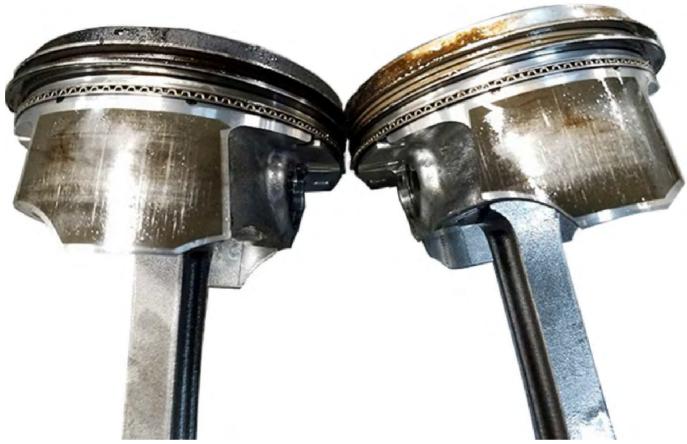
The piston skirt and piston ring damage caused by abrasive cleaning pads.

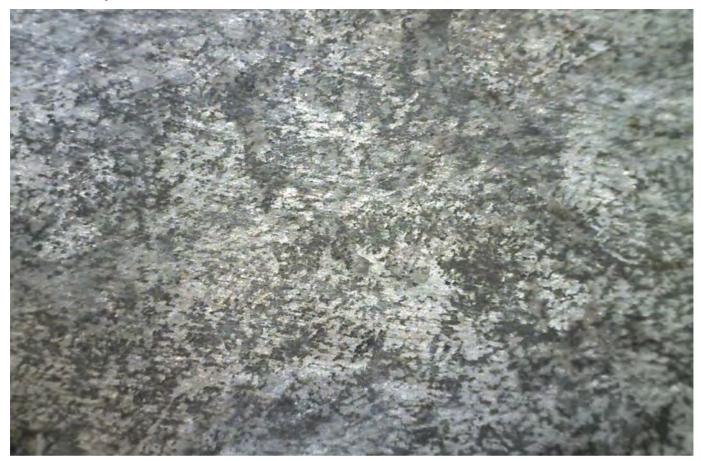
A close up of the sealing surface after cleaned with GM Low VOC Cleaner and plastic scraper.

To properly clean the sealing surface prior to reassembly, GM Low VOC Cleaner, P/N 19287401, in Canada, P/N 88901247 and in Australia, P/N 88900163, should be sprayed on the mating surface. Use care to avoid getting solvent in any area other than the mating surface to be cleaned. Allow it to soak in for several minutes to loosen the old RTV sealer/gasket material. GM strongly recommends using a plastic razor blade or non- metallic scraper to remove all loose sealer/gasket material.

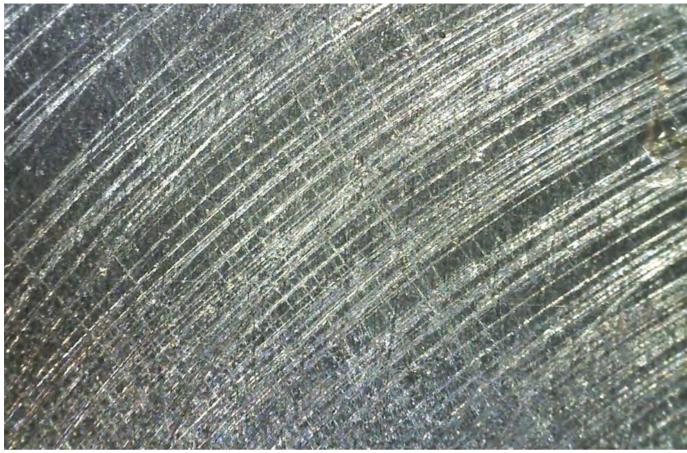
A close-up of the surface shows deep grooves caused by using an abrasive cleaning disc.

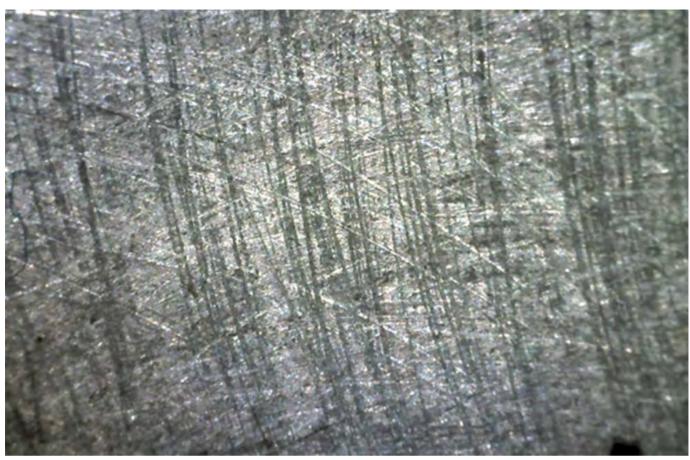
4791276

A close-up of the surface shows deep grooves caused by use of a wire wheel.
