Service Bulletin

Bulletin No.: 22-NA-019

Subject: Malfunction Indicator Lamp (MIL) Illuminated with DTC P2251 and/or DTC P2254 Set

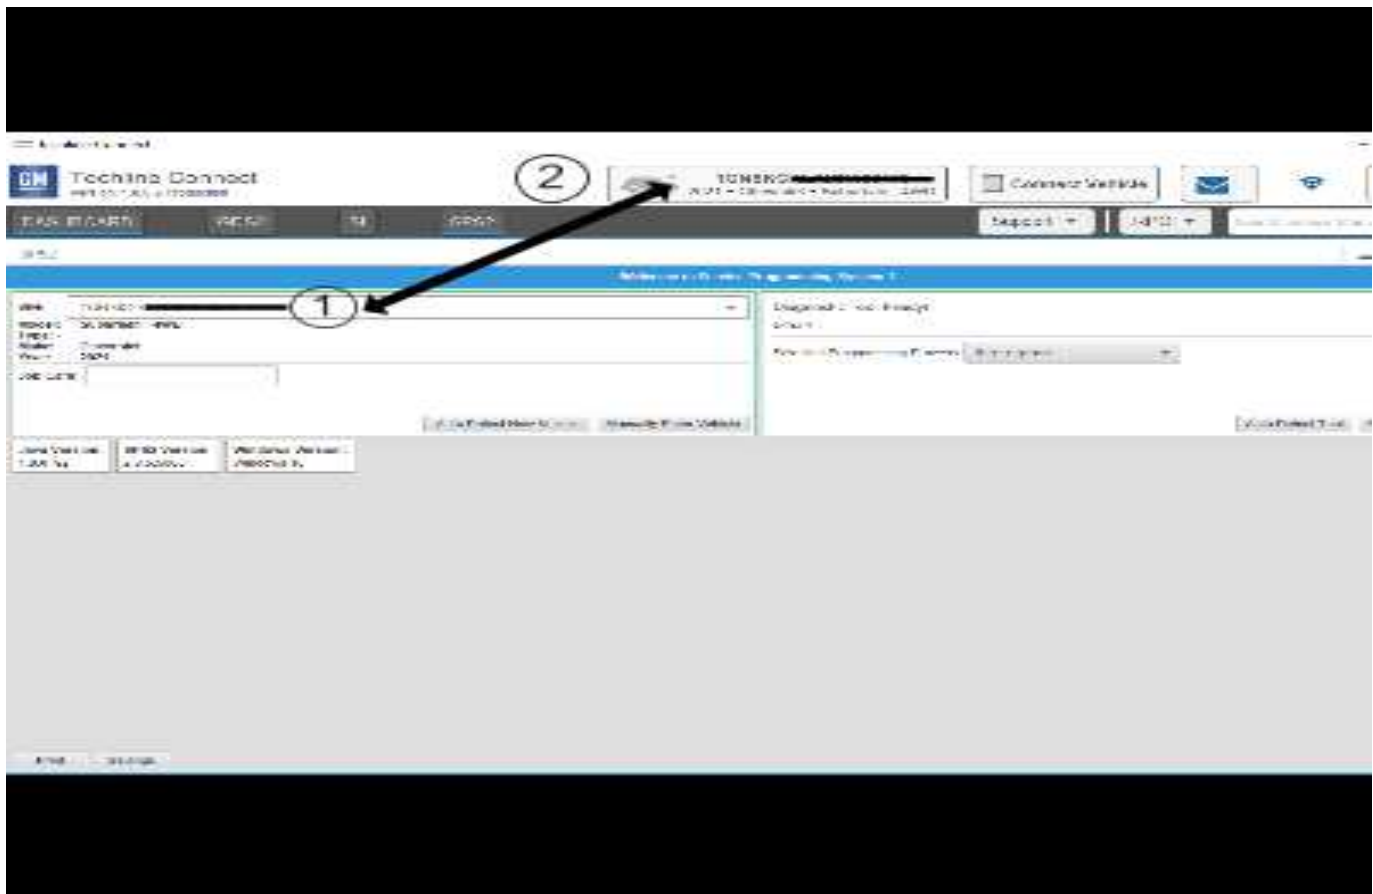
Caution: Be sure the VIN selected in the drop down menu (1) is the same as the vehicle connected (2) before beginning programming.

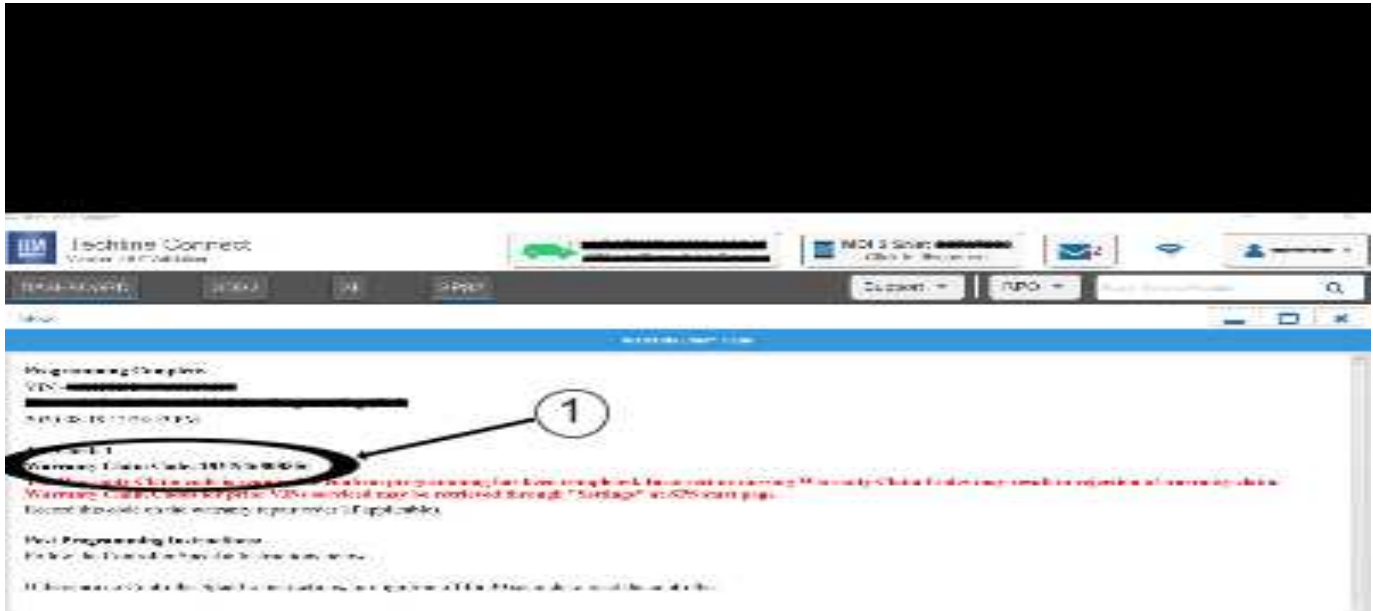
Note: The screenshot above is an example of module programming and may not be indicative of the specific module that is being programmed. Module selection and VIN information have been blacked out.

Important: To avoid warranty transaction rejections, you **MUST** record the warranty claim code provided on the Warranty Claim Code (WCC) screen shown above on the job card. Refer to callout 1 above for the location of the WCC on the screen.

1. Reprogram the Engine Control Module. Refer to *K20 Engine Control Module: Programming and Setup* in the Service Manual.

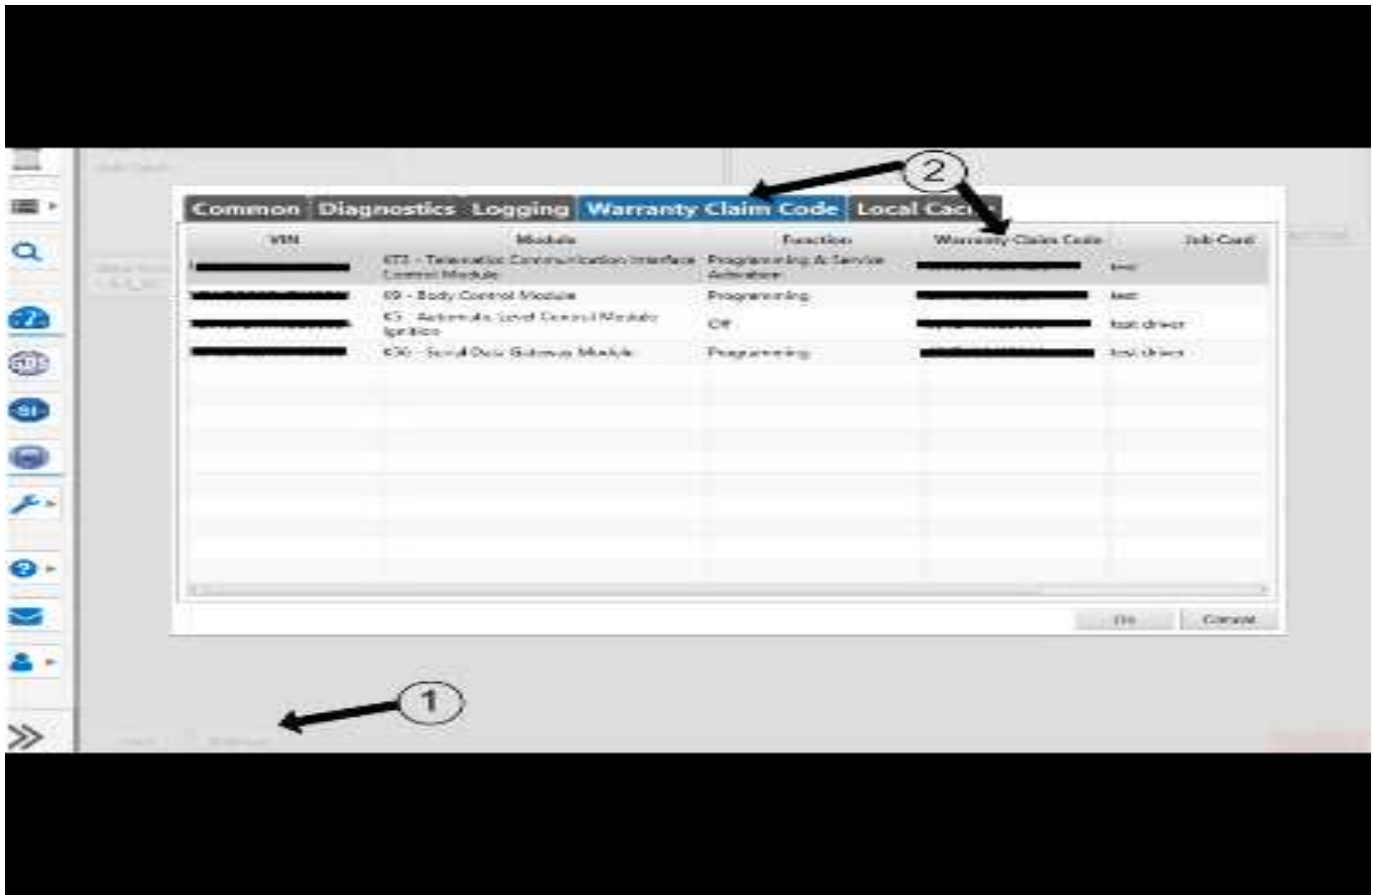
6125774

If the Warranty Claim Code was not recorded on the Job Card, the code can be retrieved in the SPS2 system as follows:

1. Open TLC on the computer used to program the vehicle.
2. Select and start SPS2.
3. Select Settings (1).
4. Select the Warranty Claim Code tab (2).

The VIN, Warranty Claim Code and Date/Time will be listed on a roster of recent programming events. If the code is retrievable, dealers should resubmit the transaction making sure to include the code in the SPS Warranty Claim Code field.
